EWS1 Report

1-44 Bramley Hill

30th April 2021

Croydon Borough Council

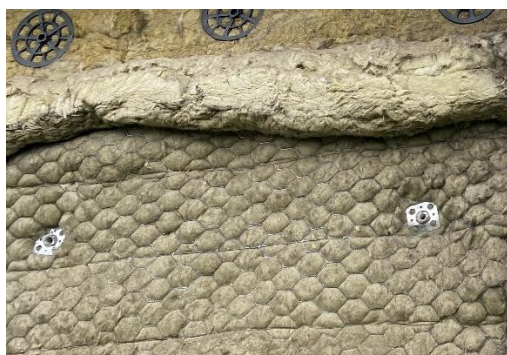
Figure 10. Location 1.1 horizontal cavity barrier with mechanical fixings.

Location 1.1 was at the second-floor level where the cavity barrier between the first and second-floor level was identified. A horizontal cavity barrier was found in this location. The cavity barrier was found to abut the cladding support bracket.

Cavity barriers at locations 1.1, 1.2 and 1.3 were found to consist of mineral wool, reinforced with wire, fixed to the underlying mineral wool insulation with metal fixings. One edge of the mineral wool cavity barrier is folded over so that it compresses onto the aluminium cladding to fill the full width of the cavity. One edge of the cavity barriers is folded over to achieve the compression. Cavity barriers should be fully folded, but only a lip has been folded over, or an edge. This is considered to be suitable because good compression is achieved and the barrier creates a good seal. It is considered that the cavity barriers folded like this would be effective in reducing the migration of fire and smoke.

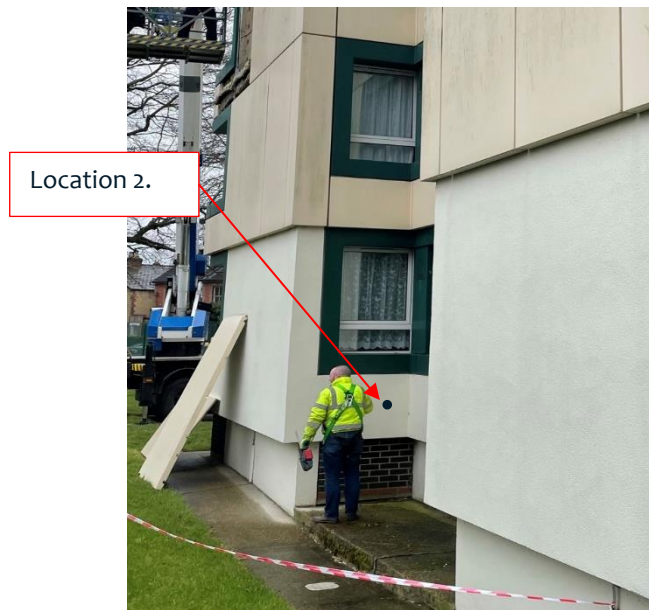
Figure 12. Location 2.

Location 2 was at the ground-floor level, investigating the make-up of the rendered system covering the ground-floor level. The aluminium cladding covers first-floor level and above. It is considered that the polyurethane foam is combustible.

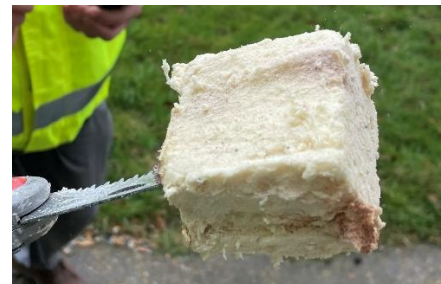
Figure 14. Location 2 – Polyurethane foam and measurement.

The system contains a 135mm thick layer of combustible polyurethane foam insulation under the render. Due to the combustible nature of the product, it is recommended that the polyurethane foam insulation at ground-floor level is replaced with insulation that is non-combustible.

- Due to the combustible nature of the product, it is recommended that the polyurethane foam insulation at ground-floor level is replaced with insulation that is non-combustible.
- Infill panels located within the external façade in communal lobbies on the east and west elevations should be replaced with panels that are non-combustible.
- Ensure that all recommendations made within the fire risk assessment are actioned.

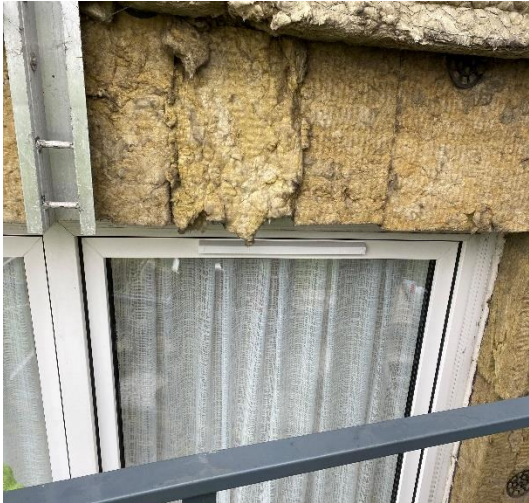
Figure 16. Location 3.1 – no cavity barriers provided around window openings.

No cavity barriers were identified around the window opening. This is consistent with the design guidance contained within Approved Document B 1992 that was current at the time the cladding and UPVC windows were installed. Window frames appear to have been installed without their original structural openings and have not been installed to suit the cavity created by the cladding.

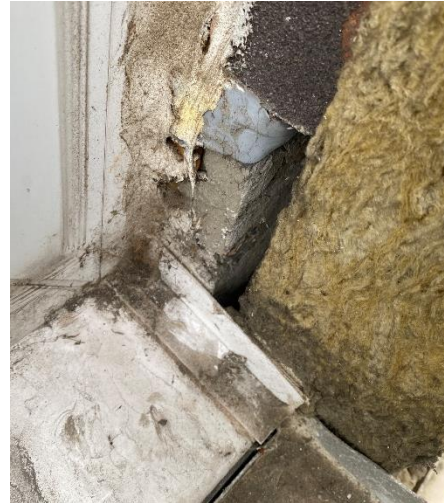
Figure 17. Location 3.1 – grey silicon/rubber expansion joint between the concrete compartment floor and the LPS panels.

A silicon/rubber expansion joint was also evident in this location between the reinforced concrete compartment floor and the LPS above. It is not considered that the silicon/rubber expansion joint seal will contribute to significant fire spread.

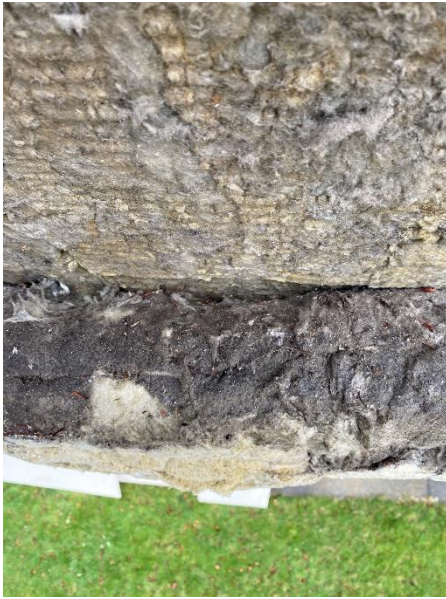
Figure 18. Location 3.2 folded cavity barrier.

Location 3.2 was at the third-floor level where the cavity barrier between the second and third-floor level was identified. The underlying substrate, consisting of large panel system, was drilled to gauge the thickness of the concrete. It was found that the concrete was at least 100mm thick.

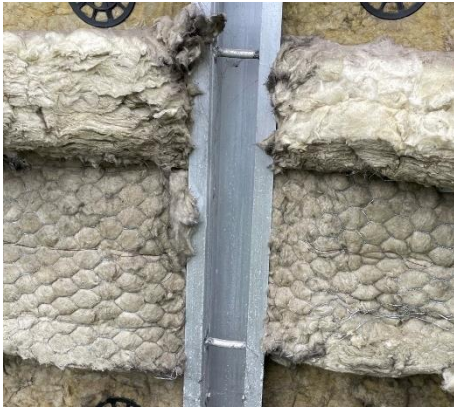
Within all three locations an aluminium bracket passes through the cavity barrier. The bracket is 100mm thick and the aluminium cladding panels fix onto it. The bracket is fixed to the underlying substrate. There is little concern that the brackets break the cavity barriers because the recessed opening in the brackets, where the cladding fixes into, is open to external air. There are also some brackets that are hidden behind panels that provide a central fixing for wider cladding panels. These are typically located below and above windows. The fixing bracket is hidden completely, so is not open to the atmosphere. This means that the cavity barrier is broken where the fixing bracket passes through it.

Figure 20. Location 3.1 - 100mm break in cavity barrier for an aluminium bracket.

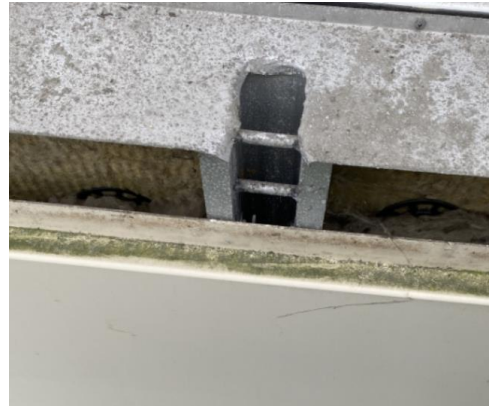
Figure 21. Location 3.3 - 100mm break in cavity barrier for an aluminium bracket. This bracket is hidden behind wider cladding panels, providing an additional fixing point for the panels.

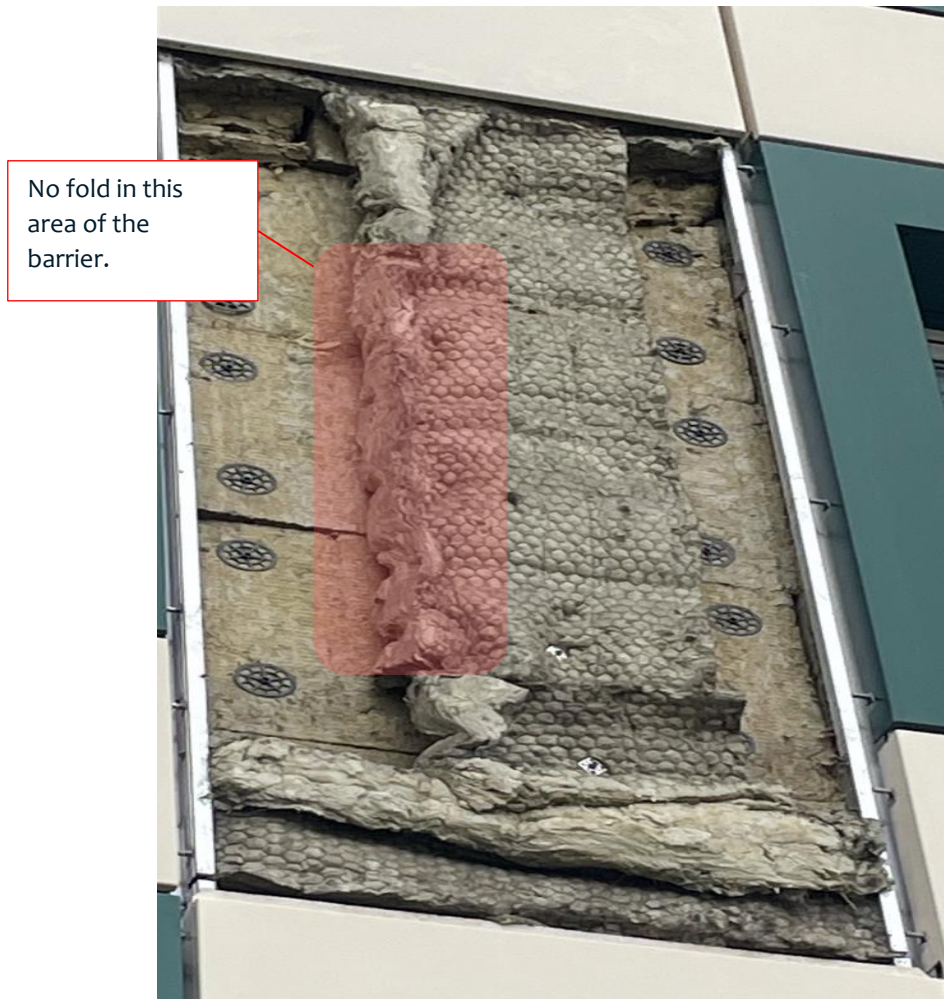
The vertical cavity barrier consists of the same mineral wool reinforced with wire. However in this location, as shown in figure 23 below, the cavity barrier is not folded along a section of it. This means that the cavity barrier would not fit compressed against the aluminium cladding panel, leaving a gap for fire and smoke to spread horizontally within the cavity. The risk is considered to be tolerable considering that it is only the vertical cavity barrier and the critical direction is vertically and not laterally. Horizontal cavity barriers were found to be compressed, meaning that any fire/smoke spread would be restricted to the cavity of the adjacent flat only and not flats above.

Figure 23. Location 4 – The vertical cavity barrier is not folded in the area highlighted.

There was also one issue identified concerning a vertical cavity barrier seen. As shown in figure 23, the cavity barrier is not folded along a section of it. This means that the cavity barrier would not fit compressed against the aluminium cladding panel, leaving a gap for fire and smoke to spread horizontally within the cavity. The risk is considered to be low and tolerable considering that this only relates to the vertical cavity barrier, and lateral fire spread is less critical. Horizontal cavity barriers were found to be compressed, meaning that any fire/smoke spread would be restricted to the cavity of the adjacent flat only and not flats above.

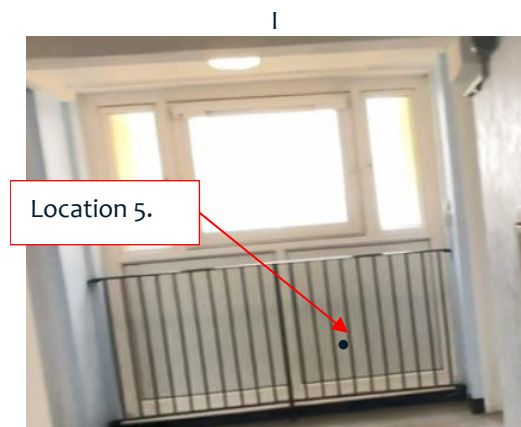
Figure 24. Location 5 – infill panel below glazed window.

Infill panels are located below glazing on external walls in the lobbies at each floor level on the west and east façade only. All infill panels appear to be the same and are consistent to those found on other similar Croydon owned buildings.

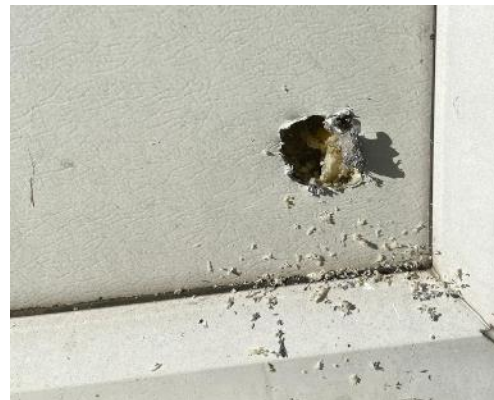
Figure 25. Location 5 – hole drilled and an unknown thermoplastic identified within the panel.

The system contains a small amount of combustible insulation within the infill panels. The window frames are broken at each floor level by reinforced concrete compartment floors and upstands. Although only a small amount of combustible insulation may be present within the infill panels, there is a risk of fire spread vertically, so therefore it is recommended that the infill panels are replaced with panels that are non-combustible.

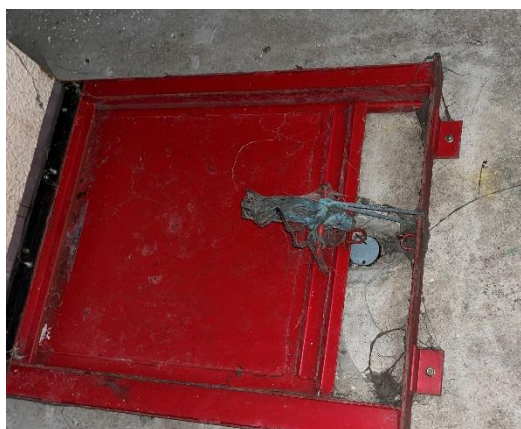
The bin store is accessed directly from external air via a door on the east façade. A bin chute serves all residential storeys, accessed directly within lobbies. The bin chute descends into the bin storeroom at ground-floor level where it is separated from the store by a heat activated fusible-link fire shutter. Unfortunately, at the time of the survey the fusible link had broken and the shutter was fixed open by rope. The fusible link should be replaced, and the rope removed.

Figure 26. Bin store automatic shutter – fixed open with rope.
