EWS1 Report

1-44 Grosvenor Road

30 April 2021

12125BB

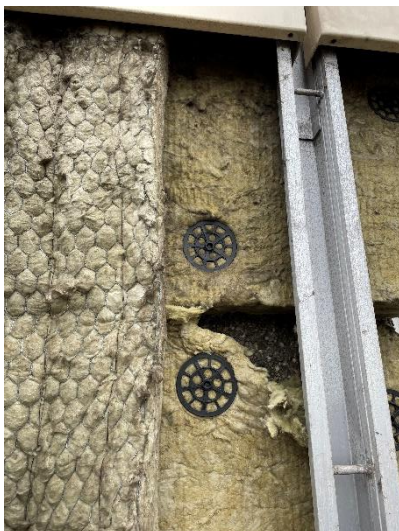
Location 1.1. was at the third floor party wall and both horizontal and vertical cavity barriers were identified. The cavity barriers at floor level sat between the aluminium rails (i.e. they were not continuous) and the vertical cavity barrier sat on the party wall between flats.

Figure 10. Location 1.1 vertical cavity barrier reinforced with wire but not folded over

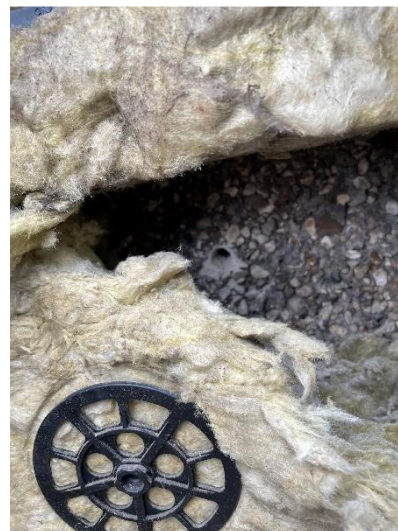
Figure 11. Location 1.1 cavity between solid concrete and aluminium panel

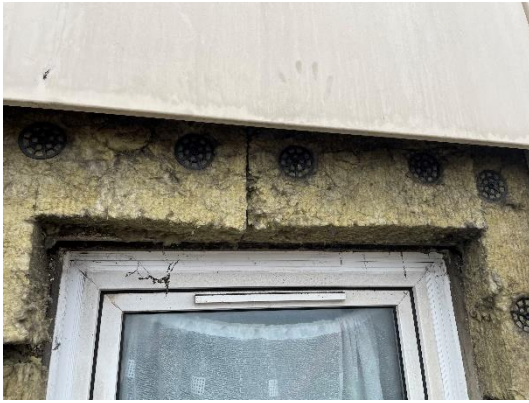
Based on information from the contractor the re-cladding took place in the late 1990's, the guidance at this time did not require cavity barriers around openings. The barrier under the opening at compartment floor level was partially folded rather than fully folded along its axis. It is considered that this will still provide an effective break in the cavity.

Figure 12. Location 1.2 no cavity barrier around window

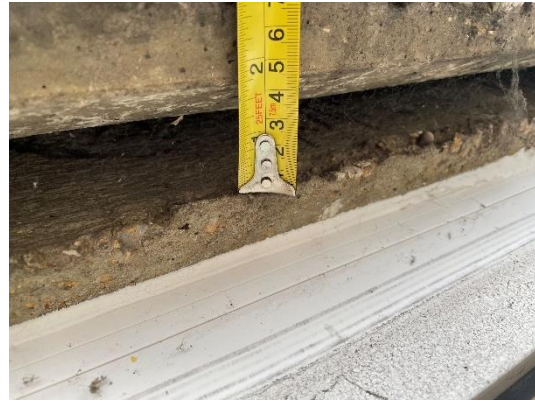
Figure 13. Location 1.2 40mm gap between LPS and infill panel

The concrete infill panel, as shown in the figures 13 and 14, appears to be a feature band that runs around the building which is integral to the existing large panel system based on the picture in Figure 1.

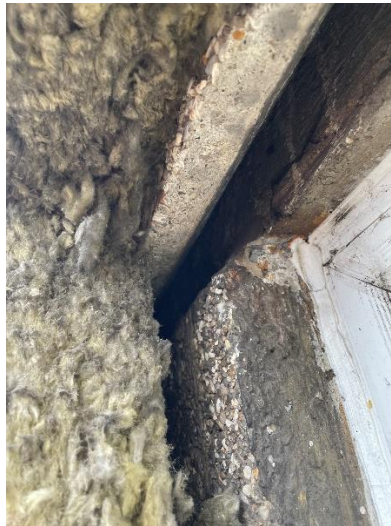
Figure 14. Location 1.2 concrete infill panel above window with 40mm gap

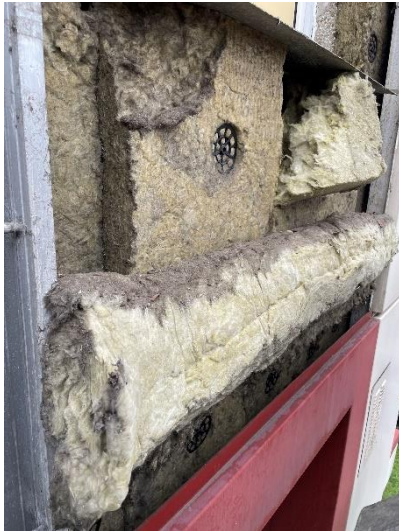
Location 1.3 was at the third floor above a flat window. There was a cavity barrier below the window at floor level but nothing above and a large gap was identified behind the old concrete infill panel.

Figure 15. Location 1.3 horizontal cavity barrier folded over and under compression

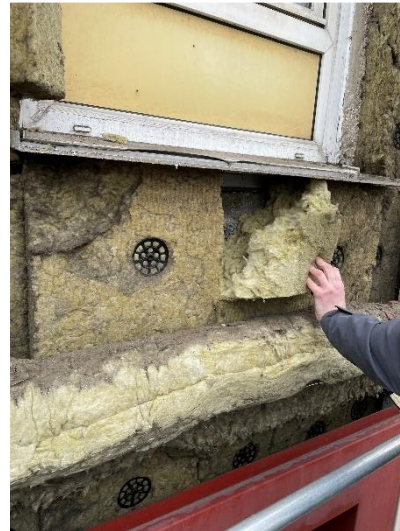
Figure 16. Location 1.3 original window frame behind insulation

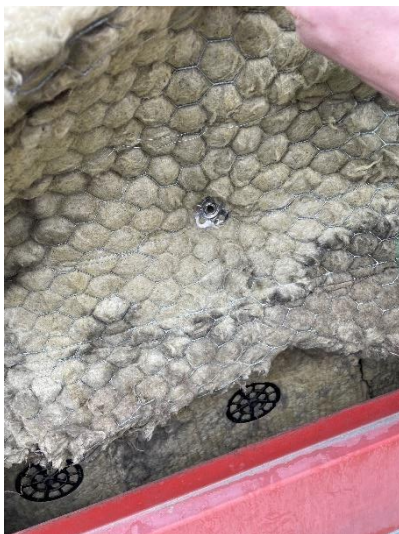
Figure 17. Location 1.3 cavity barrier reinforced with wire and provided with metal fixings to the structure behind

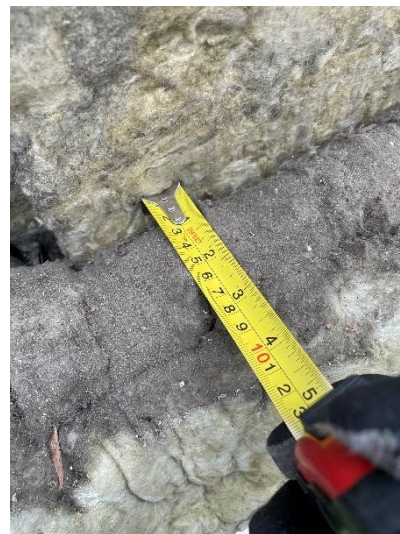
Figure 18. Location 1.3 100mm cavity barrier folded over and under compression

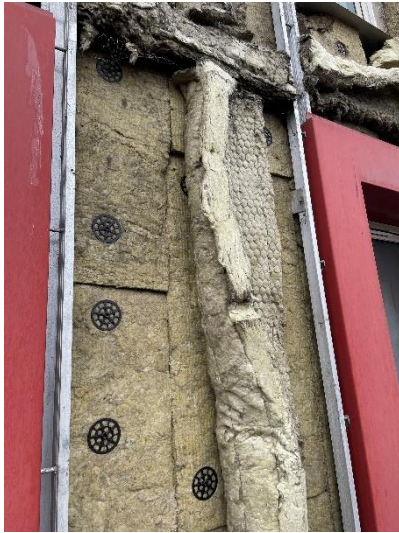
It can be seen that the cavity barriers are reinforced with wire and were predominantly folded over although they were damaged in some areas.

Figure 19. Location 1.4 vertical cavity barrier on top of insulation

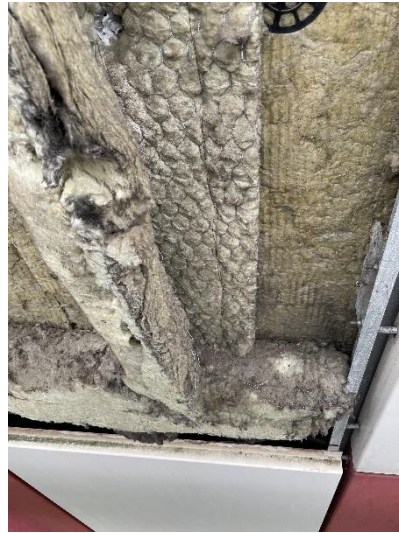
Figure 20. Location 1.4 horizontal cavity barrier at floor level. Not continuous due to aluminium rail.

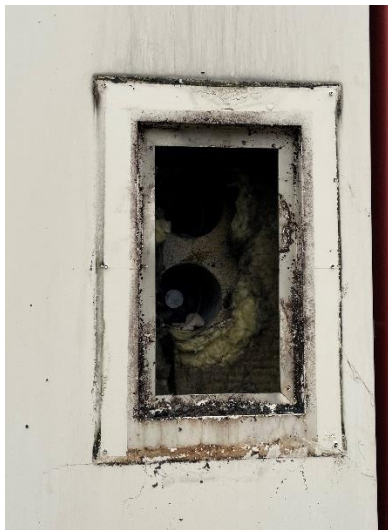
Location 1.5 is the kitchen extract duct from a flat on the third floor.

Figure 21. Location 1.5 extract duct

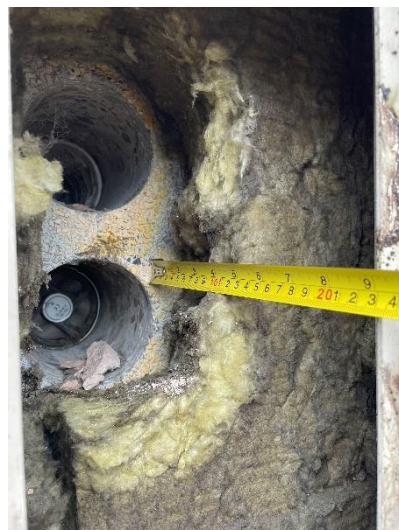
There was no cavity barrier identified.

Figure 22. Location 1.5 no cavity barrier

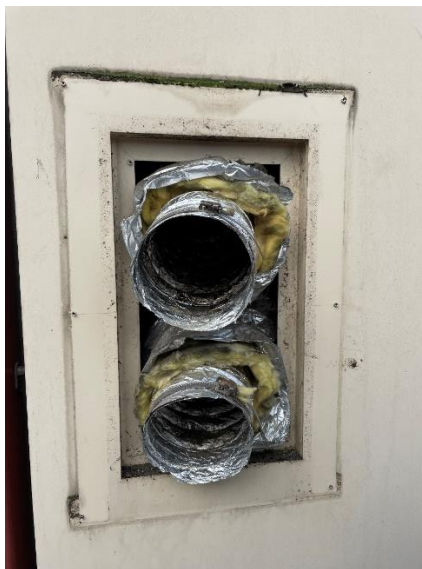
Another kitchen extract was removed on the second floor, as shown in the following figure, and a means of cavity barrier had been provided around the ductwork. This encapsulated the ductwork and was continuous to outside.

Figure 23. Location 1.5 Mineral wool wrapped around the ductwork from second floor flat

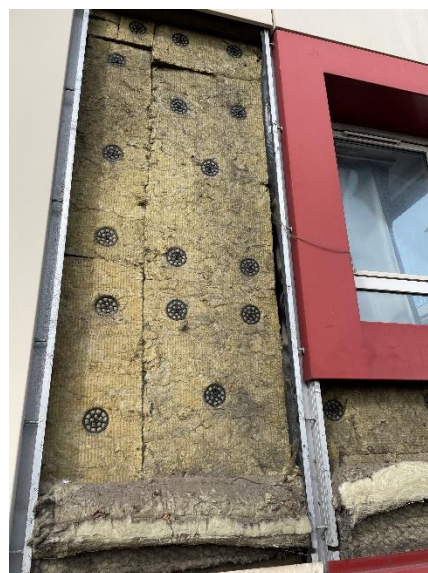
Figure 25. Location 1.6 horizontal cavity barrier at floor level identified but no vertical around the window

As noted previously, no cavity barriers would have been required around the window under the guidance at the time.

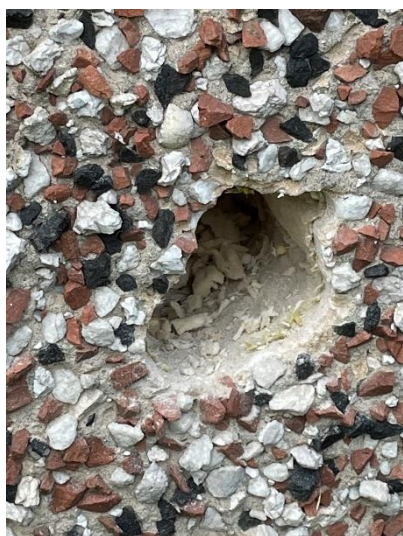
Figure 27. Location 2.1 3-5mm of render with thermo plastic insulation behind

It is recommended that the render systems should be replaced with a non-combustible system.

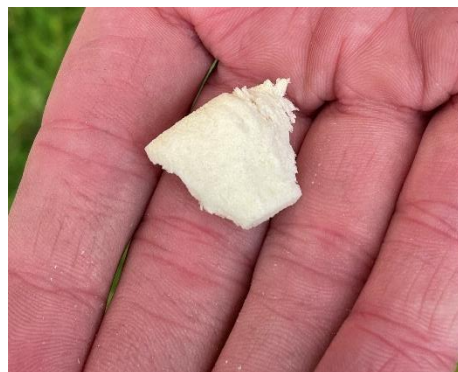
Figure 28. Location 2.1 thermo plastic material

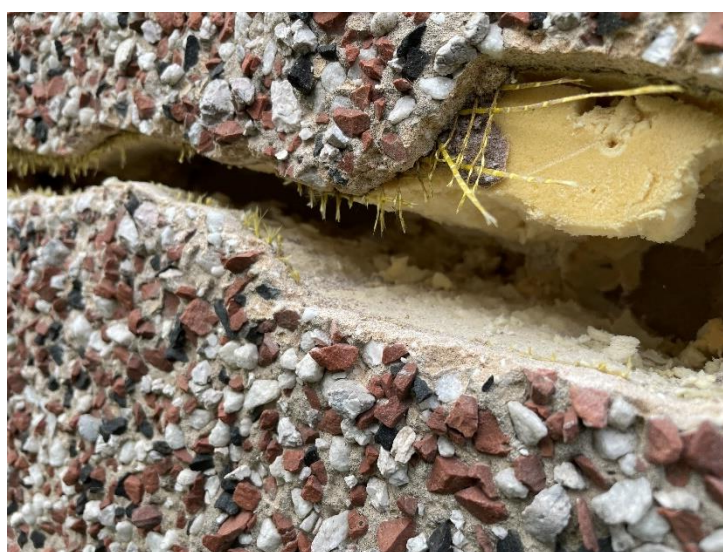
Figure 29. Location 2.1 the hole was opened further

There was no break in the in insulation identified on the party / compartment wall line. This type of material is combustible.

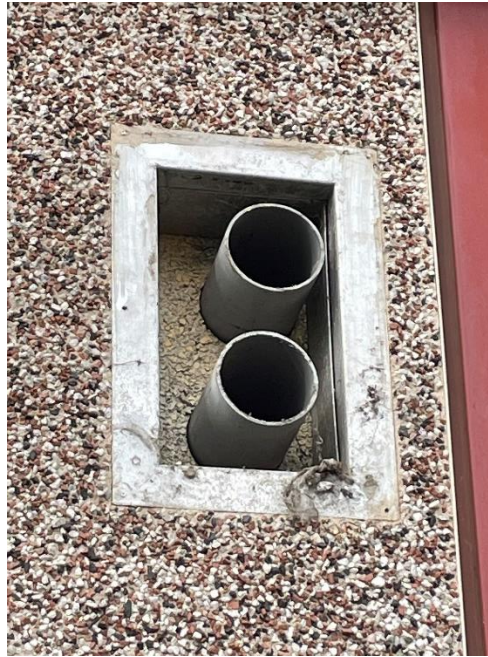
The ductwork was provided with a steel 'letterbox' enclosure to separate the ductwork from the insulation and render.

Figure 30. Location 2.2 ductwork enclosed in 'letterbox'

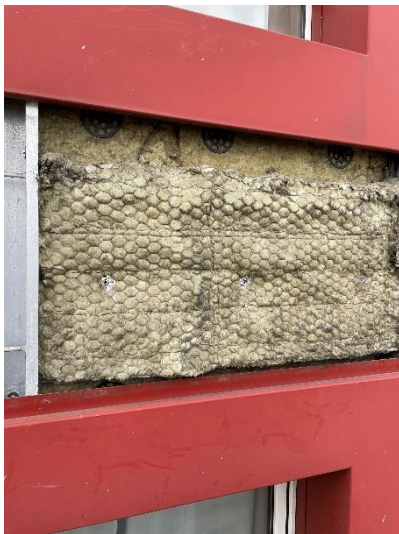
Figure 33. Location 3.1 horizontal cavity barrier reinforced with wire but not folded over

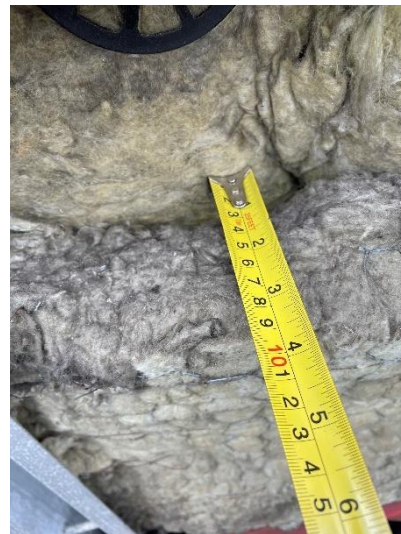
Figure 34. Location 3.1 70mm cavity barrier on top of mineral wool insulation

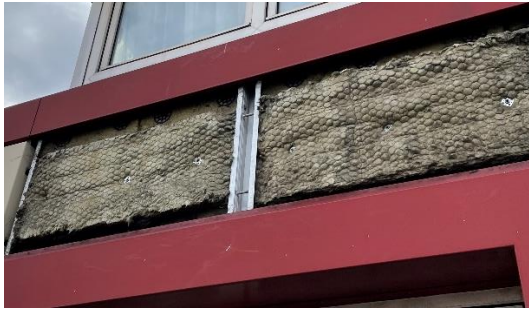
Figure 35. Location 3.1 gap in horizontal cavity barrier due to aluminium rail. Cavity barrier not folded over.

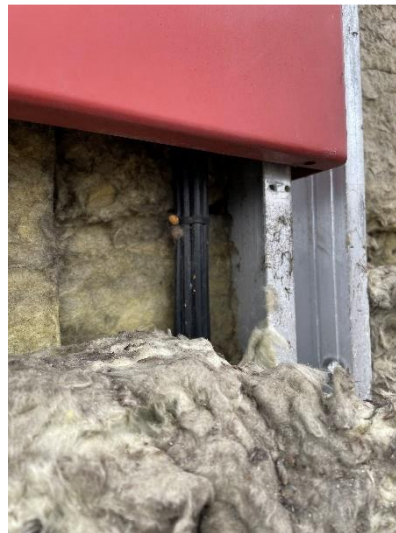
Figure 36. Location 3.1 wires were identified within the cavity.

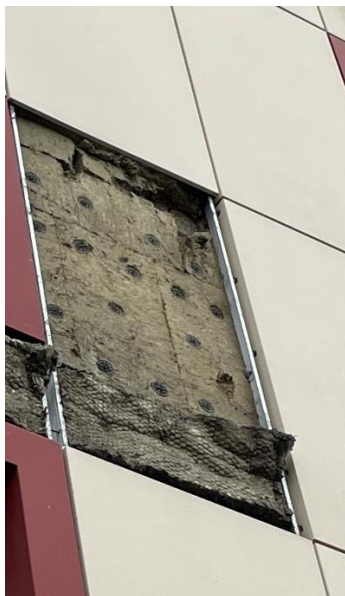
Figure 37. Location 3.2 there was no vertical cavity barrier identified

There were horizontal cavity barriers at floor levels above and below but no vertical cavity barriers around windows. It should be noted that the horizontal barriers between locations 1.1 and 1.4 were not found to be folded, and therefore it is not fitted under compression. The cavity barrier is unlikely to provide effective resistance against fire and smoke spread.

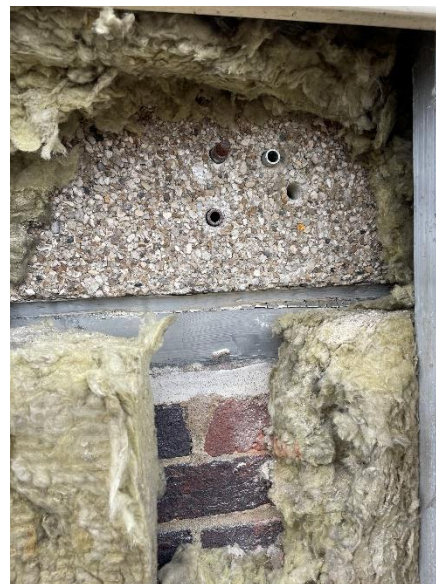
Figure 38. Location 3.2 masonry construction behind mineral wool insulation

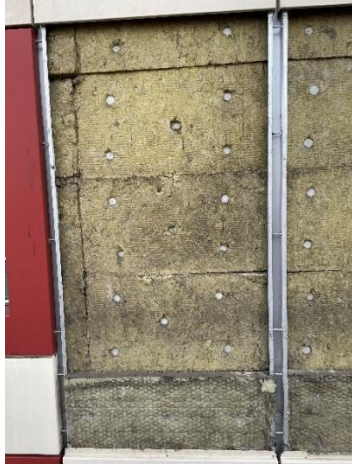
Figure 39. Location 3.3 mineral wool insulation with horizontal cavity barrier at floor level (not folded over)

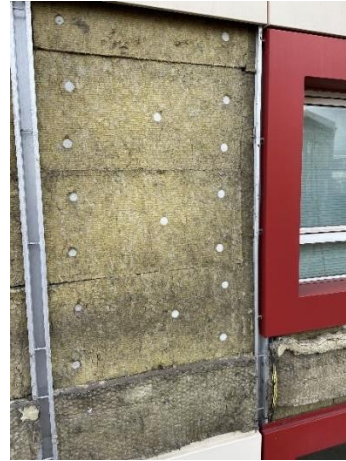
Figure 40. Location 3.3 no vertical cavity barriers around window

The brackets centrally located along wider cladding panels, such as those under the window, are hidden completely, so are not open to the atmosphere. The cavity barrier is broken where the fixing bracket passes through it.

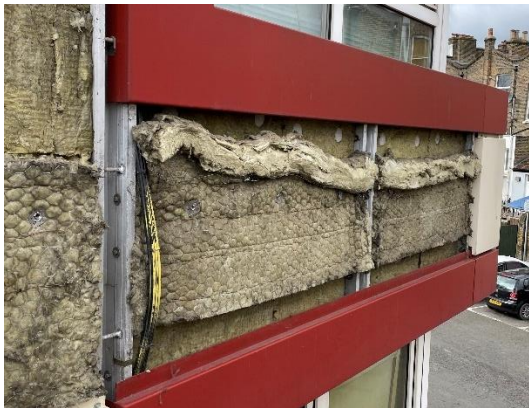
Figure 41. Location 3.4 horizontal cavity barrier broken due to aluminium rail. Wires also identified in the cavity.

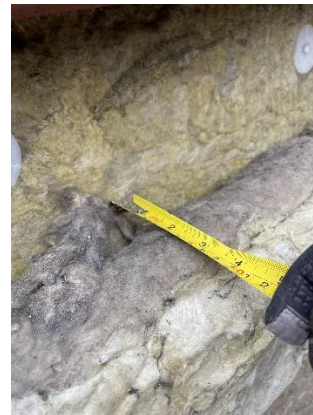
Figure 42. Location 3.4 100mm cavity barrier partially folded at the top

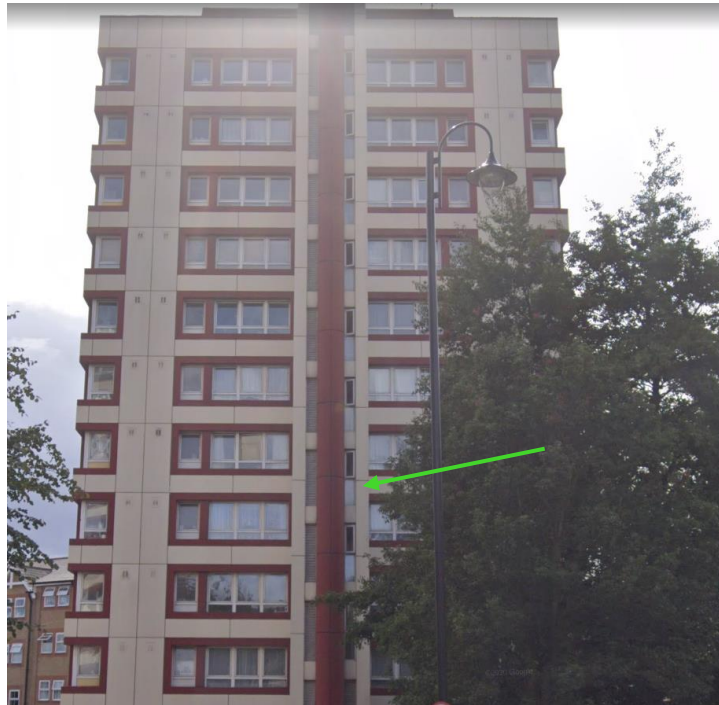
Figure 43. Infill panels

Infill panels are noted to exist on the rear elevation of the building forming the external wall system to the bin store. Figure 37 below shows the panels location and that they stack full height. The infill panel below a glazed window was opened up to identify its construction on a number of similar buildings. It was found that the infill panel is a composite panel consisting of an unknown

thermoplastic material sandwiched between two thin layers of steel. The panels appeared to be the same from a visual survey on this block.

Material	Combustibility	Volume	Comments	Recommendations
Thermo plastic infill between two layers of steel.	Typically, Euroclass E - F to BS EN 13501-1	All locations	Combustible thermo plastic sandwiched within two layers of steel between windows. Presumed to be typical on each floor.	All window infill panels are to be replaced for non-combustible alternatives on the common area sections.

With regards to the panels on the section of façade connected to the common area serving the protected stair and AOV windows, although this is recessed from the elevation with flats, it is still connected to the area accessed by a single stair, therefore BB7 recommend replacement.
