EWS1 Report

1-44 Messer Court

30th April 2021

Croydon Borough Council

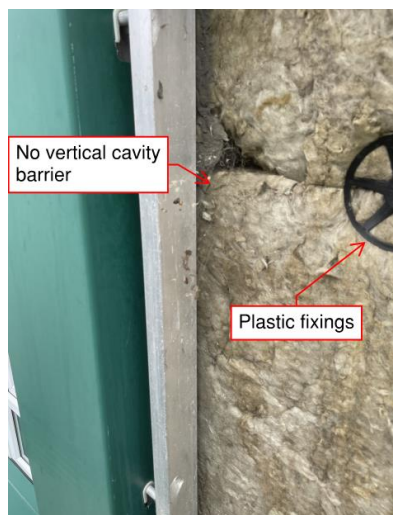
Location 1.1. was at the second adjacent to a flat's window. There was no vertical cavity barrier around the window. However, this is as expected for a building re-clad in the 1990's because cavity barriers were not required around openings.

Figure 10. Location 1.1 no vertical cavity barrier

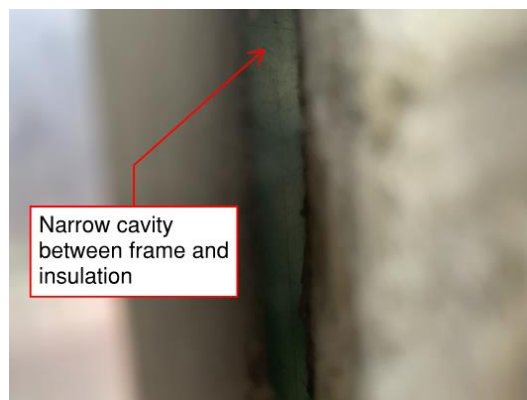
Figure 11. Location 1.1 cavity between insulation and cladding rails

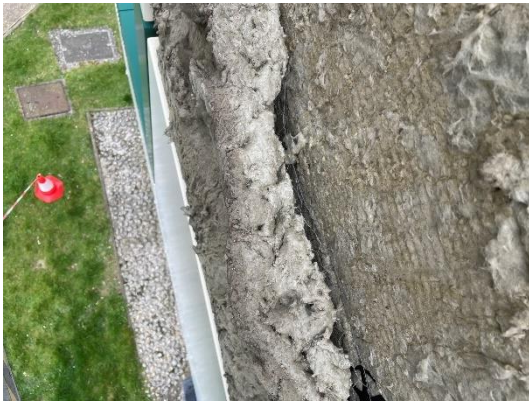
The cavity barrier is not continuous horizontally as it is interrupted by the cladding rails and is installed on the external face of the insulation.

Figure 12. Location 1.2 non continuous cavity barrier at floor level

For the cavities to be divided at compartment lines, as was the design intent of guidance at the time of the over cladding, it is recommended to ensure horizontal and vertical cavity barriers are installed along compartment lines and are fitted under compression. Reference should be made to the relevant sections of ADB for materials, orientation, and fixings.

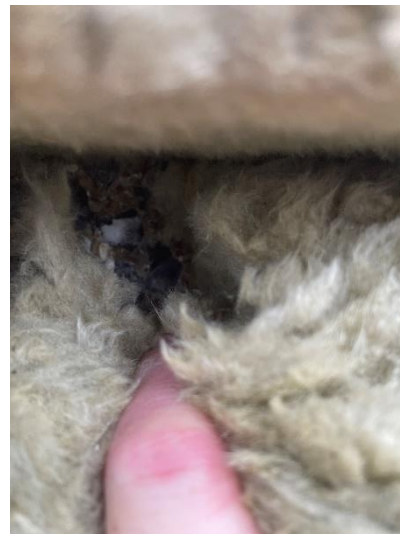
Figure 13. Location 1.2 – Rough stone cladding behind insulation

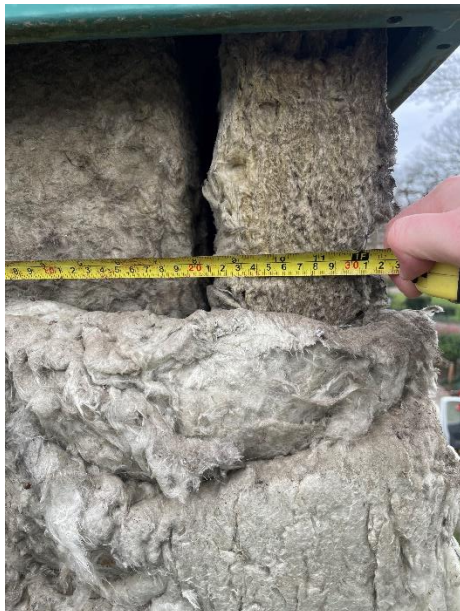
Location 2.1 was on the second floor below a window on the corner of the building. The windows have been installed into the original structural openings and, therefore, have not been moved to suit the cavity. Cavity barriers are not continuous either below windows or at slab level as they are interrupted by the cladding rails. The brackets centrally located along wider cladding panels, such as those under the window, are hidden completely, so are not open to the atmosphere. The cavity barrier is broken where the fixing bracket passes through it.

Figure 15. Location 2.1 horizontal cavity barrier around the corner

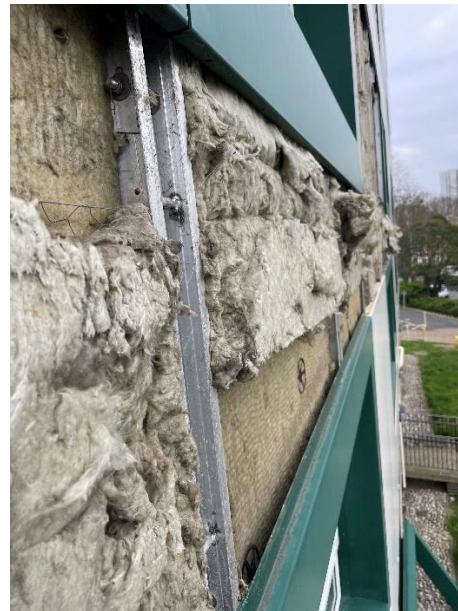
Figure 16. Location 2.1 horizontal cavity barrier is not continuous due to the aluminium rails and changes level under the window

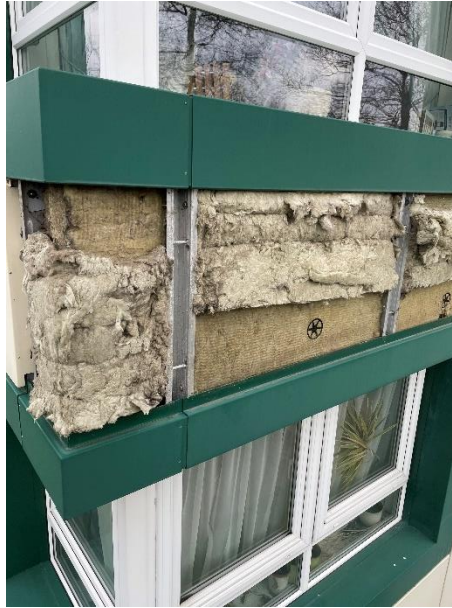
Figure 17. Location 2.2 cavity barriers are not continuous below the window or at slab level

Again, the barriers were mineral wool type product reinforced with wire, which were common at the time of installation. This cavity barrier has to be folded over in order to ensure that the barrier fills the full depth of the cavity to reach the rear of the cassette panel, however, the barriers were found in some cases to be poorly fitted with gaps appearing next to the façade carrier system, it was not under compression so it may allow fire to bypass the compartment line here, which is not permissible.

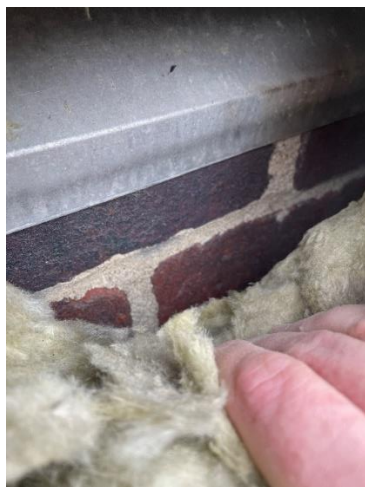
Figure 18. Location 2.2 original brickwork external wall and metal coping

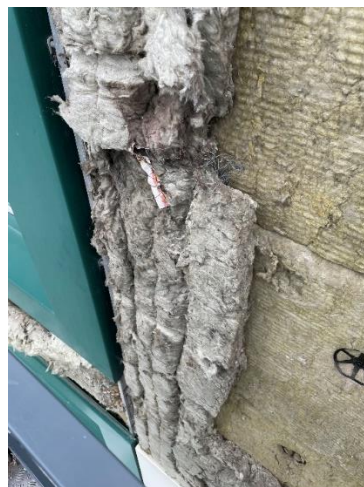
Figure 19. Location 2.2 vertical cavity barrier around the window

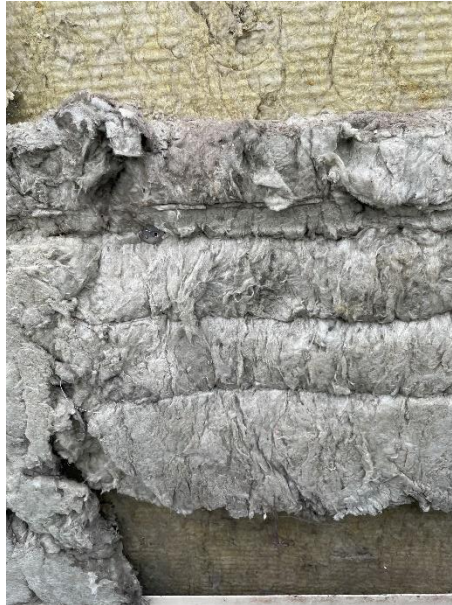
Location 2.2 was on the second floor between two windows of the same compartment. There is one vertical cavity barrier around the edge of the window. There are two horizontal cavity barriers that are not continuous due to the cladding rails and the cavity barriers appear to be staggered at different levels.

Figure 20. Location 2.2 horizontal cavity barrier at approximately slab level. The cavity barrier has not been folded and was not installed under compression.

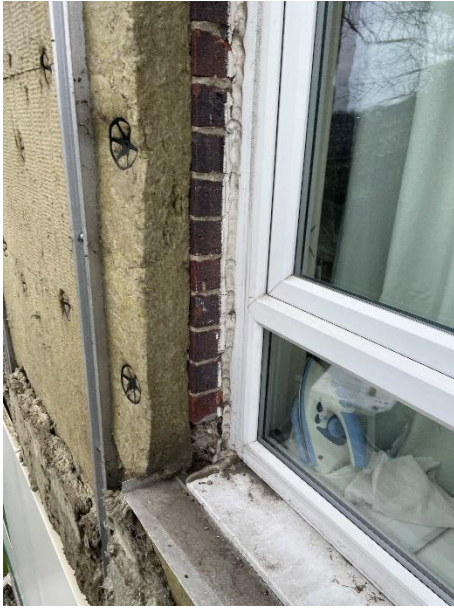
Location 2.3 was the area around the window at second floor. The windows have been installed into the original structural openings and, therefore, have not been moved to suit the cavity. It was also noted that a high degree of silicone sealant had been used around the openings which, as discussed in Section 3, is a risk, however, is considered to be low risk in terms of fire spread.

Figure 21. Location 2.3 exposed brick and mastic surrounding the window frame

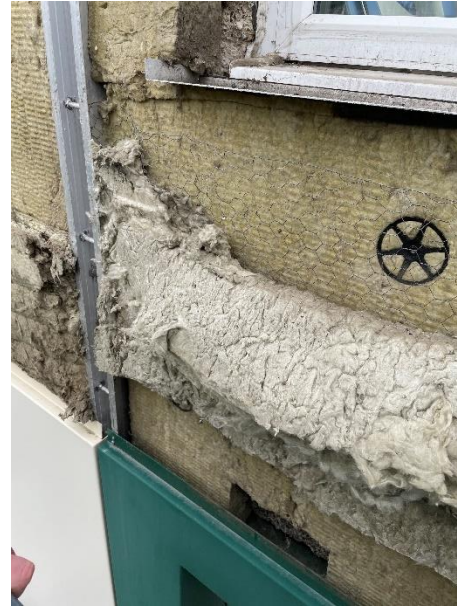
Again, the barriers were mineral wool type product reinforced with wire, which were common at the time of installation. This cavity barrier has to be folded over in order to ensure that the barrier fills the full depth of the cavity to reach the rear of the cassette panel, however, the barriers were found in some cases to be poorly fitted with gaps appearing next to the façade carrier system, it was not under compression so it may allow fire to bypass the compartment line here, which is not permissible.

Figure 22. Location 2.3 folded horizontal cavity barrier approximately below the window. Letterbox of removed insulation

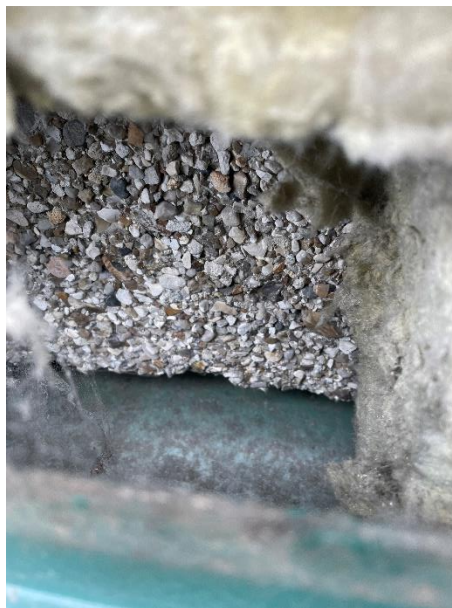
Figure 23. Location 2.3 original rough stone concrete behind the insulation

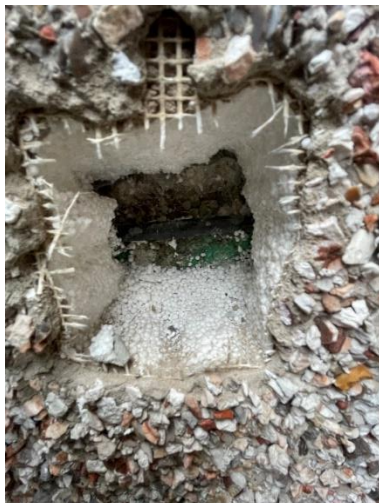
EPS Insulation was found at the ground floor of the building of all elevations. The insulation was installed over the original masonry external wall system, as shown in Figure 26, with a rendered stone finish. Small areas of this render were damaged prior to the inspection which BB7 removed for further inspection. EPS has a Euroclass E rating meaning that it is a highly combustible material.

Figure 26. Location 3 EPS behind stone cladding system. The original RC structure can be seen at the rear of the cavity

The original skin of the external wall, i.e., RC LPS construction, is considered to be a low risk item. The presence of the combustible EPS insulation over the masonry is considered to be of low risk of uncontrolled fire spread as the system was found at low level only at ground floor. However, to enhance the life safety to the occupants BB7 recommend replacement of the insulation for a non-combustible alternative.

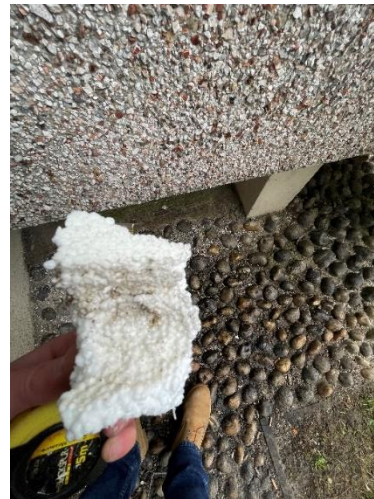
Figure 27. EPS removed from system

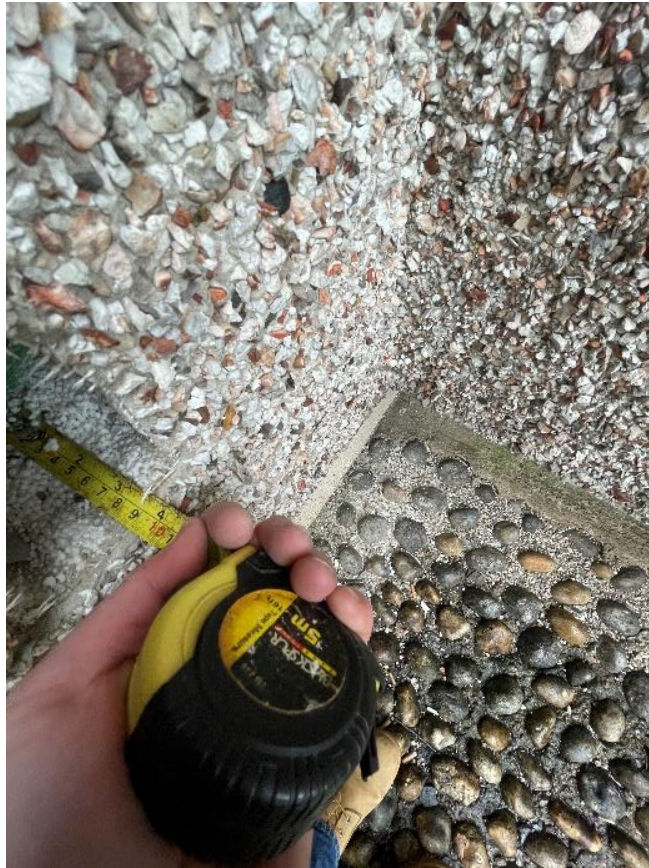
Figure 28. Location 3 shows 90mm depth of EPS system at ground floor

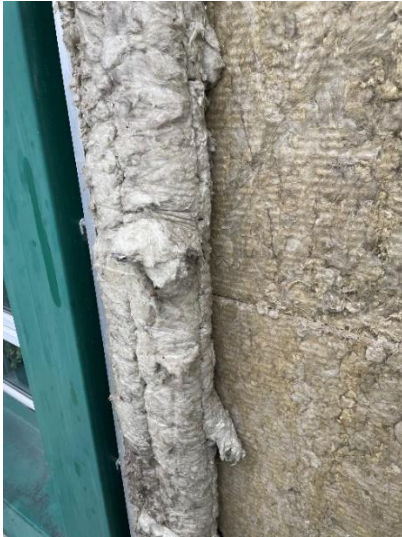
Location 4.1 shows a folded, vertical cavity barrier around the window. It appears to serve dual purpose in dividing the cavity between the two flats as discussed above which is considered reasonable.

Figure 30. Location 4.1 vertical cavity barrier around window and between two flats

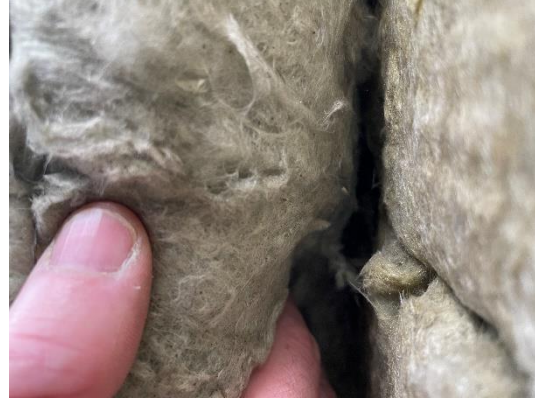
Figure 31. Location 4.1 cavity barrier compressed against insulation

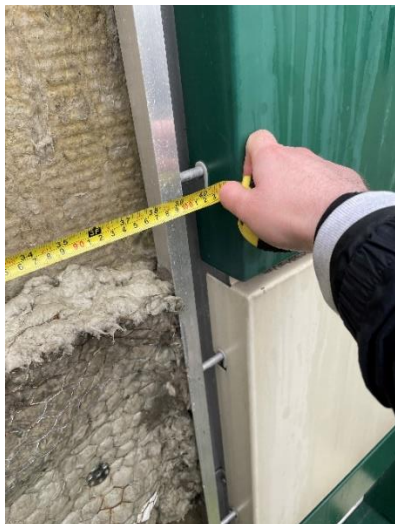
Location 4.2 at third floor slab level showed a horizontal cavity barrier that was not folded and was not continuous due to the aluminium rails. The barrier exists between rails. Although the horizontal cavity barrier was not fitted under compression, the junction between horizontal and vertical cavity barriers appears complete which should limit the spread of fire within the cavity.

Figure 32. Location 4.2 / 4.3 horizontal cavity barrier at slab level only. There is no vertical cavity barrier around the right hand window.

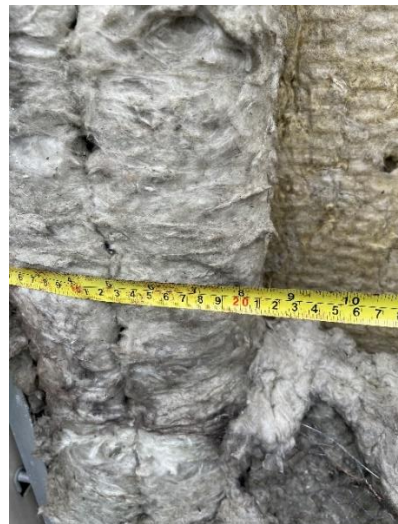
Figure 33. Location 4.2 junction of horizontal and vertical cavity barriers

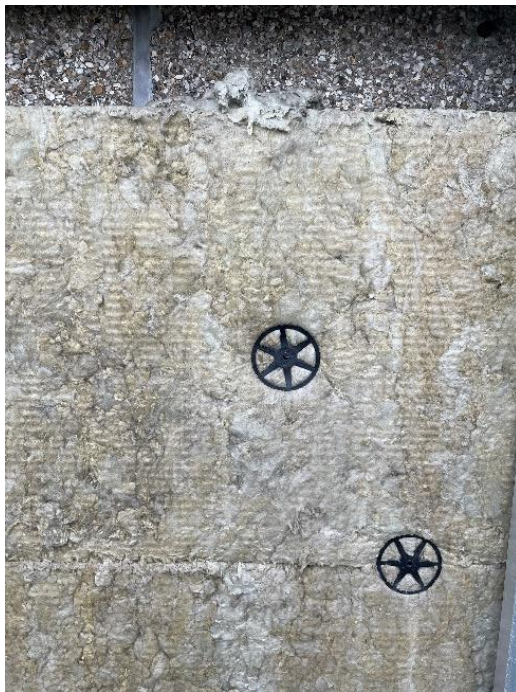
The insulation in Figure 34 is fixed by plastic clips and the panels do not appear to consist of EPS or XPS. Considering the predominant use of non-combustible materials, the panels, join, and plastic fixings are not considered to pose a significant risk.

Figure 34. Location 4.4 where the cavity is not fully filled with insulation

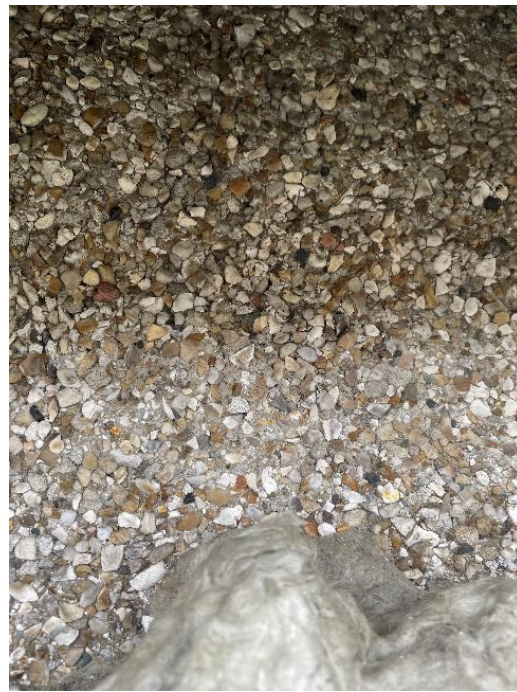
Figure 35. Location 4.4 portion of the original external wall not concealed by insulation

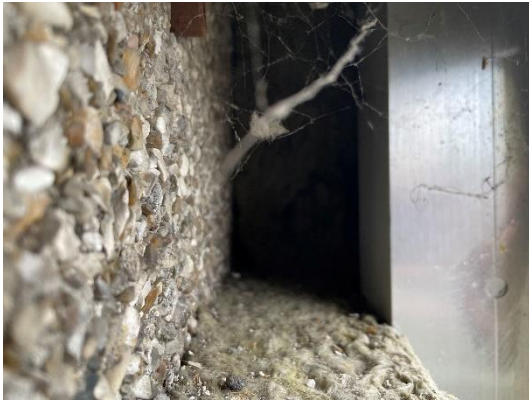
Figure 36. Location 4.4 cavity between the original external wall and the aluminium cladding / rails

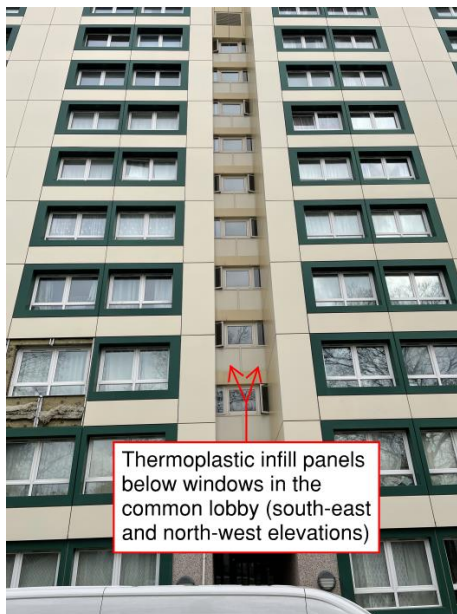
Location 5 was the infill panels below windows of the common lobbies of each upper residential storey. BB7 did not intrusively survey these panels, however, they have been opened up to identify its construction on a number of similar buildings. It was found that the infill panel is a composite panel consisting of an unknown thermoplastic material sandwiched between two thin layers of steel. The panels appeared to be the same from a visual survey on this block.

Figure 39. Lobby windows and infill panels within recessed portion of the elevation

- Any infill panels with thermo plastic insulation should be replaced with a non-combustible alternative.
- Cavity barriers should be provided under compression horizontally at floor levels and vertically at compartment walls where they are not installed.
- The render system at ground floor should be replaced for a non-combustible alternative.
- The fusible link on the damper serving the bin chute should be inspected and serviced regularly.
- All points raised on the Fire Risk Assessment should be adhered to.

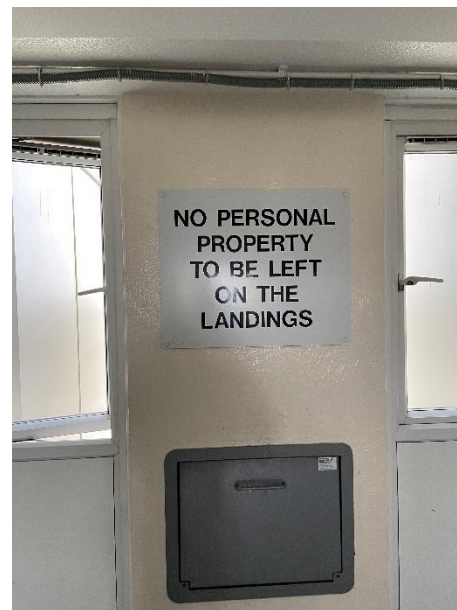
Figure 40. Lobby windows and infill panels (internal view)

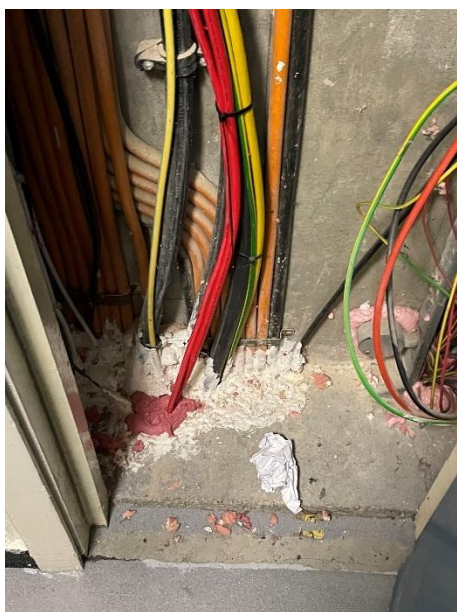
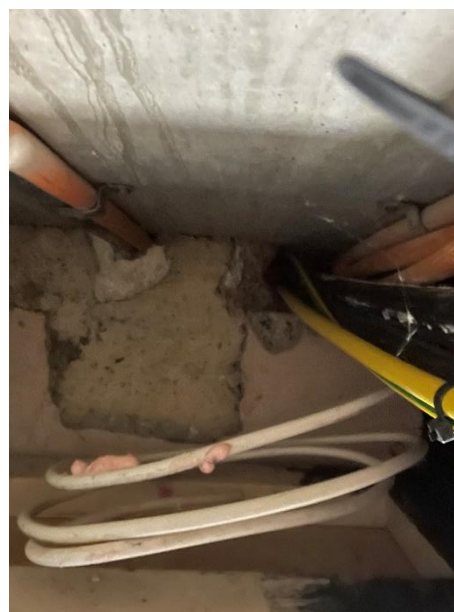
The flats opened into a lobby with ventilation via an AOV. It is presumed that the AOV works on detection which was identified in the lobby. There were also service risers located in the lobby with 'Masterboard with Intumescent sealant' fire stopping provided to service penetrations, however, there were some issues identified, including poor fire stopping around cable penetrations.

Figure 41. Poor fire stopping around service penetrations

Figure 42. Poor fire stopping around service penetrations

- The findings and recommended actions within the FRAs should be implemented.
- Residents should be informed of their responsibilities in terms of fire safety.
- Risers in the lobby and stair should be reviewed to ensure fire and smoke spread is limited into the escape routes.
- The local FRS will need to be informed of the assessment findings.
- Electronic locks require an emergency override device in accordance with BS 7273-4

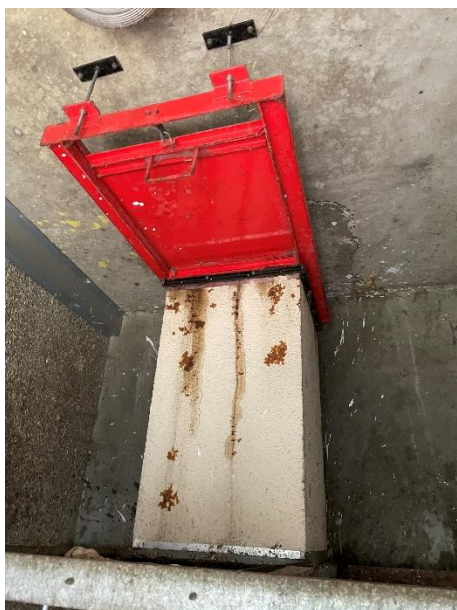
The bin store at ground floor was provided with a sprinkler head to reduce the potential fire size and a damper on a fusible link was provided at the end of the bin chute to reduce the chance of fire spread. This is shown in the following figure.

Figure 43. Bin chute fusible link
