# **EWS1 Report**

**1 – 44 Violet Lane**

**30<sup>th</sup> April 2021**

**Croydon Borough Council**

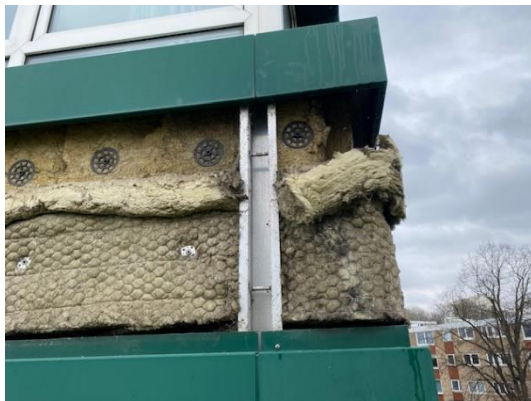
Location 1.1 was at the 2<sup>nd</sup> floor under a flat window. Horizontal cavity barriers were identified at floor level. However, no cavity barriers were found around the window opening. Based on information from the contractor the re-cladding took place in the late 1990's, the guidance at this time did not require cavity barriers around openings. The barrier under the opening at compartment floor level was partially folded rather than fully folded along its axis. It is considered that this will still provide an effective break in the cavity.

**Figure 10.** Location 1.1 horizontal cavity barrier folded over and under compression

- The render systems should be replaced with a non-combustible system.
- Cavity barriers should be provided where missing at compartment lines or be remediated such that they are under compression where they are not currently.
- The fusible link on the damper serving the bin chute should be serviced regularly.
- The infill panels on the bin chute elevation should be replaced for a non-combustible alternative.
- A fire risk assessment should be undertaken.

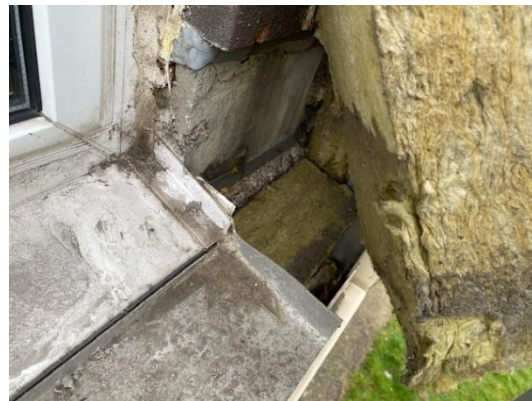
**Figure 11.** Location 1.1 Showing that there are no cavity barriers in place around the window openings. Original building features can be seen.

There were no cavity barriers around the flat windows, however, if a fire were to break out of a window, then it is unlikely to rapidly spread through the cavity and up the building due to the lack of combustible materials and the flame front will not have a substrate to continue the fire spread. Furthermore, when fitted properly the fire spread will be inhibited by the horizontal cavity barriers at floor level. It was found in numerous locations that the cavity barriers were not fitted under compression meaning that there is potential for fire to bypass the cavity barriers. Whilst this would be considered to be low risk if limited instances were found, on this building BB7 did not find evidence of compartment floor barriers being folded and fully filling the cavity to the rear of the cassette panels. On that basis BB7 recommend that the cavity barriers are upgraded to ensure that they will inhibit the unseen spread of fire and smoke. This can be done in one of two ways:

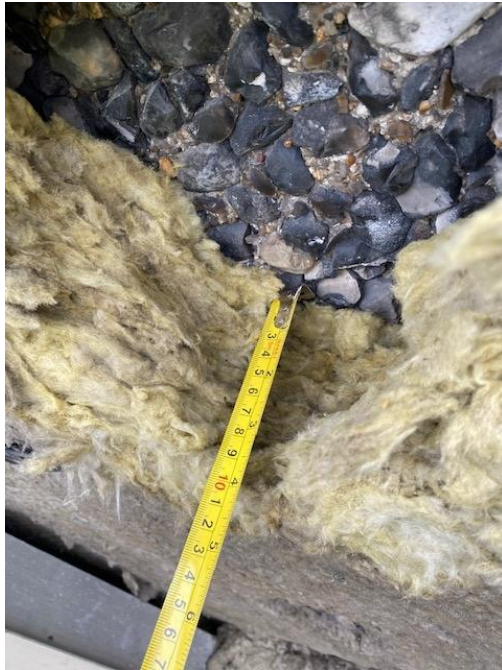
**Figure 12.** Location 1.2 solid concrete behind 100mm mineral wool insulation

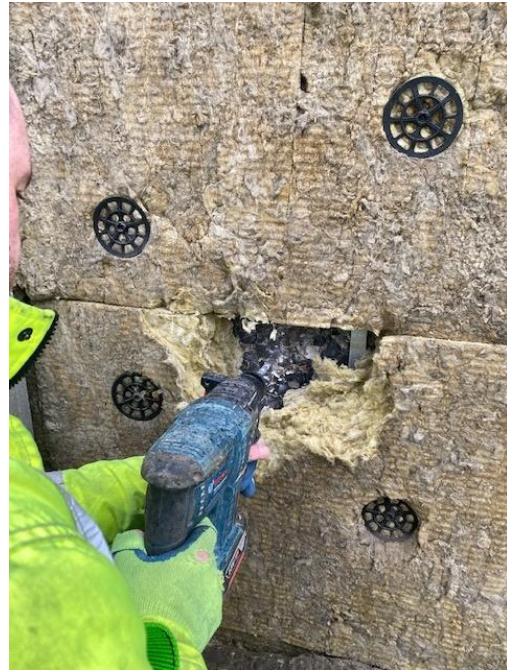
This was on the elevation of a single flat, therefore, a vertical cavity barrier was not expected. The horizontal barrier above this point which was found to be folded, and therefore was fitted under compression and appeared to provide an effective lateral break.

**Figure 13.** Location 1.2 cavity barrier with robust metal fixing and reinforced with mineral wool

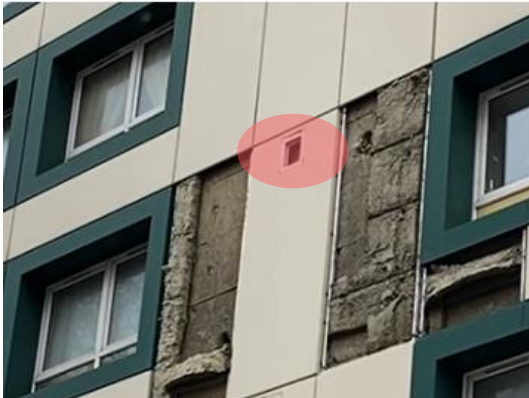
Location 1.3 was at a kitchen extract duct on the 2<sup>nd</sup> floor. The full panel could not be removed but the outer vent panel was removed to show the duct was wrapped in mineral wool and was continuous to outside.

**Figure 14.** Location 1.3 kitchen extract with the louvred panel removed

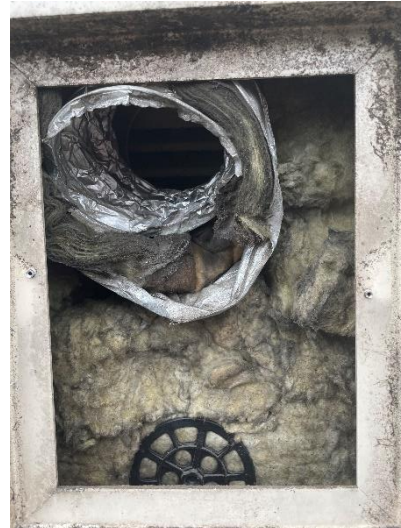
**Figure 15.** Location 1.3 30mm mineral wool encapsulating ductwork

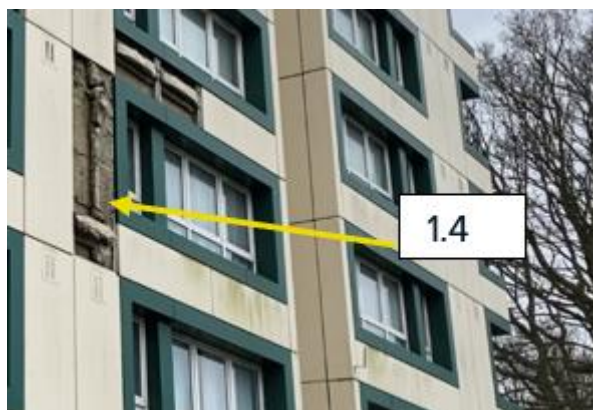
Location 1.4 was intended to be a survey of a compartment line but both horizontal and vertical cavity barriers were identified. The cavity barriers at floor level sat between the aluminium rails (i.e. they were not continuous) and the vertical cavity barrier sat on the party wall between flats.

It was found at this location that there are intermediate rails which are not open to fresh air and form a cavity between two windows. This will be addressed in Section 8 of this report.

**Figure 16.** Location 1.4 horizontal and vertical cavity barriers identified.

It should be noted that sections of the horizontal barriers between locations 1.1 and 1.4 were not found to be folded, and therefore it is not fitted under compression. The cavity barrier is unlikely to provide effective resistance against fire and smoke spread.

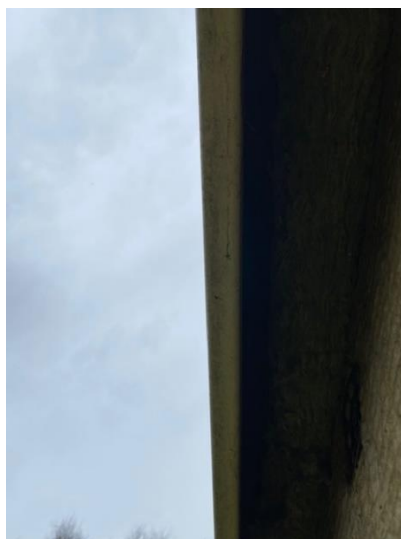
The window surrounds were not removed from this area so in order to determine if there were cavity barriers in place around the window was taken from underneath the frame of third floor window. There were no barriers evident.

**Figure 17.** Location 1.5 view from underneath the third floor window on the north face.

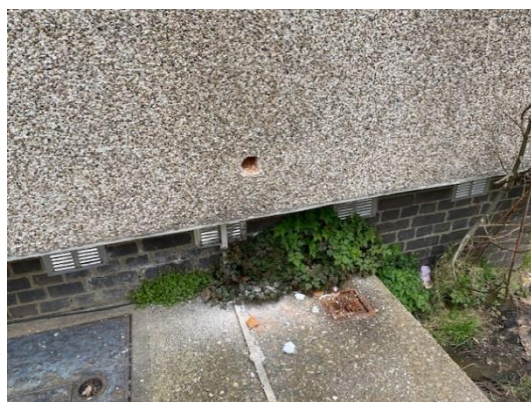
**Figure 19.** Location 2.1 – 150mm deep insulation to concrete behind

There was no break in the in insulation identified on the party / compartment wall line. Both insulants are combustible. It is not common to find two insulants interfaced as seen at this location.

**It is recommended that the render systems should be replaced with a non-combustible system.**

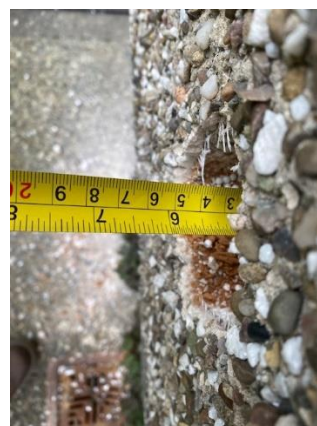
**Figure 20.** Location 2.1 - 3-5mm of render with 145mm of insulating material

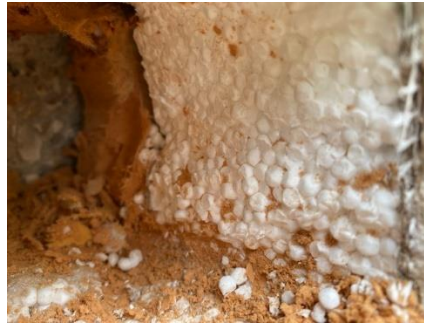
**Figure 21.** EPS & PIR insulation

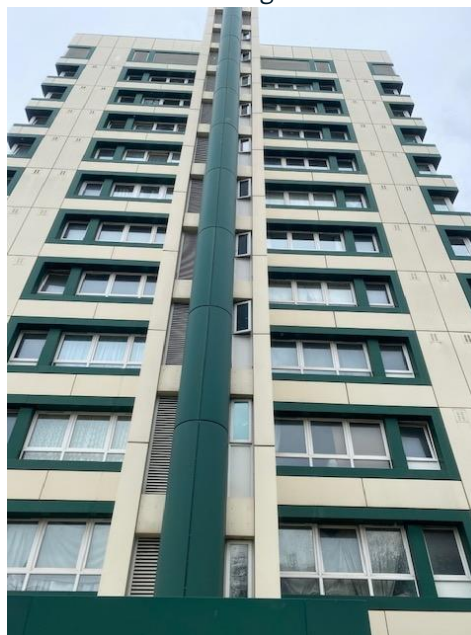
Figure 22 shows the permanent ventilation located on each level next to the chute, the spandrel panels can be seen beneath the windows to the right of the chute.

**Figure 22.** Bin chute extension

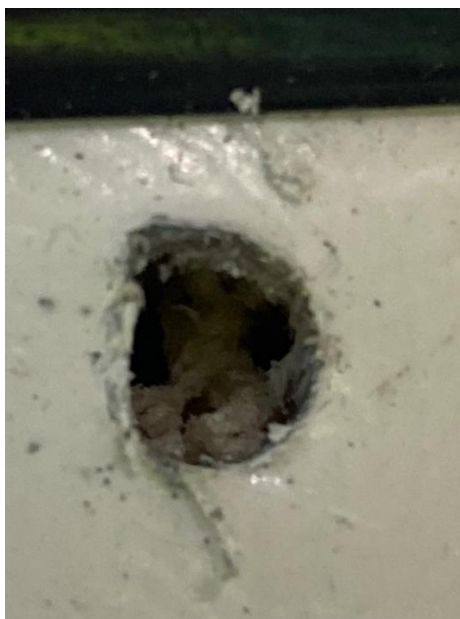
Infill panels are noted to exist on the rear elevation of the building forming the external wall system to the bin store. Figure 23 below shows the panels location and that they stack full height. The infill panel below a glazed window was opened up to identify its construction on a number of similar buildings. It was found that the infill panel is a composite panel consisting of an unknown thermoplastic material sandwiched between two thin layers of steel. The panels appeared to be the same from a visual survey on this block.

**Figure 23.** Infill panel showing the infill material between the steel

Material	Combustibility	Volume	Comments	Recommendations
Thermo plastic infill between two layers of steel.	Typically, Euroclass E - F to BS EN 13501-1	All locations	Combustible thermo plastic sandwiched within two layers of steel between windows. Presumed to be typical on each floor.	All window infill panels are to be replaced for non-combustible alternatives on the common area sections.

With regards to the panels on the section of façade connected to the common area serving the protected stair and AOV windows, although this is recessed from the elevation with flats, it is still connected to the area accessed by a single stair, therefore BB7 recommend replacement.

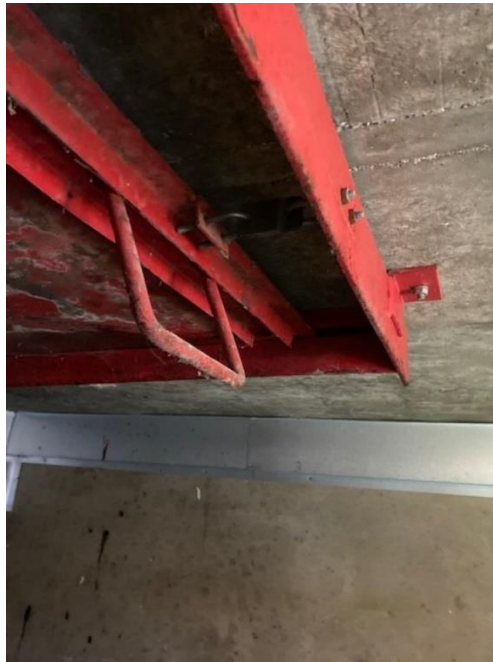
bin store is provided with a wall mounted sprinkler and a fusible link damper at the base of the bin chute which will limit potential fire size and spread. This is shown in the following figure.

**Figure 24.** Bin store fusible link and sprinkler are located in the bin store.
