EWS1 Report

1-87 Belgrave Road

30th April 2021

Croydon Borough Council

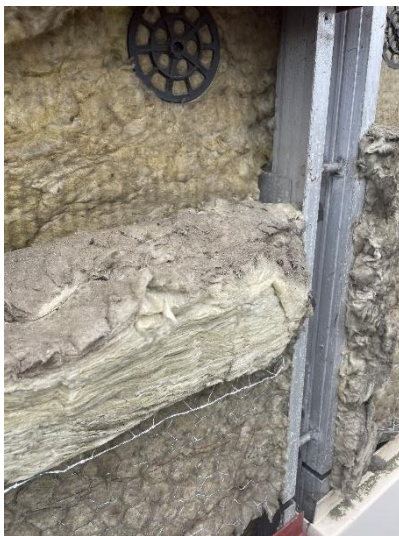
Location 1.1 was at the 2nd floor under a flat window. Horizontal cavity barriers were identified at floor level. However, no cavity barriers were found around the window opening. Based on information from the contractor the re-cladding took place in the late 1990's, the guidance at this time did not require cavity barriers around openings. The barrier under the opening at compartment floor level was partially folded rather than fully folded along its axis. It is considered that this will still provide an effective break in the cavity.

Figure 10. Location 1.1 horizontal cavity barrier folded over and under compression

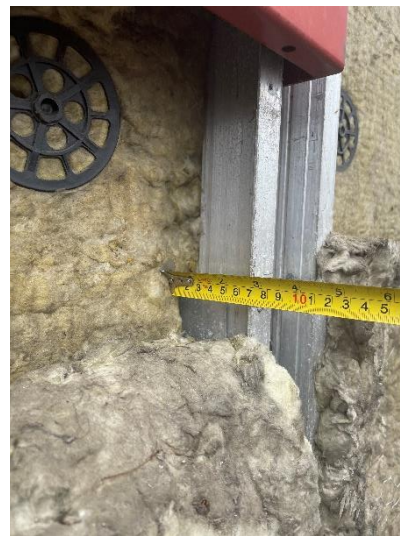
Figure 11. Location 1.1 70mm clear cavity

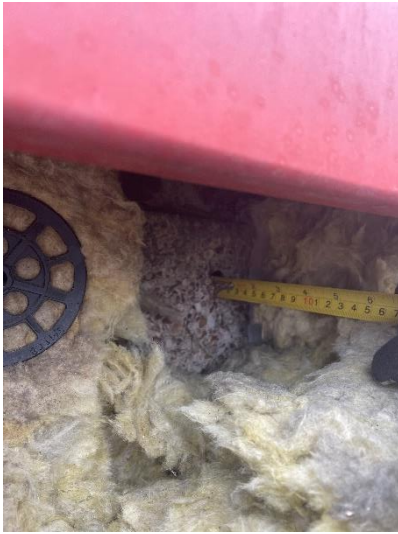
Figure 12. Location 1.1 solid concrete behind 100mm mineral wool insulation

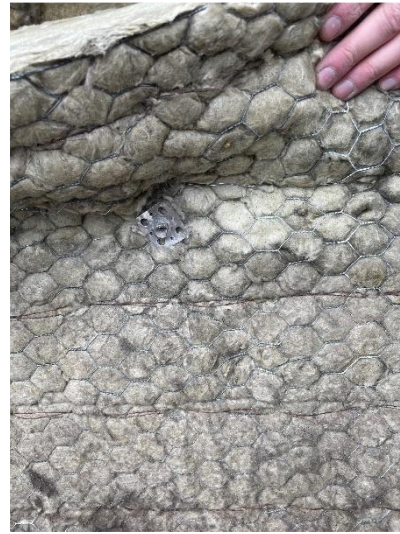
Figure 13. Location 1.1 cavity barrier with robust metal fixing and reinforced with mineral wool

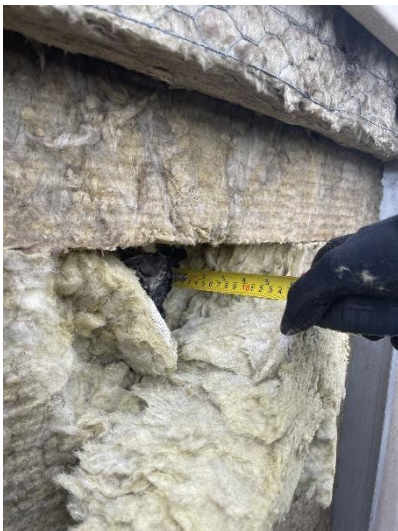
Figure 14. Location 1.2 concrete behind 100mm mineral wool

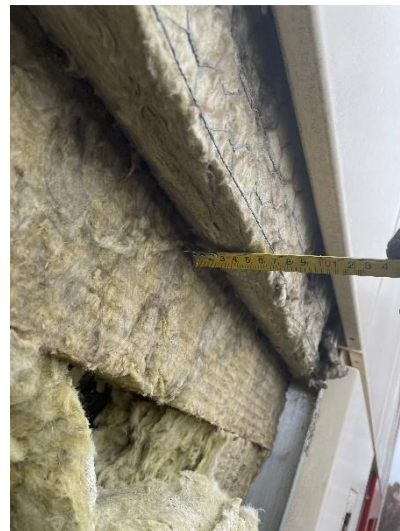
Location 1.2 was behind a large panel between flat windows on the 2nd floor. A horizontal cavity barrier was found at 3rd floor level. There was no vertical cavity barrier around the window as per location 1.1. This was on the elevation of a single flat, therefore, a vertical cavity barrier was not expected. The horizontal barrier above this point which was partially obscured by the cladding above was not found to be folded, and therefore it is not fitted under compression. The cavity barrier is unlikely to provide effective resistance against fire and smoke spread.

Figure 15. Location 1.2 70mm cavity barrier at 3rd floor level.

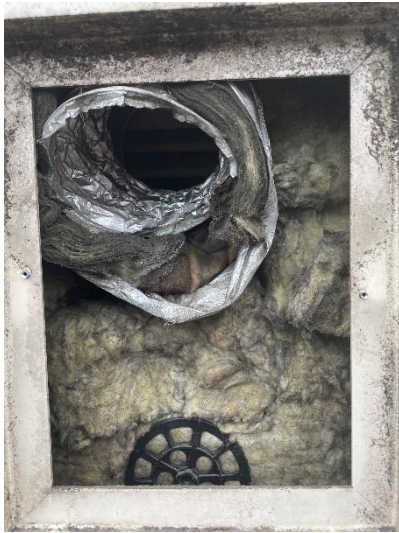
Location 1.3 was at a kitchen extract duct on the 2nd floor. The full panel could not be removed but the outer vent panel was removed to show the duct was wrapped in mineral wool and was continuous to outside.

Figure 16. Location 1.3 kitchen extract ductwork wrapped with mineral wool

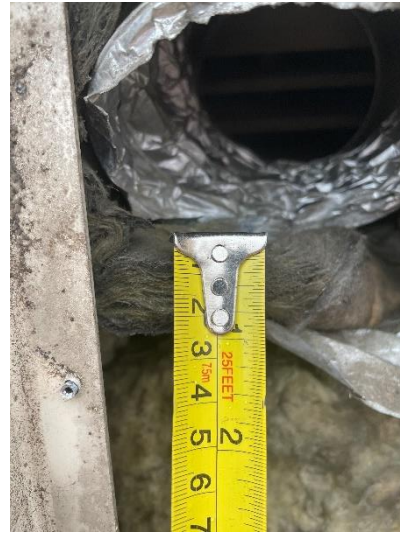
Figure 17. Location 1.3 30mm mineral wool encapsulating ductwork

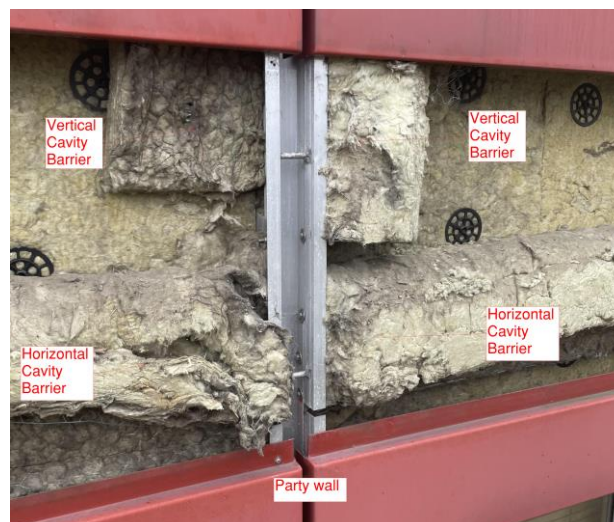
Location 1.4 was at the party wall between flats on the 2nd floor and both horizontal and vertical cavity barriers were identified. The cavity barriers at floor level sat between the aluminium rails (i.e. they were not continuous) and the vertical cavity barrier sat on the party wall between flats. It was found at this location that there are intermediate rails which are not open to fresh air and form a cavity between two windows. This will be addressed in Section 8 of this report.

Figure 18. Location 1.4 horizontal and vertical cavity barriers identified.

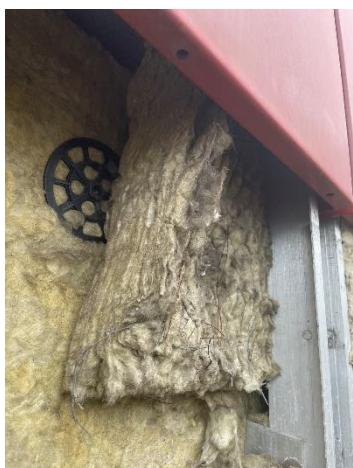
Figure 19. Location 1.4 vertical cavity barrier damaged and not under compression

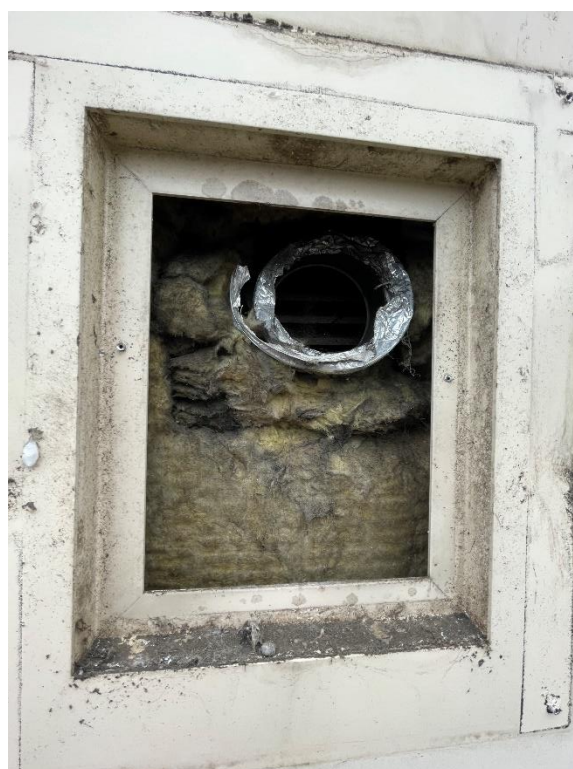
Location 1.5 was at the kitchen extract on the 3rd floor. There was no cavity barrier identified around the ductwork.

Figure 21. Location 1.5 kitchen extract with no cavity barrier

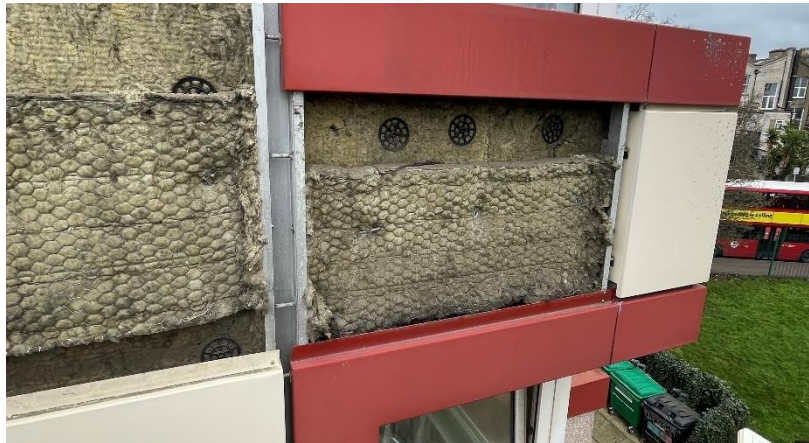
Location 1.6 was under the flat window at 3rd floor level. Horizontal cavity barriers were identified, however, they were not folded over and unlikely to be under compression behind the panel. They also sat between the aluminium rails so were not continuous, but the barriers were found to be sat flush with the insulation.

Figure 22. Location 1.6 horizontal cavity barrier not continuous or folded over

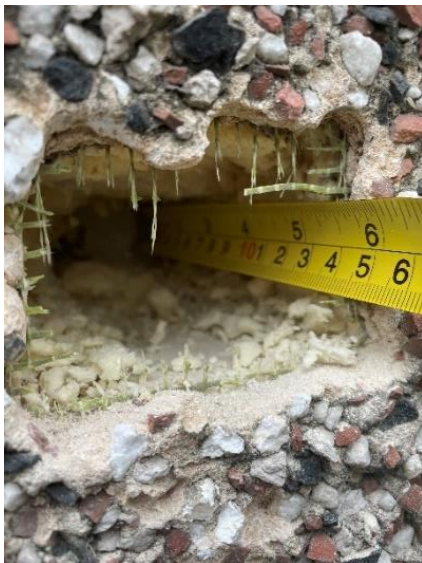
Figure 24. Location 2.1 – 150mm deep insulation to concrete behind

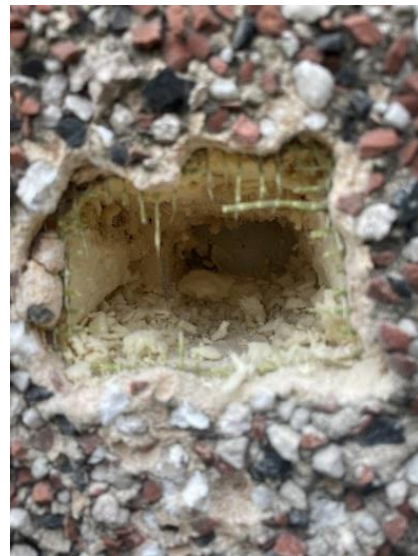
Figure 25. Location 2.1 - 3-5mm of render with thermo plastic insulation behind

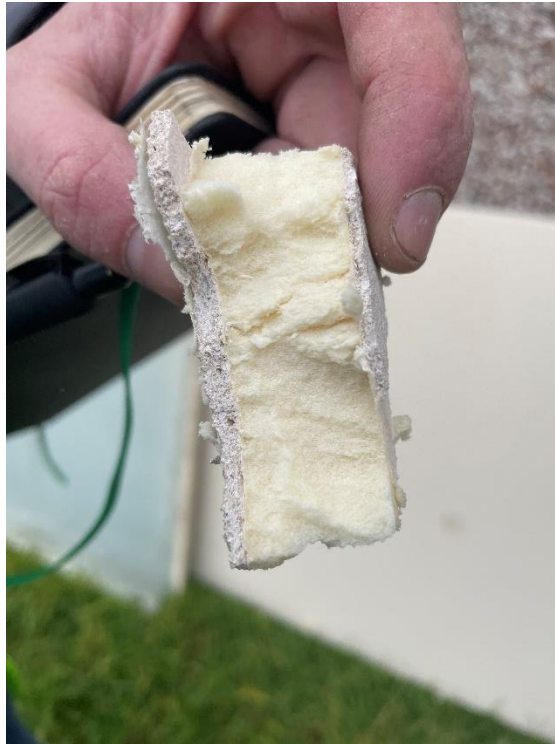
Figure 26. Location 2.1 thermo plastic insulation material

There was no break in the in insulation identified on the party / compartment wall line. This type of material is combustible.

It is recommended that the render systems should be replaced with a non-combustible system.

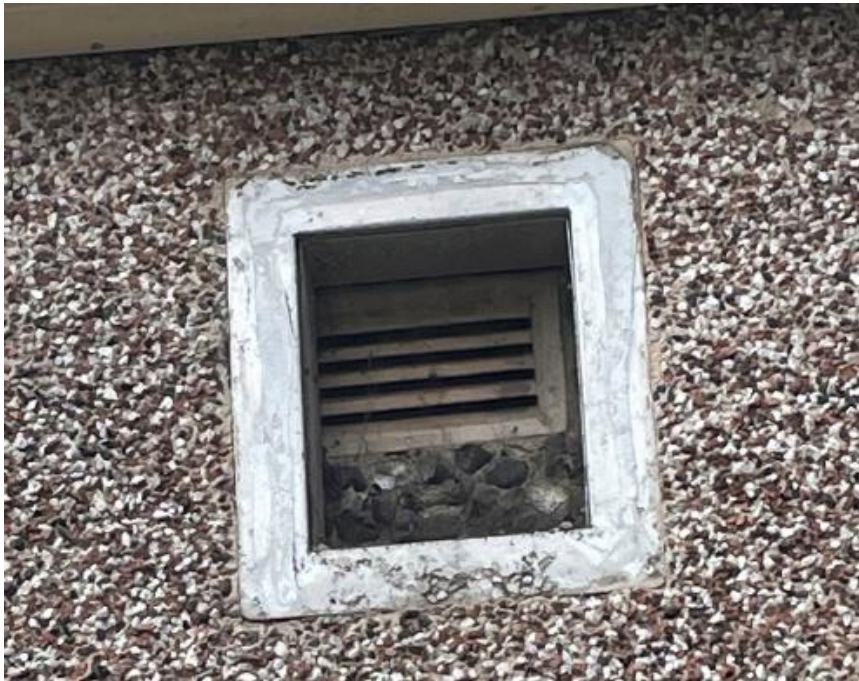
Location 2.2 was at the kitchen extract on the ground floor. The ductwork was provided with a steel 'letterbox' enclosure to separate the ductwork from the insulation and render.

Figure 27. Location 2.2 extract boxed in with steel

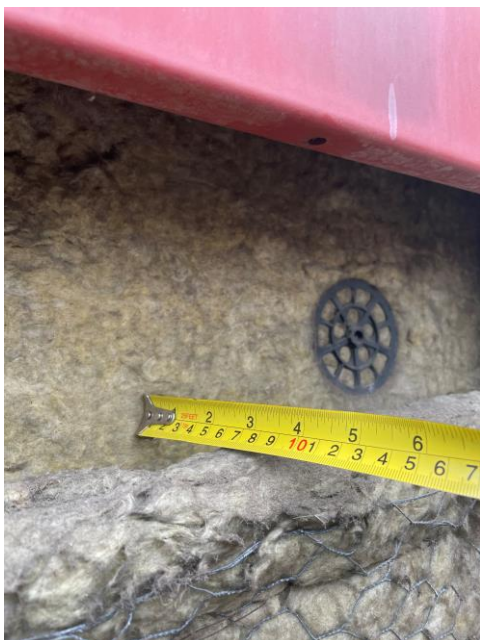
Location 3.1 was under the flat window on the 2nd floor and horizontal cavity barriers were identified; however, they did not form a continuous horizontal fire break and they were not folded over so unlikely to be under compression behind the panel and will not likely restrict fire/smoke spread.

Figure 29. Location 3.1 100mm horizontal cavity barrier on top of mineral wool insulation

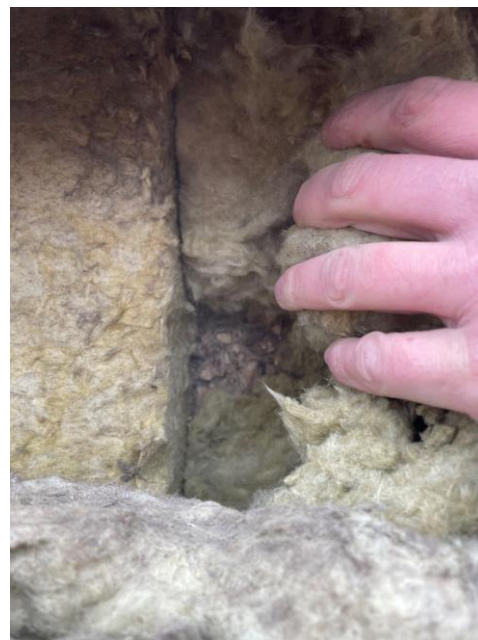
Figure 30. Location 3.1 solid concrete behind 100mm mineral wool insulation

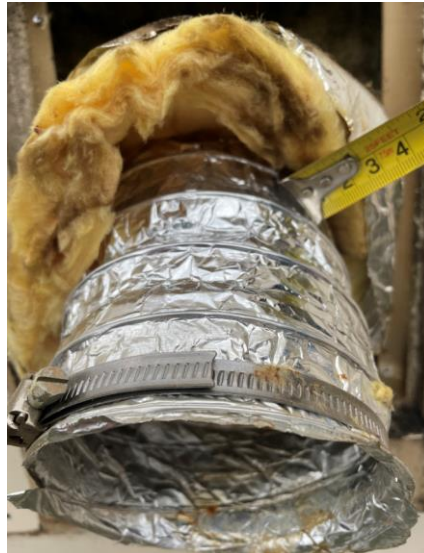
Location 3.2 was at the kitchen extract from a flat on the 2nd floor. A means of protection had been provided around the ductwork. This encapsulated the ductwork and was continuous to outside.

Figure 31. Location 3.2 duct to outside wrapped in 30mm mineral wool

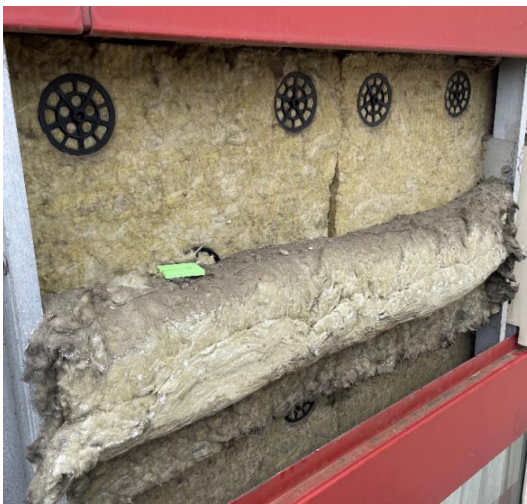
Location 3.3 was at 2nd floor under the flat window. A horizontal cavity barrier was identified and folded over, therefore, compression fit.

Figure 32. Location 3.3 horizontal cavity barrier

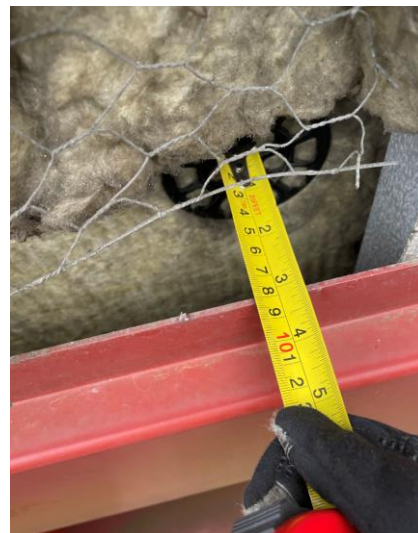
Figure 33. Location 3.3 80mm cavity between insulation and panel

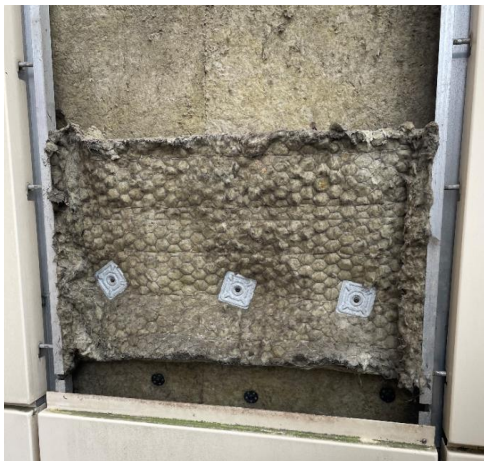
Figure 35. Location 4 horizontal cavity barrier mechanically fixed but not folded over

There were no vertical cavity barriers identified in this location, however, the horizontal cavity barriers were in place at floor levels. The cavity barriers are not under compression in this section of external wall and will not likely provide an effective means for inhibiting fire and smoke spread.

The system present on the refuse chute/lobby section of the building is very similar to the system present on the building with the exception of the substrate. Whilst cementitious particle boards are Euroclass B combustible materials they contribute very little to fire spread generally. BS8414 testing with combustible insulants show that the temperatures at the sheathing board layer are normally low and in the region of room temperature. BB7's recommendations for this system are the same as that for the main system in that cavity barriers should be compression fitted to prevent the unseen spread of fire and smoke.

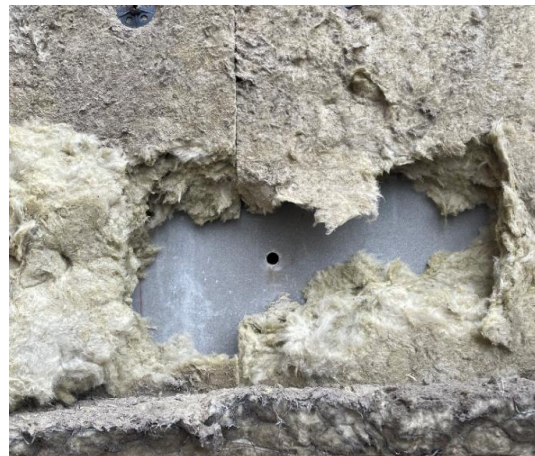
Figure 36. Location 4 approx. 10mm thick CPB

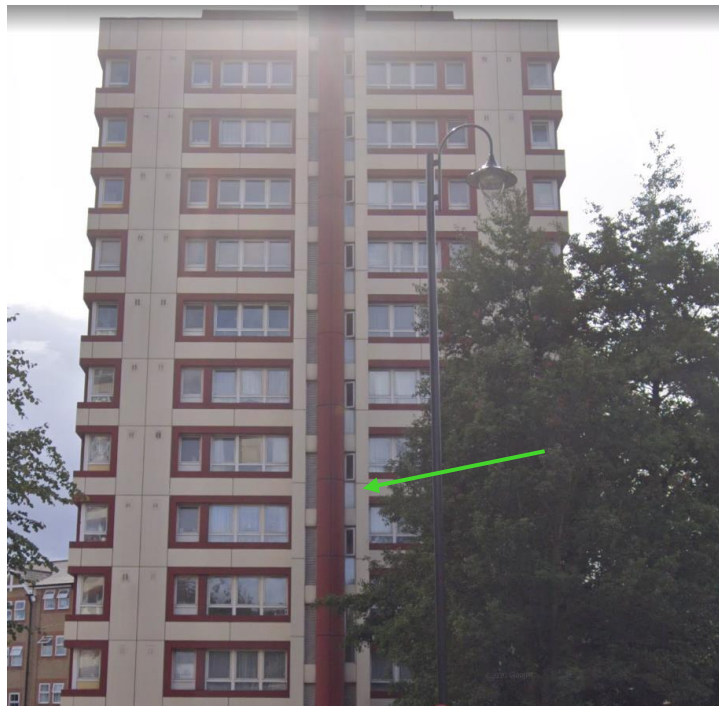
Infill panels are noted to exist on the rear elevation of the building forming the external wall system to the bin store. Figure 37 below shows the panels location and that they stack full height. The infill panel below a glazed window was opened up to identify its construction on a number of similar buildings. It was found that the infill panel is a composite panel consisting of an unknown thermoplastic material sandwiched between two thin layers of steel. The panels appeared to be the same from a visual survey on this block.

Figure 37. Infill panels

With regards to the panels on the section of façade connected to the common area serving the protected stair and AOV windows, although this is recessed from the elevation with flats, it is still connected to the area accessed by a single stair, therefore BB7 recommend replacement.

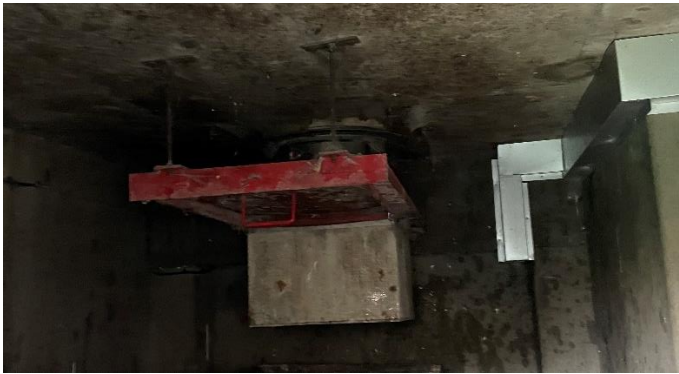
The bin store is accessed from the lift lobby via a ventilated lobby separated with double door fire protection. The doors inspected appeared to be solid and robust with working self-closers. The bin store is provided with a wall mounted sprinkler and a fusible link damper at the base of the bin chute which will limit potential fire size and spread. This is shown in the following figure.

Figure 38. Bin store fusible link and sprinkler
