# **EWS1 Report**

1-87 Regina Road

Croydon

30<sup>th</sup> April 2021

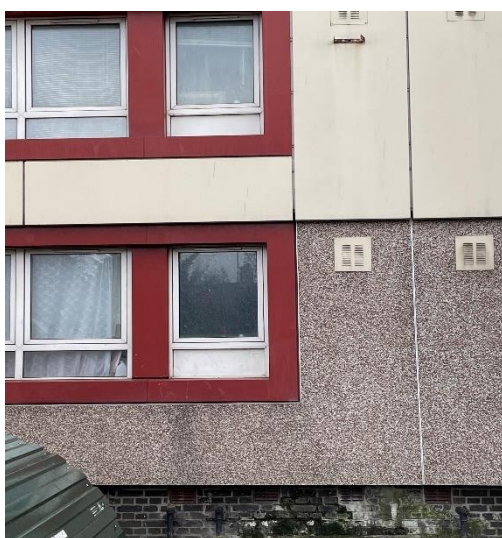
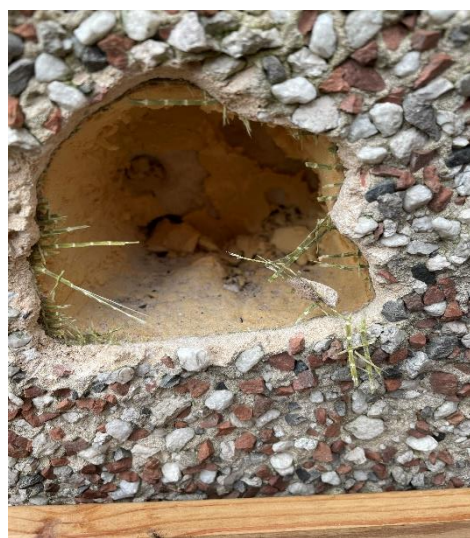
Location 1 was on the lower rear elevation at ground floor level where the cladding exists. The system was found to be:

- 10mm render
- 100mm PIR insulation Euroclass E combustible thermoset insulation
- 130mm solid concrete. A hole was drilled through the concrete in some locations to determine the thickness, however, it could not be further determined what was behind the concrete without potentially compromising the integrity of the structure and causing damage internally. Based on the style of construction the LPS panel would be substantially larger than 110mm. This was also confirmed based on a view underneath the external walls at ground floor level.

This location was surveyed due to the presence of the render system. The PIR exists at all points on the ground floor level and is continuous in nature. The system returns into the bin store and also the buildings entrance. No cavity exists as part of this system.

**Figure 12.** View of location of render with PIR cladding system behind

**Figure 13.** View through system

The insulant was found to be used on a masonry cavity only where the leaf is >75mm thick. Combustible insulants have historically been permissible for use on masonry due to the dense, robust, inert and non-combustible nature of the masonry meaning that uncontrolled fire spread is a low risk. However, there is a higher risk when this is placed on the surface of the blockwork. Whilst we will work on the basis that the product is, from a risk perspective, the actual material is of little importance due to the location of the insulation found at the ground floor only.

In any case BB7 would recommend that the product is replaced to ensure life safety of the occupants. These systems are known to support fire spread so a risk does still remain.

We have identified high-risk materials at low level in the block with PIR insulation noted at low level, which is defined as high risk within the government guidance. This material should be removed and replaced with a non-combustible alternative.

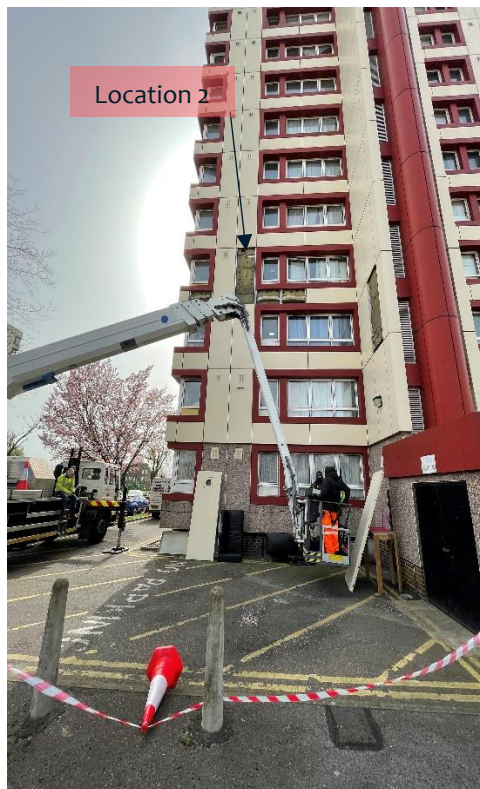
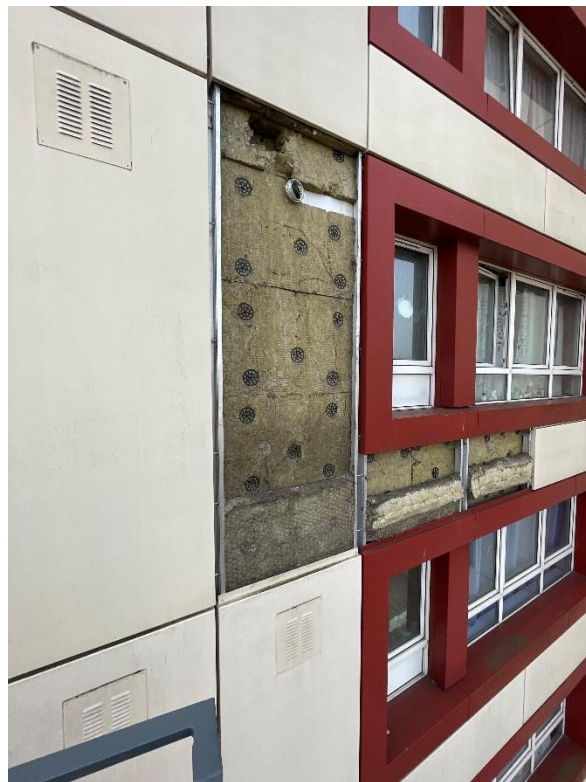
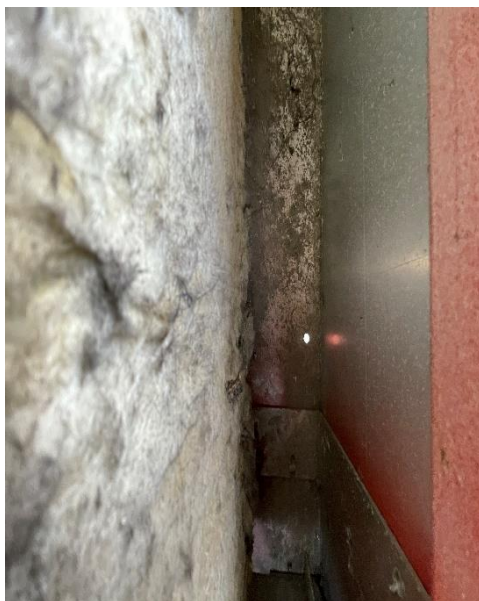
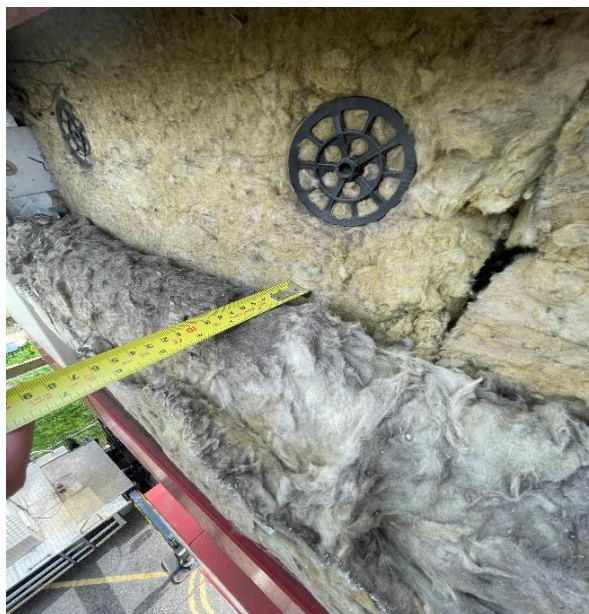
**Figure 15.** View of barrier not folded on the continuous cladding section, however the barrier has been folded at the area between openings.

**Figure 16.** View behind metal cladding    **Figure 17.** Measurement of barrier

A horizontal cavity barrier was found in the inner cavity in this location behind the metal cladding, it was a reinforced mineral wool product. The barrier was found to be poorly fitted, it was not under compression or folded in place to fully fill the cavity, so it may allow fire to bypass the compartment line here, which is not permissible.

A horizontal cavity barrier was found in the cavity in this location. The horizontal barrier was in line with the compartment floor. The barriers were mineral wool type product reinforced with wire, which were common at the time of installation. This cavity barrier has to be folded over in order to ensure that the barrier fills the full depth of the cavity to reach the rear of the cassette panel, however, the barrier was found to be poorly fitted with gaps appearing next to the façade carrier system between windows, it was not under compression so it may allow fire to bypass the compartment line here, which is not permissible.

Cavity barriers would be required between the mineral wool insulation and the external metal covering. Considering the extent of the metal cladding in this location, BB7 would have expected full cavity barrier provisions as per Approved Document B although at the time of installation, cavity barriers would not have been required around openings. A cavity barrier should exist across the whole system from RC structure to the inside face of the aluminium cladding which was not found in this case. However, this could be considered acceptable as both the mineral wool and metal cladding are non-combustible and would not likely contribute to a façade fire. In addition to this, as the mineral wool is the same material as the cavity barriers, this would reduce the likelihood of the cavity barrier being flanked by fire.

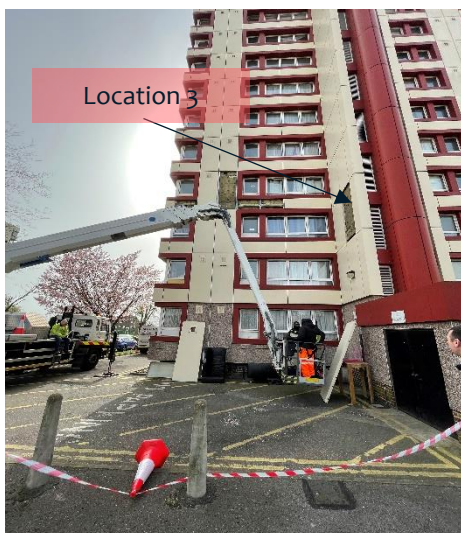
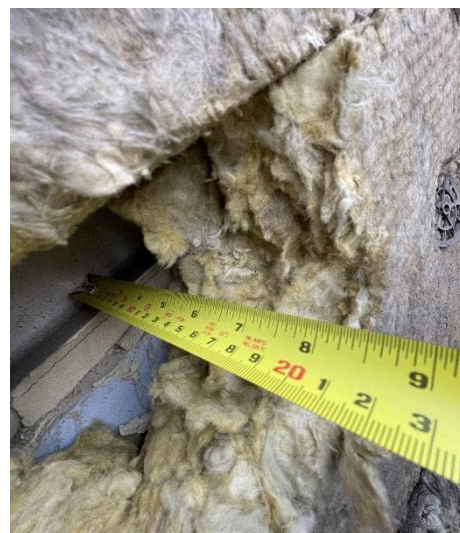
This location was surveyed due to the presence of the metal cladding, cavity barriers would be expected as there are compartment floor lines which exist. There is one cavity at this location. An outer cavity between the metal cladding and the mineral wool.

It can be seen that the construction of the refuse lobbies appears to be newer than the remainder of the building due to the presence of engineered brick and steel work. The steelwork appeared to be protected with an intumescent coating, however, this could not be confirmed.

**Figure 18.** View of location

**Figure 19.** Measurement of system

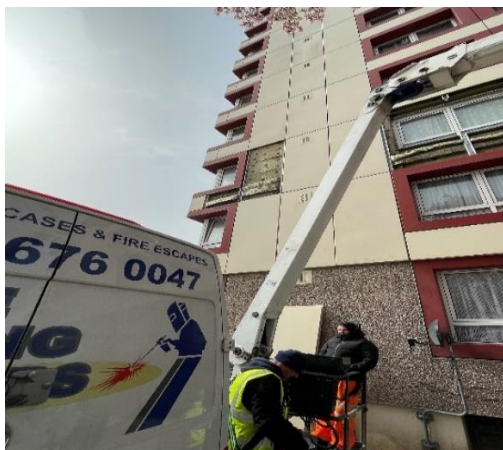
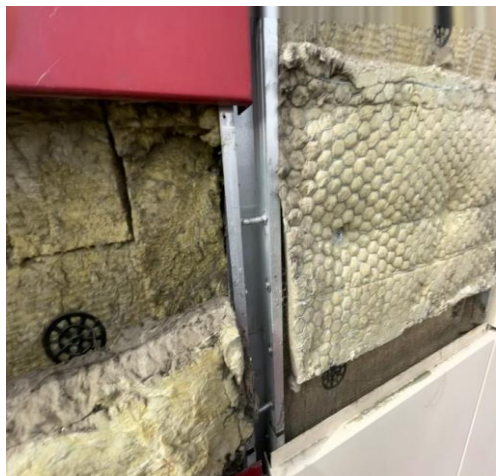
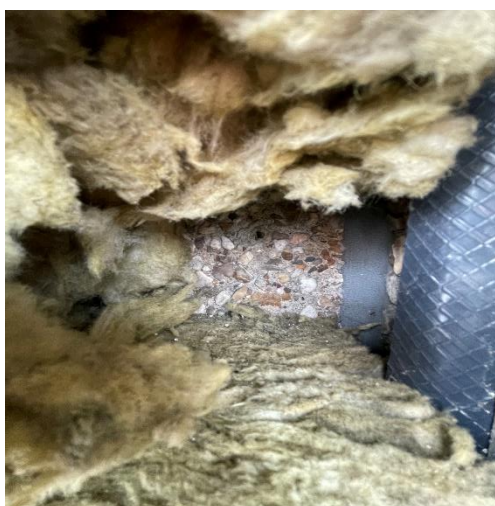
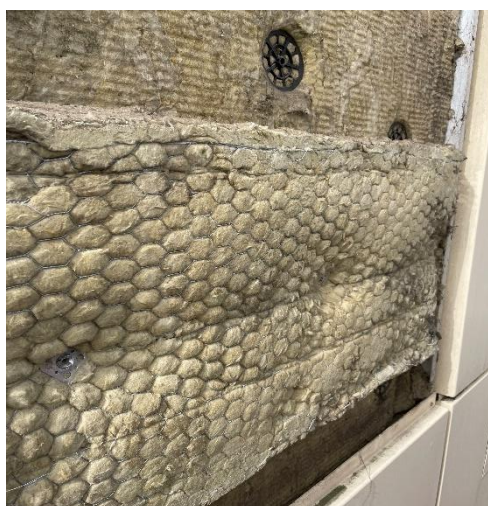
A horizontal cavity barrier was found in the cavity in this location. The horizontal barrier was in line with the compartment floor. This cavity barrier has to be folded over in order to ensure that the barrier fills the full depth of the cavity to reach the rear of the cassette panel, however, the barrier was found to be poorly fitted with gaps appearing next to the façade carrier system, it was not under compression so it may allow fire to bypass the compartment line here, which is not permissible.

Cavity barriers would be required between the mineral wool insulation and the external metal covering. Considering the extent of the metal cladding in this location, BB7 would have expected

full cavity barrier provisions as per Approved Document B although at the time of installation, cavity barriers would not have been required around openings. A cavity barrier should exist across the whole system from RC structure to the inside face of the aluminium cladding which was not found in this case. However, this could be considered acceptable as both the mineral wool and metal cladding are non-combustible and would not likely contribute to a façade fire. In addition to this, as the mineral wool is the same material as the cavity barriers, this would reduce the likelihood of the cavity barrier being flanked by fire. This location was surveyed due to the presence of the horizontal compartment line and corner of window.

**Figure 21.** Cavity barrier not folded next to correctly installed barrier

**Figure 23.** Barrier incorrectly installed

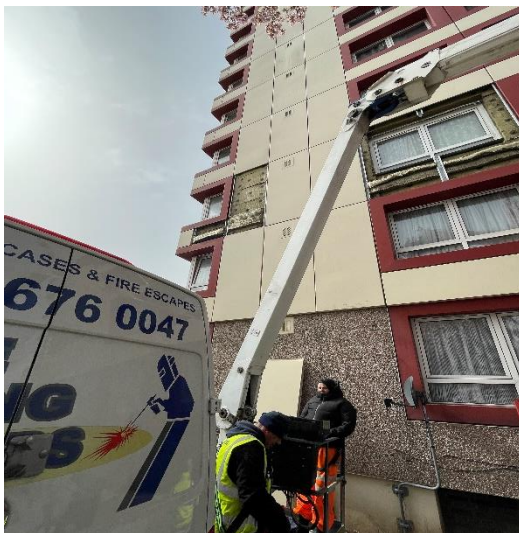
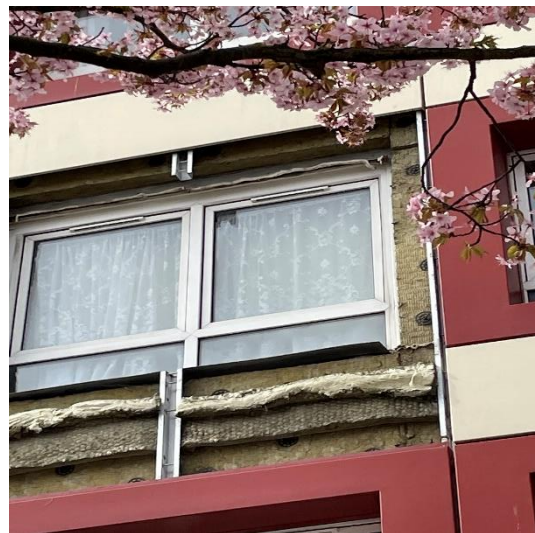
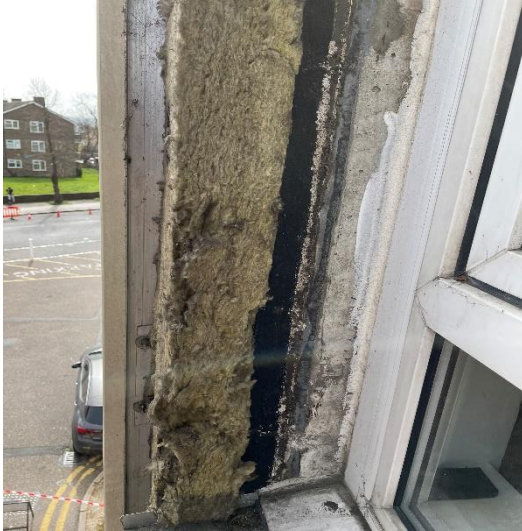
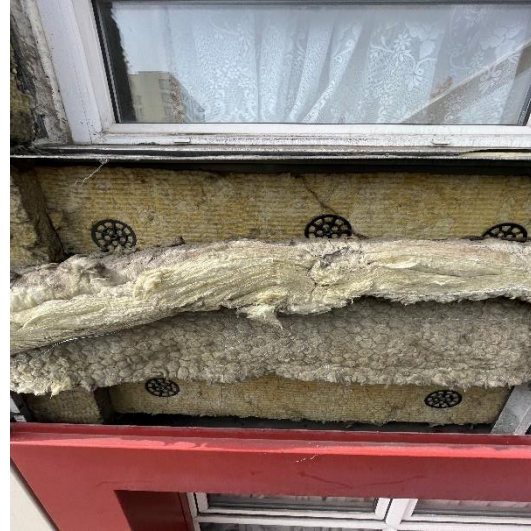
This location was surveyed due to the presence cladding and the vertical and horizontal compartment lines, cavity barriers would not be expected at the window openings as they are not a requirement of the guidance at the time of design & construction. There is one cavity at this location. An outer cavity between the metal cladding and the mineral wool.

Cavity barriers appear to be present fixed to the mineral wool at compartment floor areas. The cavity barriers will inhibit uncontrolled fire spread within the cavity as they are folded correctly filling the full depth of the cavity.

**Figure 27.** Poorly fitted cavity barrier under window

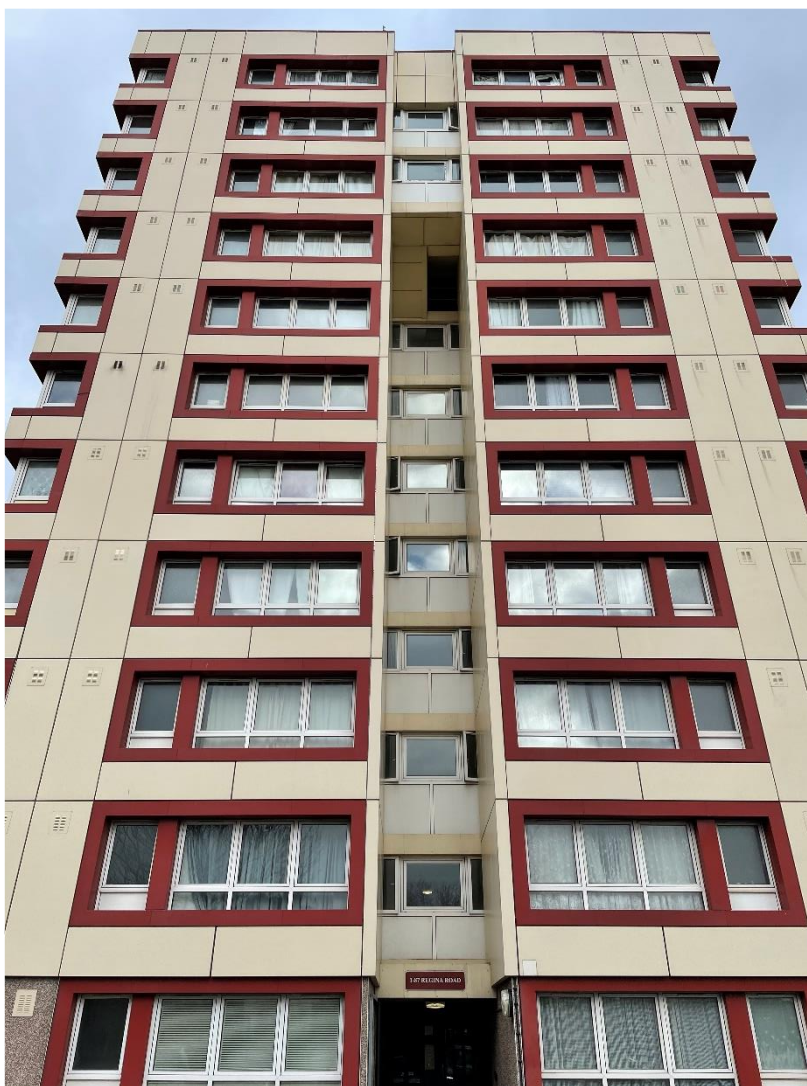
**Figure 28.** Infill panels

Infill panels are noted to exist on either side of the building forming the external wall system to the common areas. Figure 28 below shows the panels location and that they stack full height. The infill panel below a glazed window was opened up to identify its construction on a number of similar buildings. It was found that the infill panel is a composite panel consisting of an unknown thermoplastic material sandwiched between two thin layers of steel. The panels appeared to be the same from a visual survey on this block.

Similarly, the infill panels, which are considered high risk combustibles, should be removed and replaced with a non-combustible alternative.

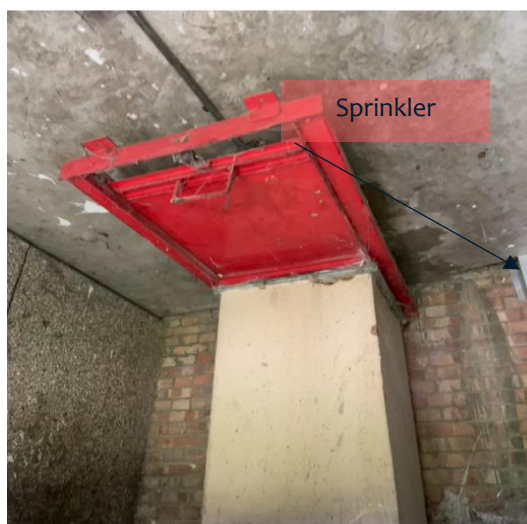
The bin chute room is accessed from the lift lobby on the upper floors via a ventilated lobby separated with double door fire protection. There was external access at ground floor. The doors inspected appeared to be solid and robust with working self-closers. The bin store at ground floor was provided with a side mounted sprinkler head to reduce the potential fire size and a damper on a fusible link was provided at the base of the bin chute to reduce the chance of fire spread.

**Figure 29.** Damper & sprinkler

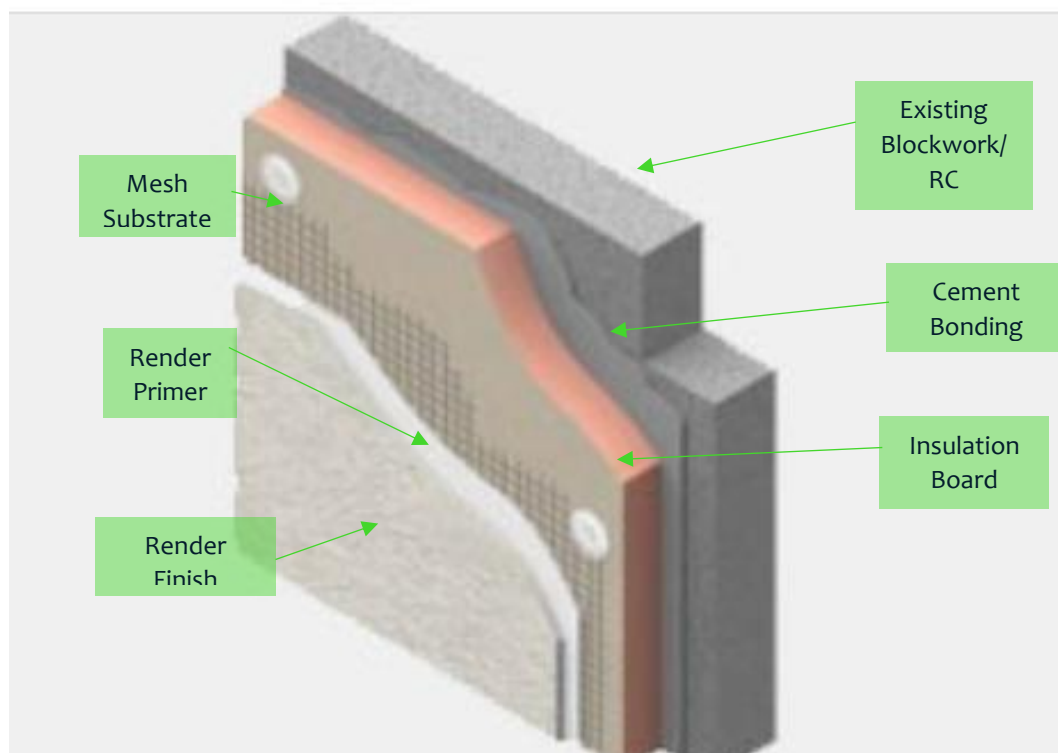
Two combustible insulants were found to be used. One insulation type was found on 1-87 Regina Road, but could not be confirmed on site on the day of inspection; however, based on the colour of the insulation it appeared to be similar to the Celotex SW3000 range.

Celotex have discontinued SW3000. However, it was described as “a PIR board designed for external wall upgrade, usually used as a part of external wall insulation systems for ultimate external wall thermal performance. The board is coated with glass tissue facings which only improve its insulation value”. Celotex SW3000 is a combustible material.

**Figure 31.** Image of PIR insulation system

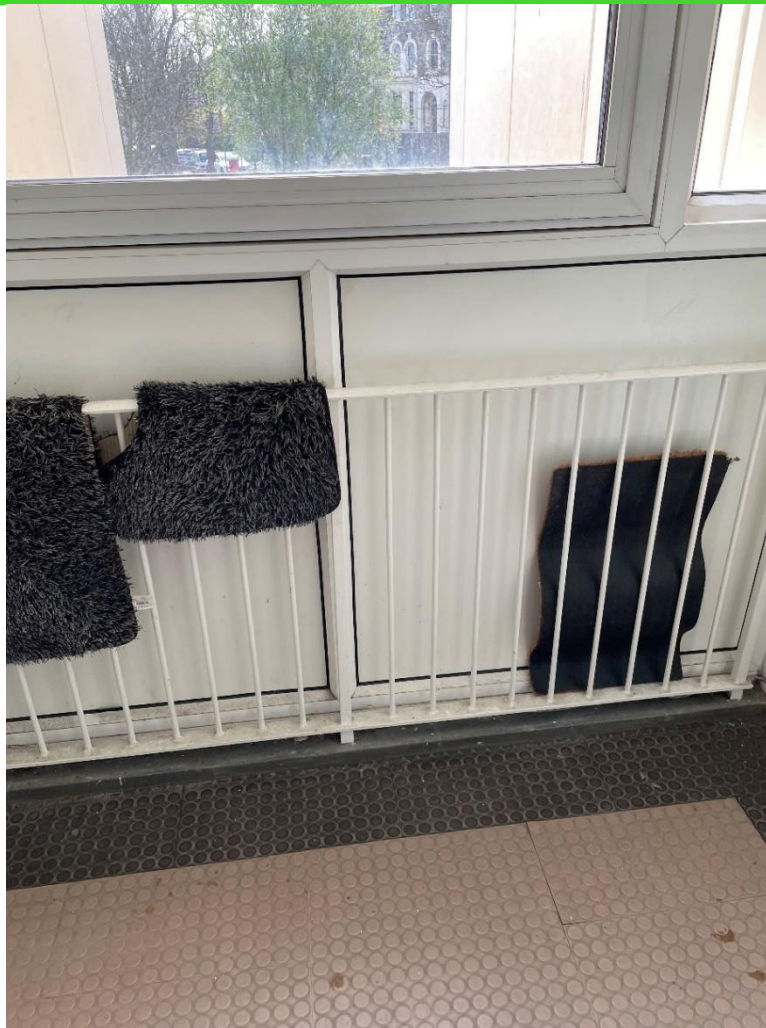
**Figure 34.** Typical infill panel

**It is recommended that all window infill panels are to be replaced for non-combustible alternatives on the common area sections.**

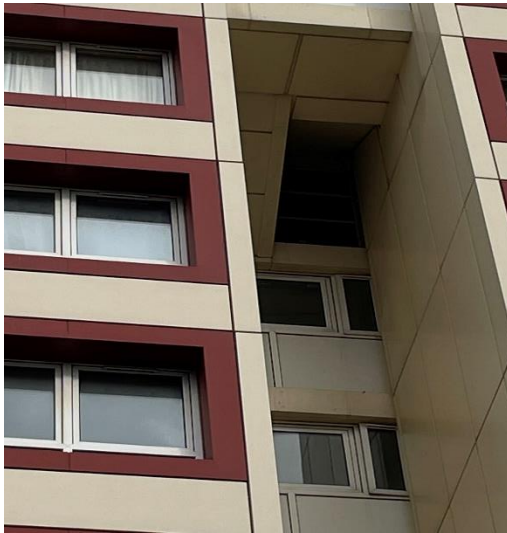
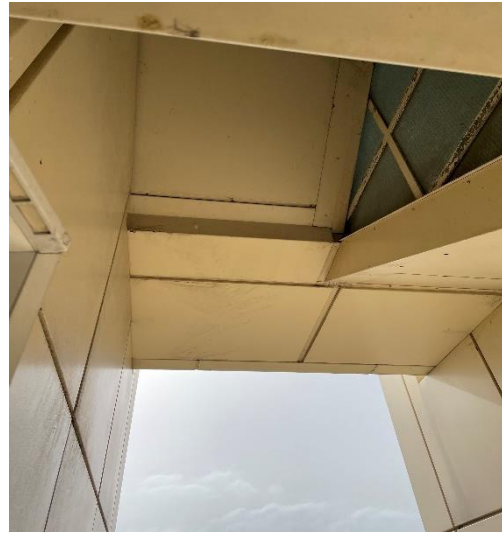
place at compartment lines as the shape of this overhang could increase the chance of fire spread at this location. With the addition of a Georgian wire glass forming part of the enclosure also present, this could also prove to be a weak point, although it should attain some sort of fire resistance it will perform worse than the cladding in the event of a fire.

**Figure 33.** Overhang at front elevation

**Figure 34.** Overhang from inside block with Georgian wire glass
