# **EWS1 Report**

**133-176 Gordon  
Crescent, Croydon**

**30<sup>th</sup> April 2021**

**12125BB**

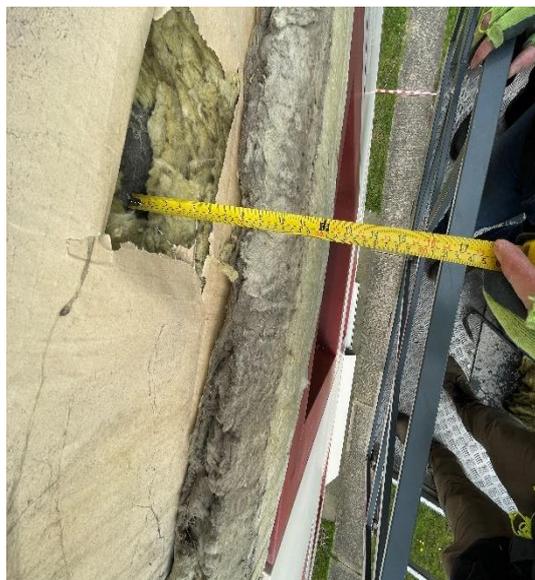
- 130mm horizontal (floor level) reinforced mineral wool cavity barriers with metal fixings has been folded over in some areas to increase the level of compression (Figure 12 & 13). It was noted in various areas that compression was not being achieved and some gaps were clearly visible.

**Figure 12.** Location 1, Horizontal cavity barrier seen from above. Rockwool insulation, building

- Any composite panels with infill combustible insulation should be replaced with a non-combustible alternative.
- BB7 recommend that the cavity barriers are upgraded to ensure that they will inhibit the unseen spread of fire and smoke. This can be done in one of two ways:
  - Fold the existing barriers such that they are under compression; or
  - Provide new barriers.

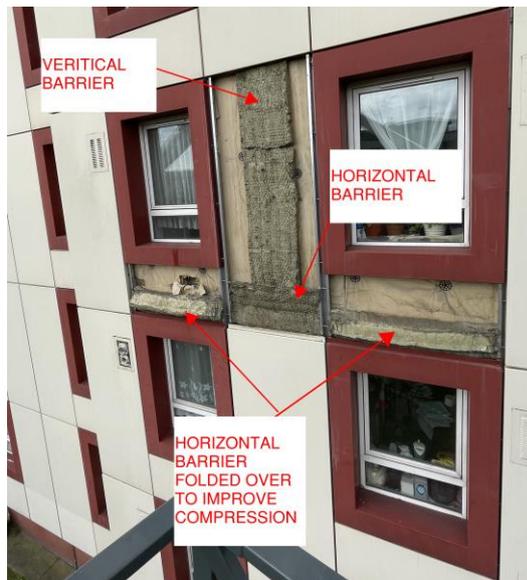
**Figure 13.** Location 1, Horizontal & vertical cavity barriers exposed. Note that two barriers are not folded to be under compression and the

paper and the wall beyond can be seen.

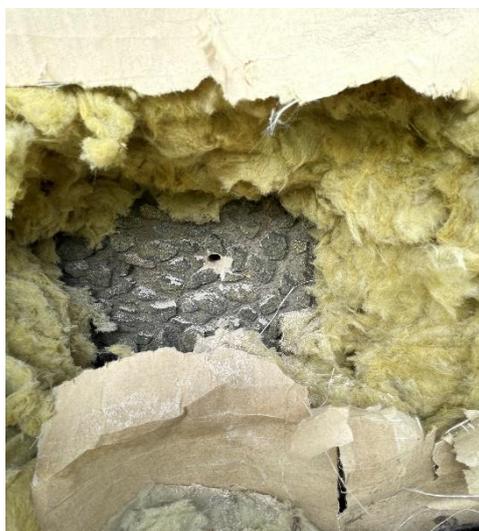
**Figure 14.** Concrete panel behind insulation exposed and trial hole drilled to test depth.

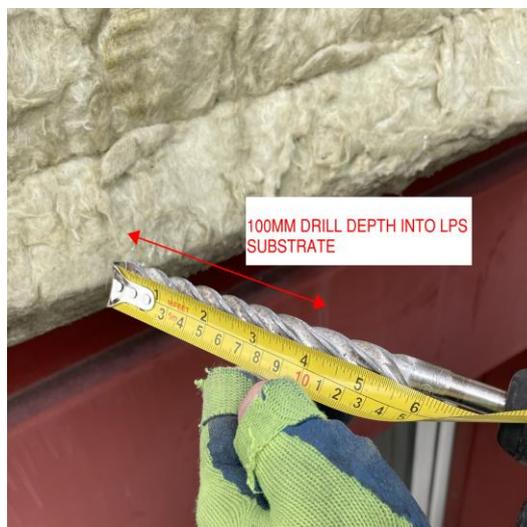
- 100mm solid concrete. A hole was drilled through the concrete to determine the thickness; however, it could not be further determined what was behind the concrete without potentially compromising the integrity of the structure and causing damage internally (Figures 14 & 15). In some cases brick work was found, this is likely to be a flank wall. Please refer to Section 3 for further information.

**Figure 15.** Trial hole drilled to 100mm into LPS substrate. The RC was thicker, only a 100mm hole was made

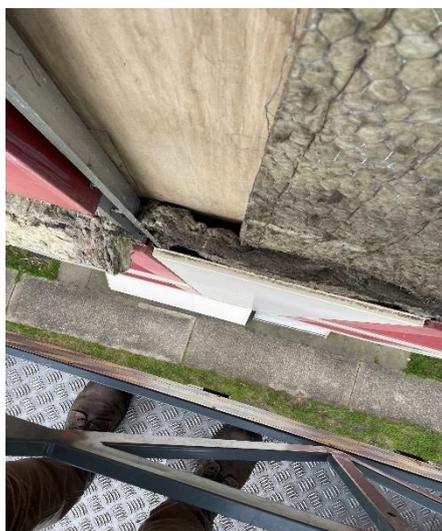
**Figure 16.** Vertical cavity barrier positioned behind the horizontal and not under compression

The barriers were mineral wool type product reinforced with wire, which were common at the time of installation. This cavity barrier has to be folded over in order to ensure that the barrier fills the full depth of the cavity to reach the rear of the cassette panel, however, the barriers were found in some cases to be poorly fitted with gaps appearing next to the façade carrier system, it was not under compression so it may allow fire to bypass the compartment line here, which is not permissible.

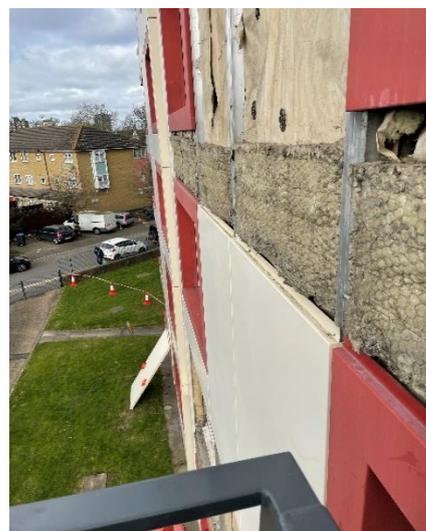
**Figure 17.** Horizontal barrier not under compression along the line of inspection area 1 and not folded such that it is under compression.

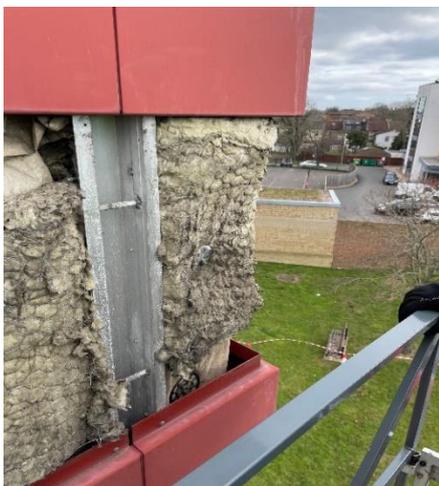
**Figure 18.** Location 2 Continuous cavity barrier at floor level. Again cavity barriers can be seen not to be under compression.

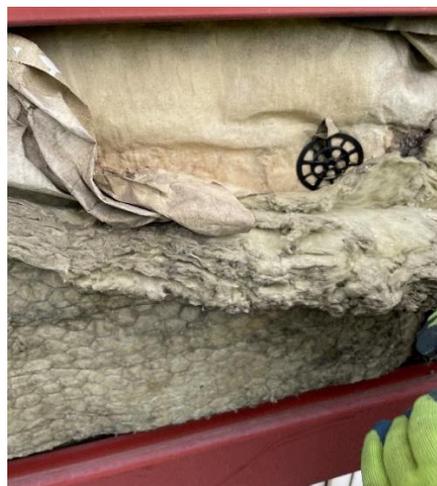
**Figure 19.** Location 2 – Horizontal barrier pulled back to exposed building paper and fixings behind.

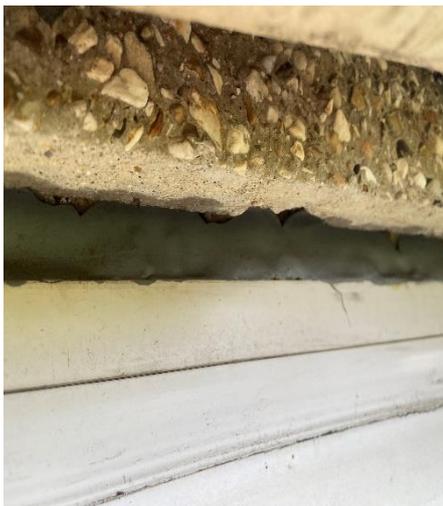
Around windows it was noted that a mastic that isn't fire rated has been used to seal the windows in. Cavity barriers were not a requirement around windows on blocks of flats until the year 2000, therefore assuming the re-clad occurred in the late 1990's the lack of barriers would have been Building Regulations compliant.

**Figure 22.** Location 3 mastic above window

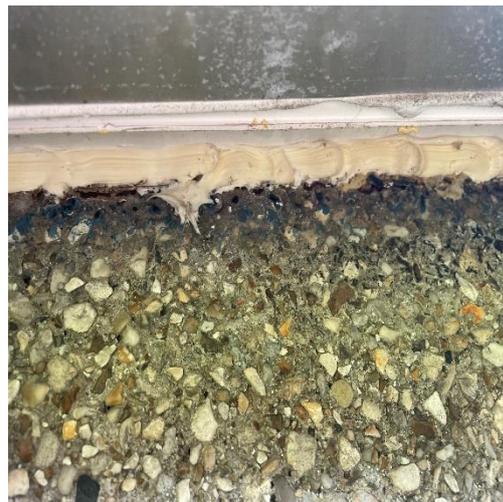
**Figure 23.** Location 3 mastic below windows

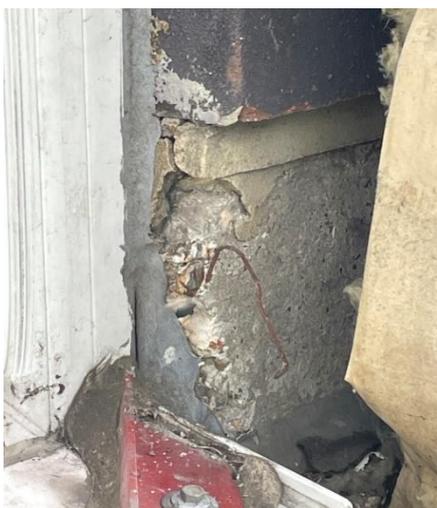
**Figure 24.** Location 3 right hand detail with masonry visible. At this point the RC upstand likely supports the brick as seen in Section 3.

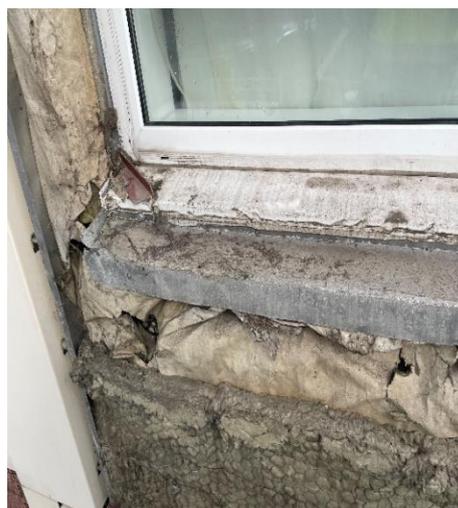
Location 3 was at the third floor around a flat window. Mineral wool insulation has been installed around the windows but cavity barriers have not been provided. As per location 1 this was allowable at the time of the re-clad. The horizontal barrier can be seen below at floor level but nothing above and it has not been installed under compression. Gaps between the window and the surrounding masonry have been filled with a mastic material, whether it is fire rated mastic is unknown. Another trial hole was drilled into the LPS substrate and as with the previous hole a depth of 100mm was achieved.

**Figure 25.** Location 3 Horizontal barrier below and rockwool positioned vertically at the side of the window

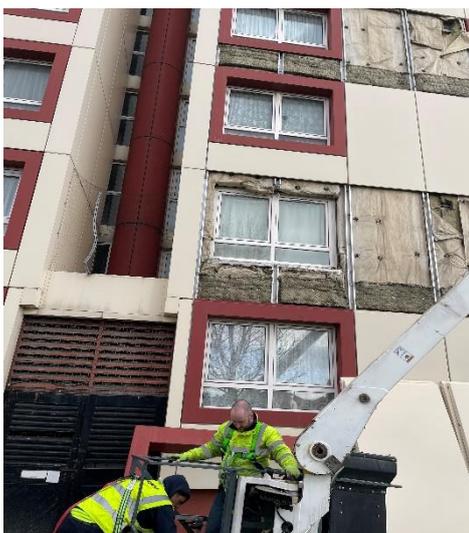
**Figure 26.** Location 4 extract window exposed. It is noted from other building examined the panels visible behind the refuse chute are not fire rated

Figure 26 shows that cavity barriers are not under compression.

It was noted that the panels on the rear elevation adjacent to the bin chute have found to be constructed of flammable material on other similar buildings. So, it is suspected they are also flammable on this building also.

- An up to date FRA should be carried out considering the new information. We'd recommend that a Type 4 is conducted on the basis of the findings of other similar blocks.
- Replace the infill panels behind the refuse chute

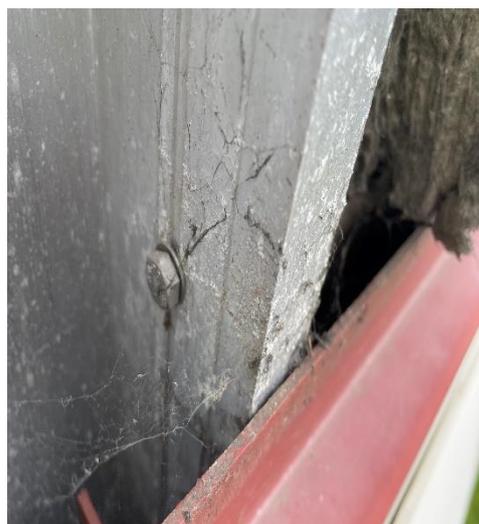
**Figure 27.** Location 4 cavity barrier was in compression against the lip of the cladding but would not have reached the rear of the cassette. Metal framing system fixed back to LPS substrate.

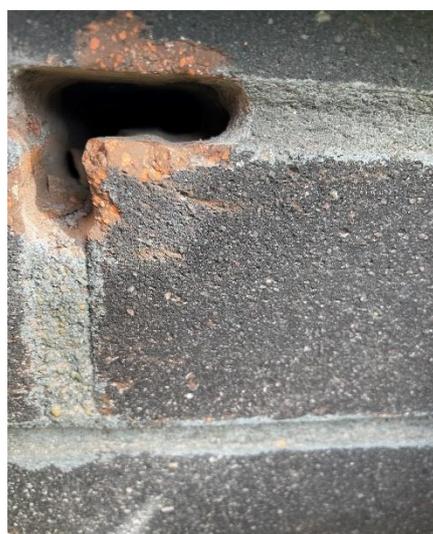
**Figure 29.** Location 4 trial hole drilled in the masonry to expose the 75mm clear cavity beyond.

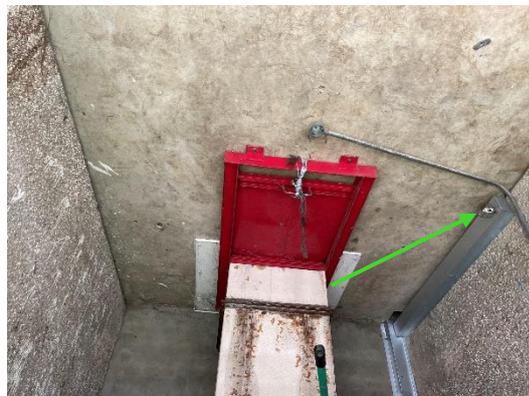
Location 5 was on the ground floor of the South elevation. The bin store was inspected, and it appears the ground floor is a cast concrete base as is the roof of the bin store. There has been a fusible link damper installed on the refuse chute, but this appears to have been tied back with

string, this should be removed. The bin store also has a sprinkler head installed to reduce fire growth.

**Figure 31.** Location 5 Sprinkler head visible in bin store area. Also note the fusible linked damper has been tied back, this should be removed.
