# **EWS1 Report**

2-56A Regina Road

Croydon

30<sup>th</sup> April 2021

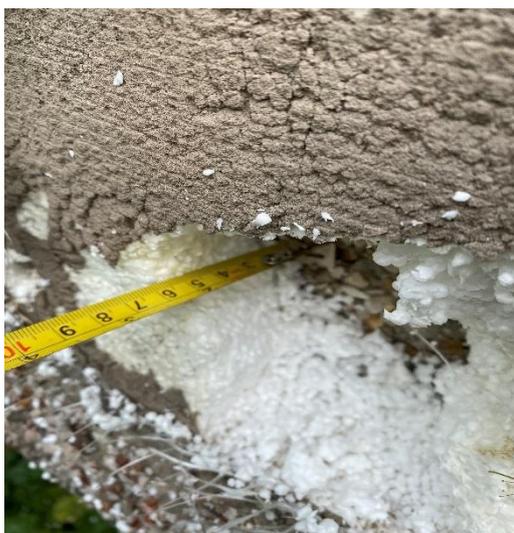
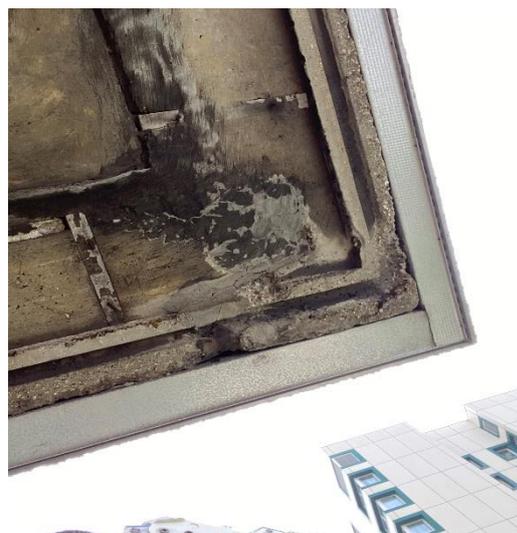
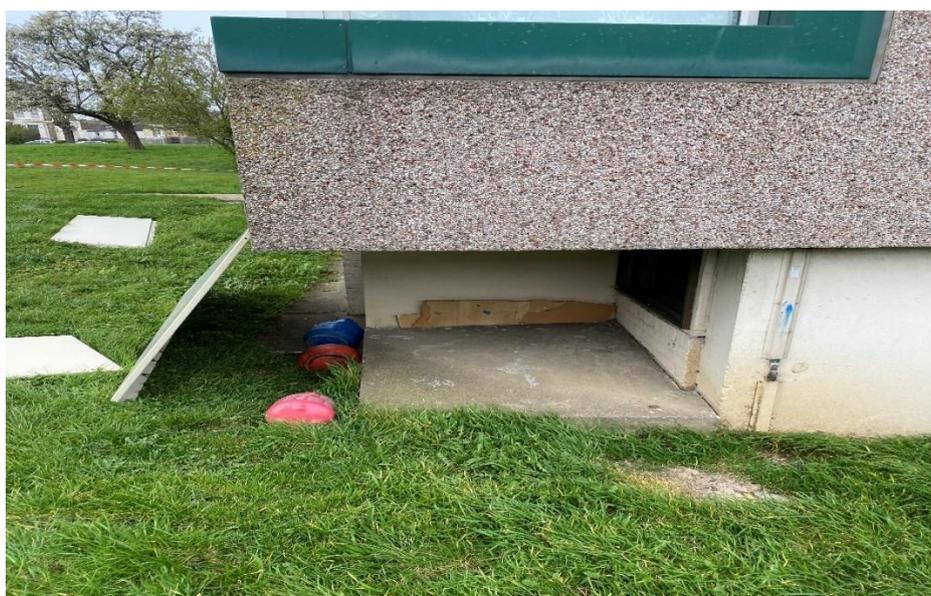
This location was surveyed due to the presence of the render system. The EPS exists at all points on the ground floor level and is continuous in nature. The system returns into the bin store and also the buildings entrance.

**Figure 12.** View of insulation

**Figure 13.** View of system from underside showing insulation on existing structure

**Figure 14.** View of insulation to lower portion of building

EPS Insulation was found to the ground floor of block 2-56A Regina Road. This insulation was placed on top of the existing RC structure, with a render finish. Small areas of this render have been damaged exposing the insulation behind where it has become slightly damaged.

EPS has a Euroclass E rating meaning that it is highly flammable. Unfortunately, no branding could be observed, and many EPS insulations are white in colour. Due to the high combustibility of these products and their behavior in fire which supports fire spread BB7 do not consider that any testing is required to determine the material properties.

The outer portion of the system where EPS cladding is mounted onto the outer skin of RC structure is not considered to be significantly high risk but it will likely exhibit fire spread to a degree. On that basis to ensure the life safety of occupants the EPS render system should be removed and replaced with a non-combustible alternative.

We have identified high-risk materials at low level in the block with EPS insulation noted at low level, which is defined as high risk within the government guidance. This material should be removed and replaced with a non-combustible alternative.

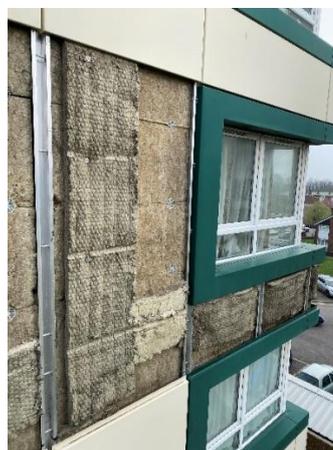
Vertical and horizontal cavity barriers were found in the cavity in this location, it was a mineral wool type product reinforced with wire. This cavity barrier has to be folded over in order to ensure that the barrier fills the full depth of the cavity. However, the barrier was found to be poorly fitted with gaps appearing next to the façade carrier system, it was not under compression or folded into position so it may allow fire to bypass the compartment line here, which is not permissible.

**Figure 16.** Poorly fitted cavity barriers around window

Cavity barriers would be required between the mineral wool cladding and the external metal covering. Considering the extent of the metal cladding in this location, BB7 would have expected full cavity barrier provisions as per Approved Document B although both the rockwool and metal cladding are non-combustible and would not greatly contribute to a façade fire.

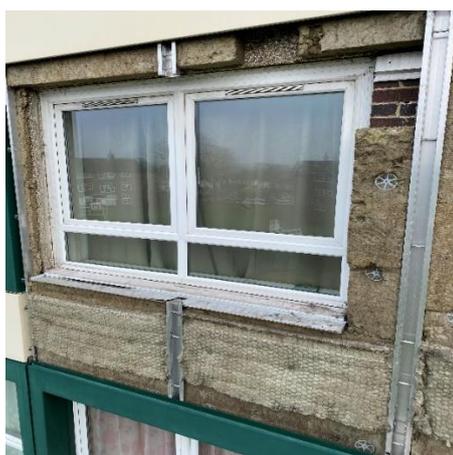
**Figure 17.** Poorly fitted cavity barrier at compartment floor. Brick wall system can be seen & no cavity barriers around window.

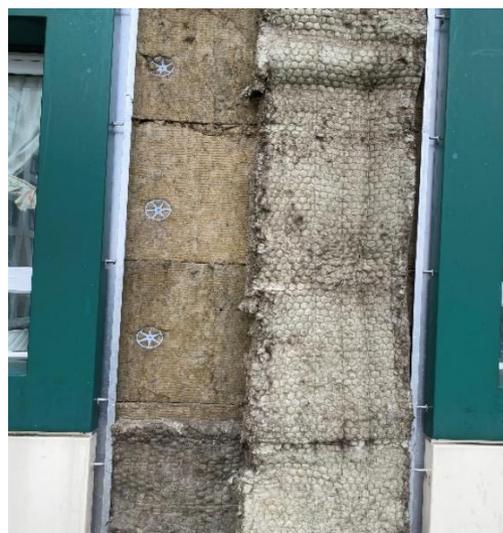
A vertical and horizontal cavity barrier was found in the cavity in this location. The horizontal barrier was in line with the compartment floor. However, the vertical barrier was not at the compartment line and therefore, we assume this is provided for an effective lateral break. The barriers were mineral wool type product reinforced with wire, which were common at the time of installation. This cavity barrier has to be folded over in order to ensure that the barrier fills the full depth of the cavity to reach the rear of the cassette panel, however, the barrier was found to be poorly fitted with gaps appearing next to the façade carrier system, it was not under compression so it may allow fire to bypass the compartment line here, which is not permissible.

**Figure 20.** Vertical compartment line not under compression.

Cavity barriers would be required between the mineral wool insulation and the external metal covering. Considering the extent of the metal cladding in this location, BB7 would have expected full cavity barrier provisions as per Approved Document B although at the time of installation, cavity barriers would not have been required around openings. A cavity barrier should exist across the whole system from RC structure to the inside face of the aluminium cladding which was not found in this case. However, this could be considered acceptable as both the mineral wool and metal cladding are non-combustible and would not likely contribute to a façade fire. In addition to this, as the mineral wool is the same material as the cavity barriers, this would reduce the likelihood of the cavity barrier being flanked by fire.

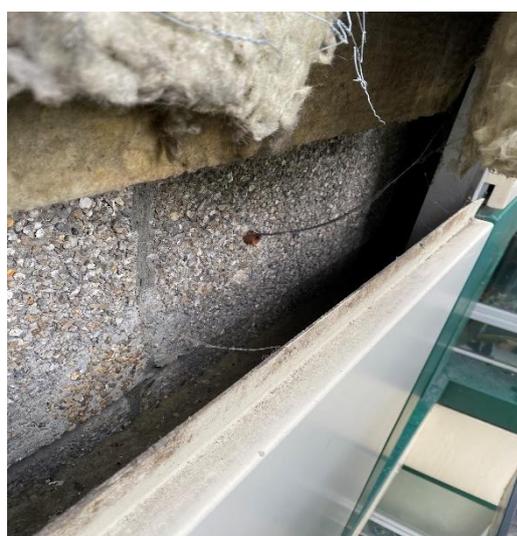
**Figure 22.** Gap behind metal cladding

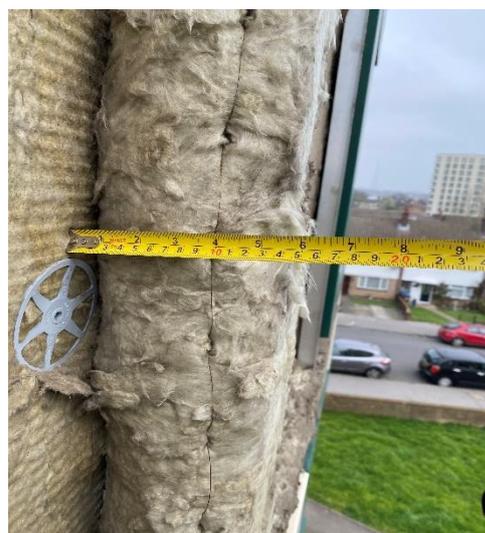
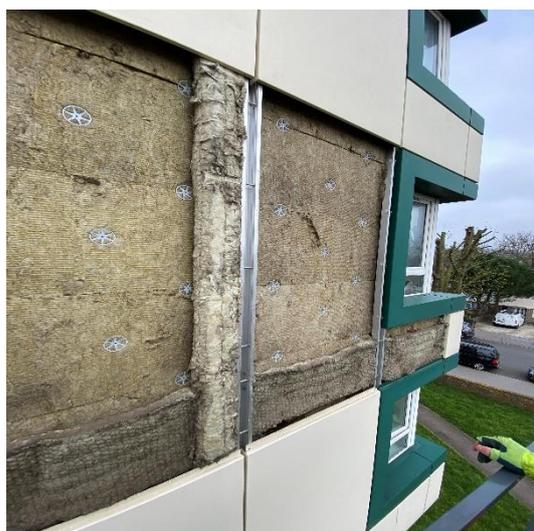
This location was surveyed due to the presence of the compartment line and the window. The cavity barrier was a reinforced mineral wool product, however they not folded in areas to fill the metal cladding completely and therefore do not provide an effective break against fire.

**Figure 24.** Folded cavity barrier

**Figure 25.** Non folded horizontal barrier

- The EPS insulant and render at lower floors needs to be replaced with a non-combustible alternative.
- Cavity barriers in the Aluminium cladding system should be either remedied such that they are under compression or new barriers provided.
- The infill panels at windows should be removed and replaced with a non-combustible.

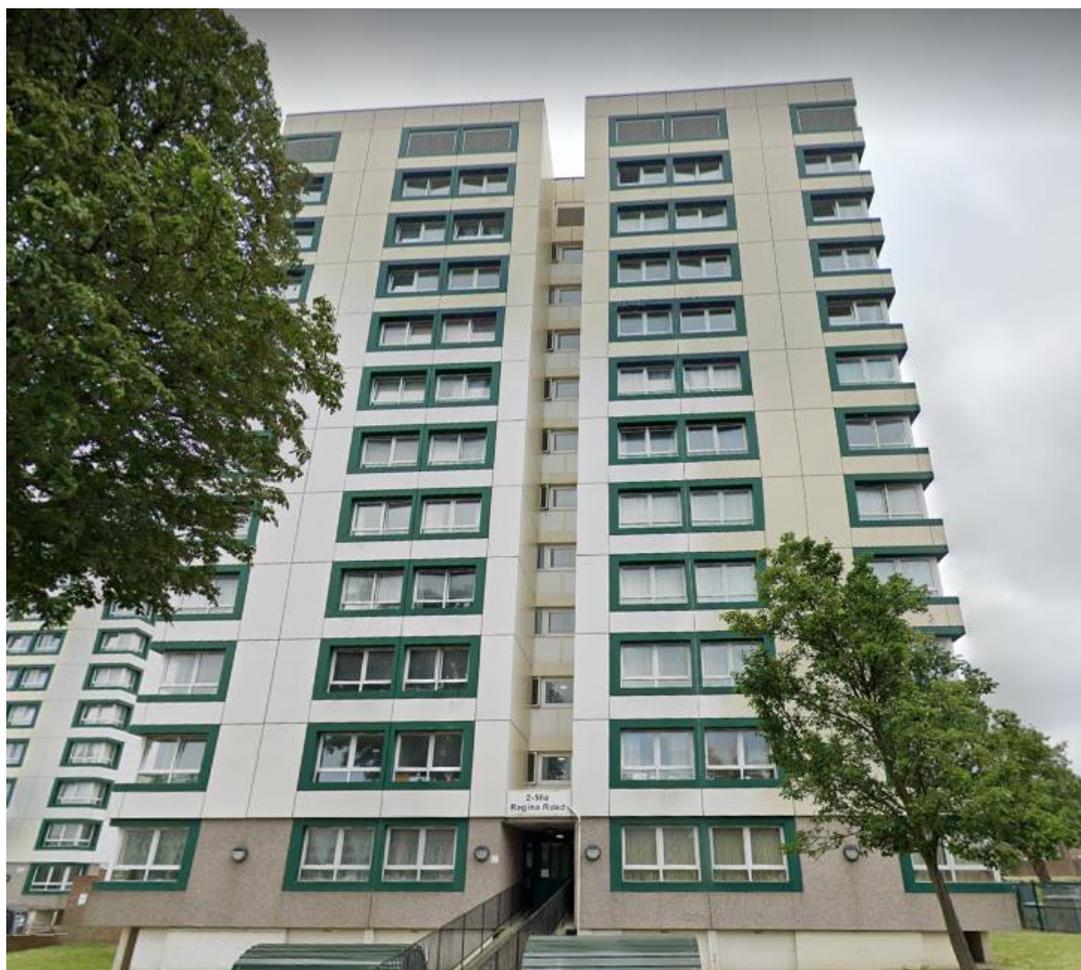
Infill panels are noted to exist on either side of the building forming the external wall system to the common areas. Figure 27 below shows the panels location and that they stack full height. The infill panel below a glazed window was opened up to identify its construction on a number of similar buildings. It was found that the infill panel is a composite panel consisting of an unknown thermoplastic material sandwiched between two thin layers of steel. The panels appeared to be the same from a visual survey on this block.

**Figure 27.** Infill panels

Similarly, the infill panels, which are considered high risk combustibles, should be removed and replaced with a non-combustible alternative.

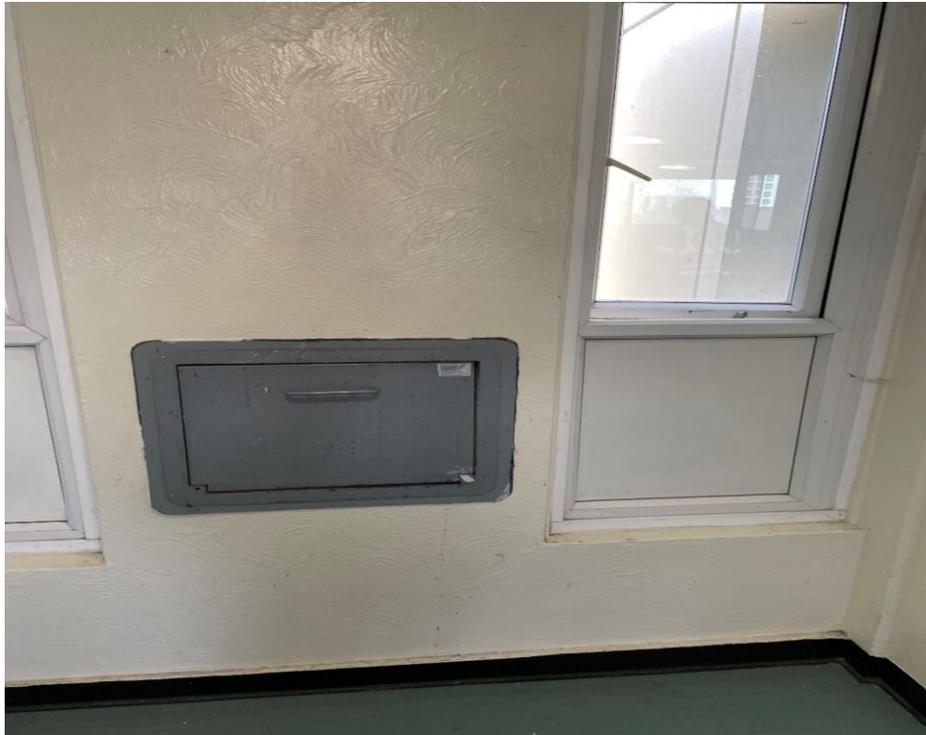
Material	Combustibility	Volume	Comments	Recommendations
Thermo plastic infill between two layers of steel.	Typically Euroclass E - F to BS EN 13501-1	Front and rear elevations	Combustible thermo plastic sandwiched within two layers of steel between windows. Presumed to be typical on each floor.	All window infill panels are to be replaced for non-combustible alternatives on the common area sections.

connected to the common area serving the protected stair and AOV windows. The infill panels stack one above the other there is potential that fire could “jump” from one to the other. In order to remove this risk, these infill panels should be removed and replaced with a non-combustible alternative. Figure 32 shows a typical infill panel.

**Figure 35.** Typical infill panel (taken from 58-108A Regina Rd images)
