EWS1 Report

463- 549D Lodge

Lane Croydon

30th April 2021

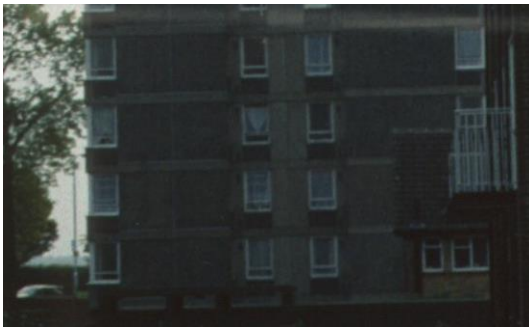
The photo taken before the building was clad helps to identify the line of the compartment floor as shown by the lighter strips on the image of the flats taken before the building was overclad. There is an expectation that where over cladding is carried out cavity barriers are put in place to inhibit fire spread over the façade of the building. These should be fitted in line with the compartment floors and walls inside which are in place to facilitate the stay put strategy. Figure 12 shows the gap between the insulation and the outer panels which should have been infilled. Clearly this is not the result of any form damage or collapse, simply that the barriers were not fitted at the time when the cladding was fitted.

Figure 11. Location 1.1 - Compartment floor lines can be seen, showing as pale lines running laterally above the windows.

recommendation for cavity barrier replacement works to be undertaken. BB7 recommend that cavity barriers are provided at all compartment wall and floor lines where they are found to be missing, and defective barriers should be replaced where found.

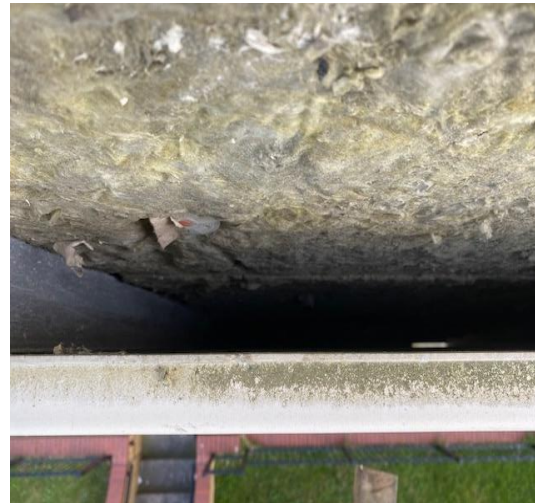
Figure 12. Location 1.1 - Showing the gap between the panelling and insulation, where the cavity barrier should be.

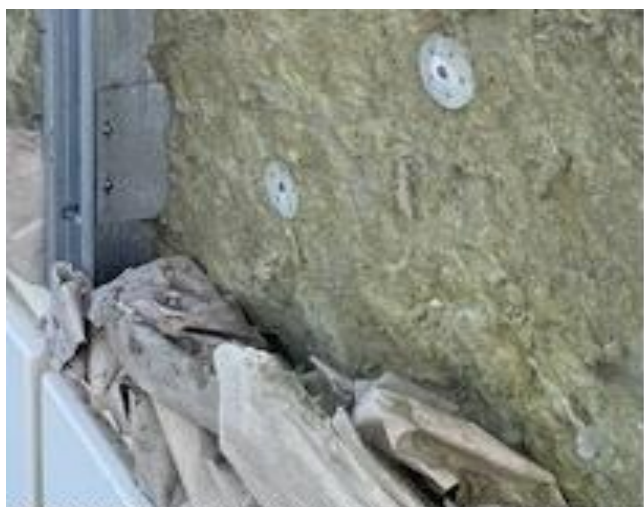
The building paper has come away from the face of the mineral wool sheets to which it was originally attached and has subsequently gathered on the horizontal rails of the framing system. It should be noted that the paper is resting on the edge of the panel and not a cavity barrier which was also missing from this location.

Figure 13. Location 1.2 – Membrane fallen away from the insulation

Each mineral wool sheet has been lined with a wax paper, designed to assist in the control of moisture, over time much of this lining has become detached and collected on the horizontal rails. In terms of fire spread this is of little significance as the fire loading is minimal as well as the material being positioned between two non-combustible components.

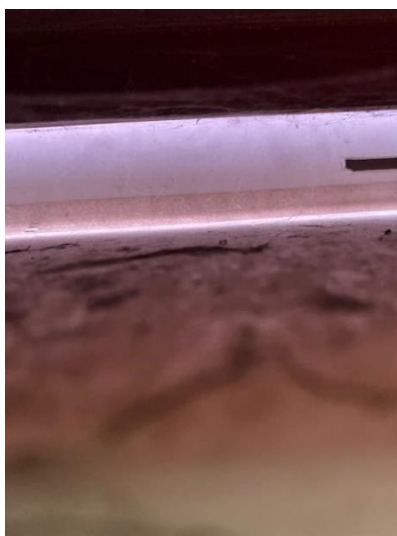
Location 1.2 Showing the second floor window surround. It was not possible to identify if there were cavity barriers in place as it was not possible for the operatives to remove the surrounding panels without fear of damaging the rail system. From the restricted view it appeared that cavity barriers were not provided, and this would be in line with the other buildings surveyed. The 1992 version of Approved Document B did not require barriers around openings, so it is likely that no barriers have been provided.

Figure 14. Location 1.3 - looking up showing that there is no cavity barrier surrounding the window

Building Regulations at the time of the over cladding work did not require cavity barrier around and the regs are not retrospectively enforceable. From an EWS1 perspective the lack of barriers around the windows would be acceptable providing compression barriers at compartment floor lines were in place at compartment floor levels. These were found to be missing in more than one location, an issue that will these will need to be resolved in order for

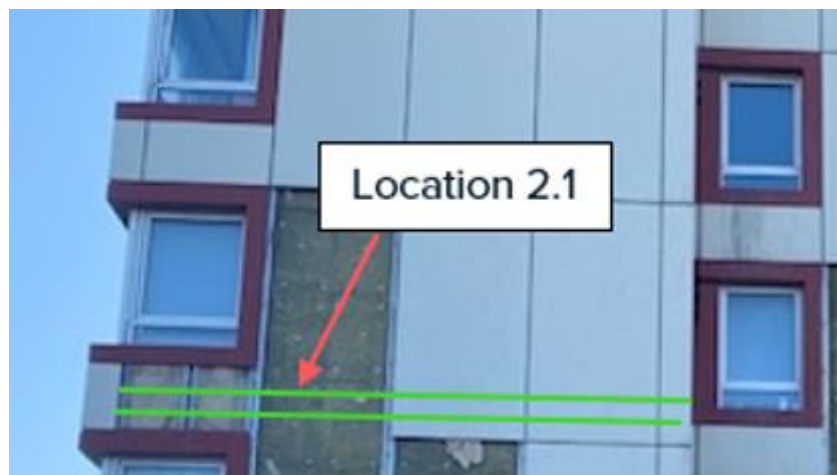
Location 2.1 was on the second floor and two panels between windows were removed. building. There is an expectation that where over cladding is carried out cavity barriers are put in place to inhibit fire spread over the façade of the building. These should be fitted in line with the compartment floors and walls inside which are in place to facilitate the stay put strategy, in addition to satisfy the functional requirement of the Building Regulations which states that the building shall be designed and constructed so that the unseen spread of fire and smoke within concealed spaces in its structure and fabric is inhibited.

Figure 16. Location 2.1 Missing cavity barrier.

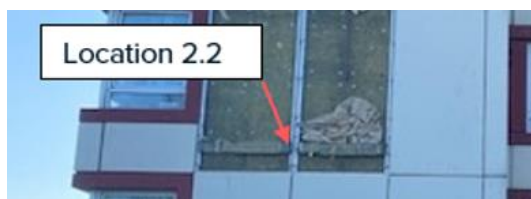
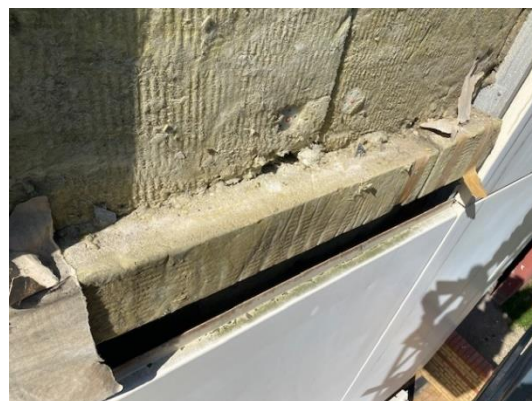
Figure 17. Location 2.2

Shows the cavity barrier in line with the compartment floor, although the insulating material is broken by a vertical rail used affix the aluminium panels the method by which the panels are hung creates closure ensuring a continuous horizontal barrier. The horizontal barrier appears to be an off cut of insulation rather than an intended cavity barrier product. The barrier is not under compression to the rear of the panel, as such it will not inhibit fire and smoke spread.

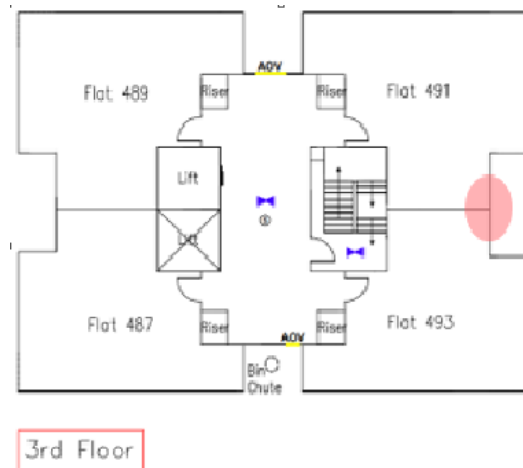
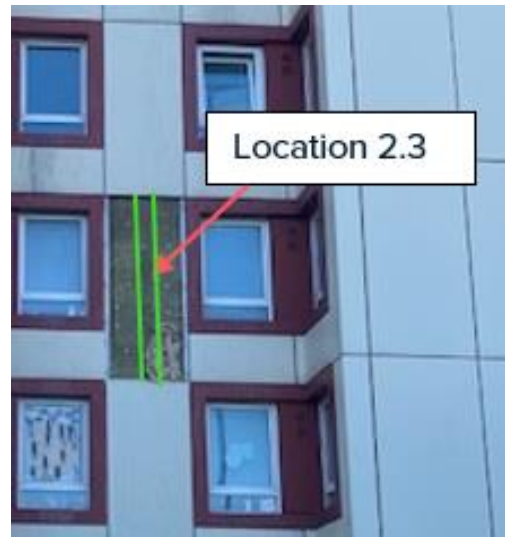
A single panel was removed in line with the partition between two flats. In addition to the lateral barriers that should be in place with the compartment floors, vertical barriers are required to align with the flat boundary walls. Each flat consists of a 60 minute 'box' the boundaries of which are required to be followed, by the cavity barriers incorporated in the over cladding. figures 19 indicates where a vertical barrier should be. Figure 20 clearly shows no barrier in place, the impact of this is an increase chance of lateral fire spread on via the external façade.

Figure 19. Location 2.3 Identified as the wall between flats 491 and 493

Figure 20. Location 2.3 the equivalent area is shown on the outside of the building. No vertical cavity barrier is in place.

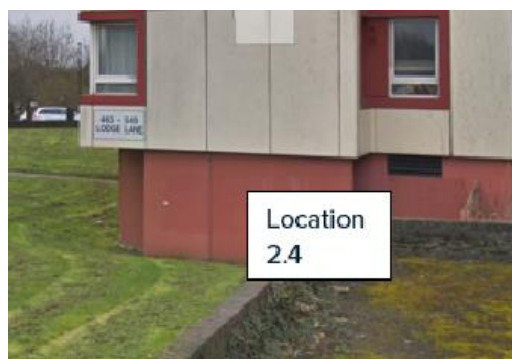
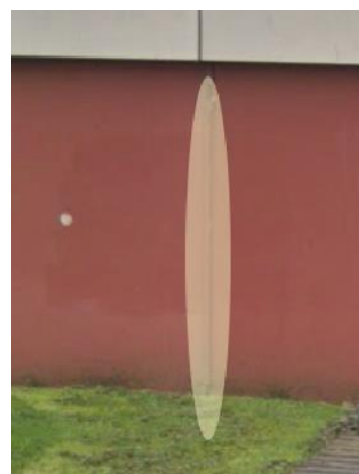
The external face has not been overclad with insulating material, the paint, which was colour matched to parts of the cladding has been directly applied to the original concrete surface. Figures 23 and 24 show the other faces of the building without the addition of insulating panels.

Figure 21. Location 2.4 refers to the ground floor external walls

Figure 22. Location 2.4. Close up showing the lightning protection strip

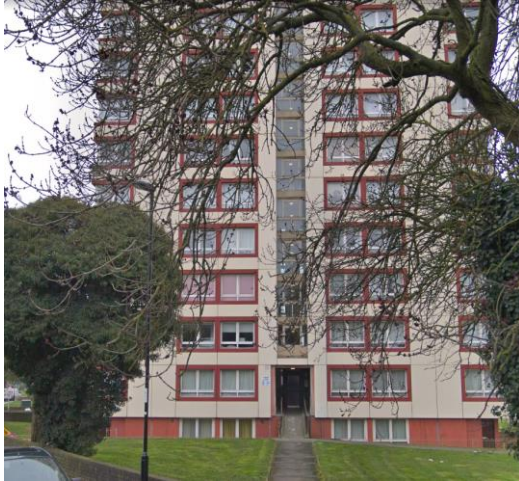
The external face of the stair enclosure on the south face is formed by glazed panels. The internal faces of the of the chute recess are clad in the same material as the rest of the building. The glazing forms a major part of the face, there are no infill panels.

Figure 23. The external face of the stair enclosure on the south face.

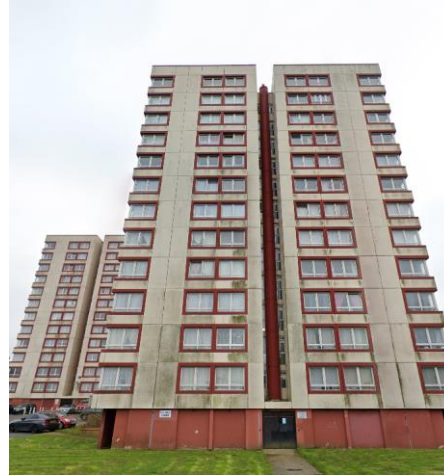
Figure 24. The internal faces of the of the chute recess. Major part of the face, there are no infill panels.

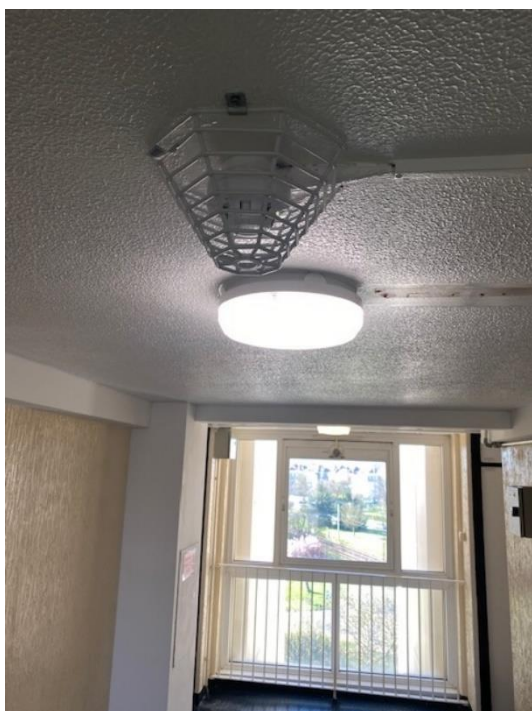
The flats open into a lobby with ventilation via an AOV. It is presumed that the AOV works on detection which was identified in the lobby. There were also service risers located in the lobby with 'Masterboard with Intumescent sealant' fire stopping provided to service penetrations, however, there were some issues identified, including poor fire stopping around cable penetrations. The sprinkler stop valve is housed in as secure cupboard located in the lobby and the sprinkler the tank is located in the roof plant room, fire stopping to the pipework where it passes through compartment floor is suitable.

Figure 25. AFD in place to operate the AOV in the lobby

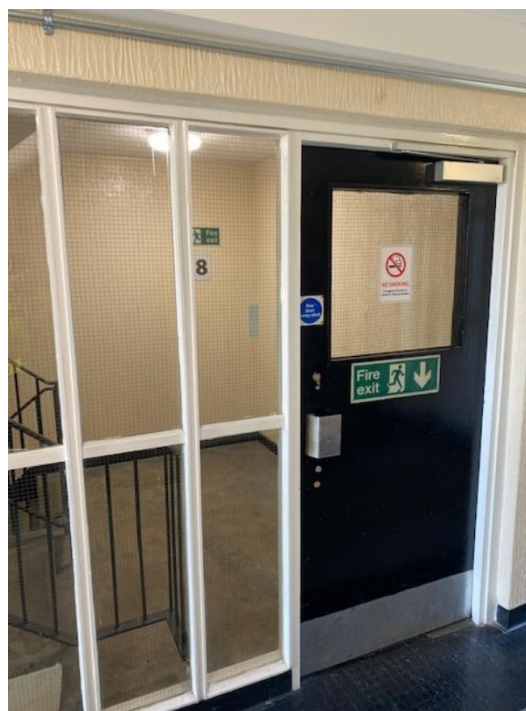
The single stair core separated from common area by Georgian wire glass partition, and part glazed fire door, although the doors appear original, they have been upgraded at some point by the addition of intumescent strips and seals. There is no ventilation at the head of the stair. This is unlikely to have been the case when the building was constructed, a hatch is now in place in what may have been a permanent vent (PV). The original design code in force at the time of construction was CP3, this would have recommended a PV at the head of the stairs. **It is recommended that the PV is reinstated at the head of the stair.**

Figure 26. Partition between the flat lobby and stair

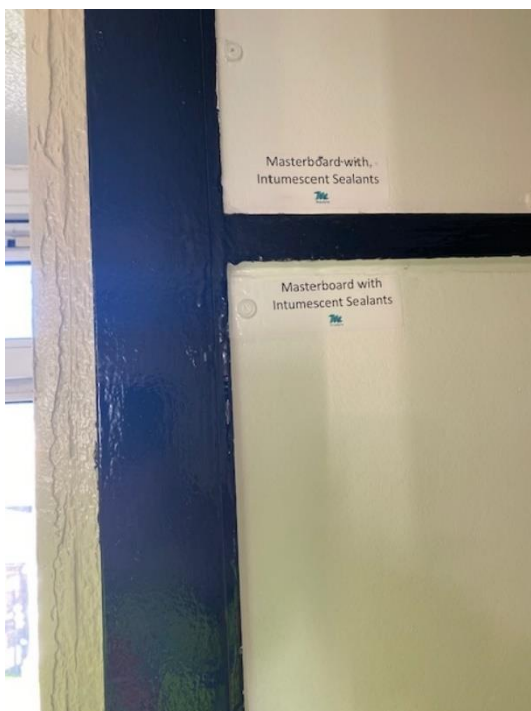
There were service risers in the protected stair. The majority were provided with 'Masterboard with Intumescent sealant' fire stopping and, although the stair should be kept sterile and remain free of fire load, the riser is not considered to prevent a significant risk.

Figure 27. View of Masterboard

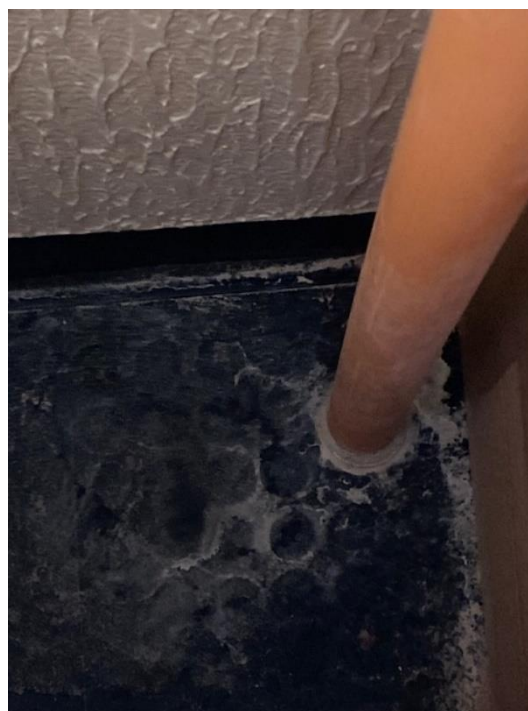
Figure 28. Location 2.4. Close up showing where the sprinkler pipe passes through the compartment floor.

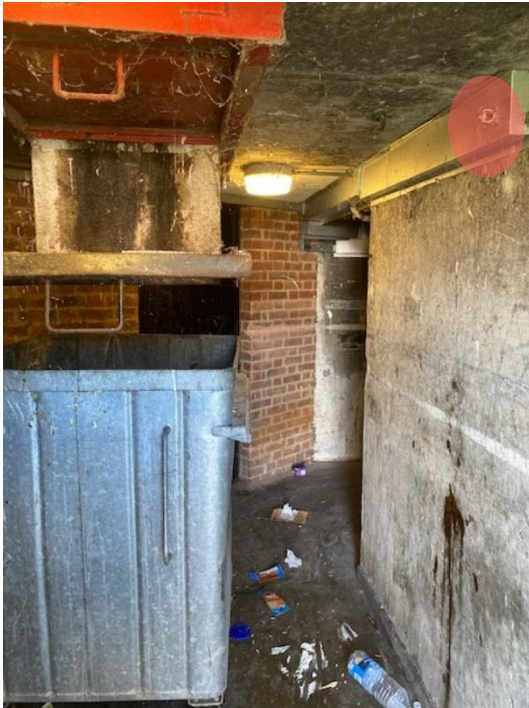
In the refuse store at ground level a standalone single sprinkler head is fixed to the wall near the wheelie bin, it is activated when the quartzoid is burst by heat; the bulb is coloured red indicating actuation at 68°C. A spring loaded shutter held open by a fusible link is positioned at the base of the chute, the bin store on the ground floor directly accessed from the outside at ground floor level. The sloping site has facilitated a lower ground floor which is accessed directly from the stair. It is likely that this was the original final part of the escape route, now however signage directs occupants back through the ground floor lobby which goes against the principle that once the stair is entered occupants should not have to re-enter the comparatively higher risk of the flat lobby area. It is recommended that the exit signage is changed to indicate the route from the base of the stairs passes through the lower ground floor and not the ground floor lobby. This change will require that the door that currently used to prevent access to that route is opened for escape purposes.

Figure 29. Showing sprinkler head (highlighted) and the spring loaded fire shutter over the wheelie bin

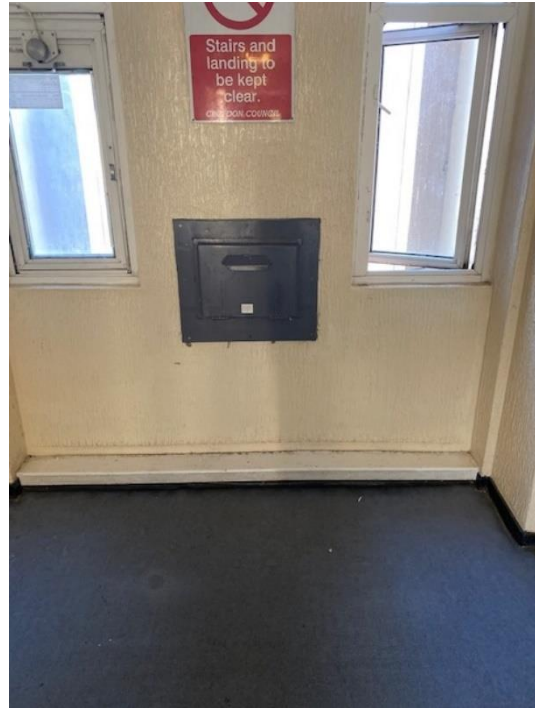
The rubbish chute hoppers are located in the flat lobbies, there is no separate lobby access, however, the provision of AOVs in the flat lobby is deemed as suitable compensation for the lack of protection at each level.

Figure 30. Typical bin chute hopper. An AOV can be seen to the top left.

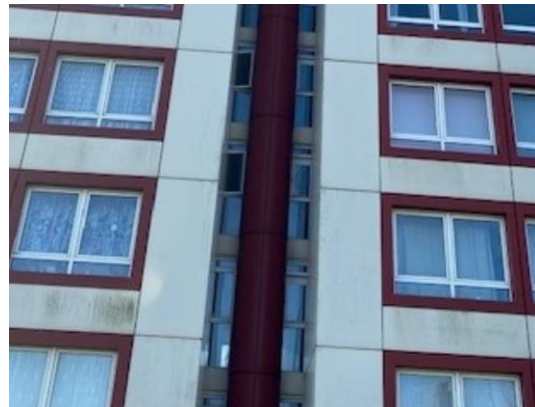
Figure 32. The internal faces of the of the chute recess are clad in the same material as the rest of the building.

The internal faces of the bin chute recess are clad in the same material as the rest of the building, spandrel panels are glazed. This combination offers very low risk of fire spread of its surface.

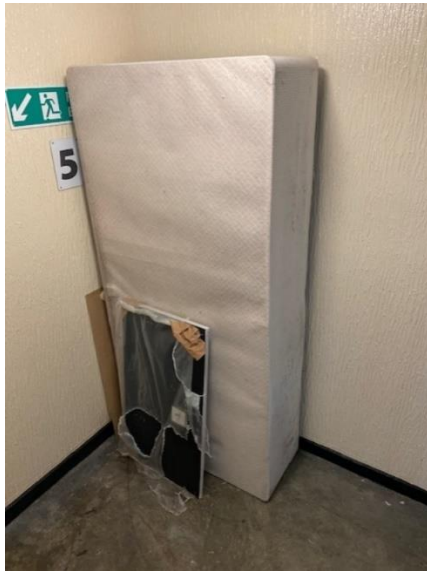
Despite the plethora of signage storage combustible storage is being stored in the stairs and lobbies.

Figure 33. In the 5th floor stair

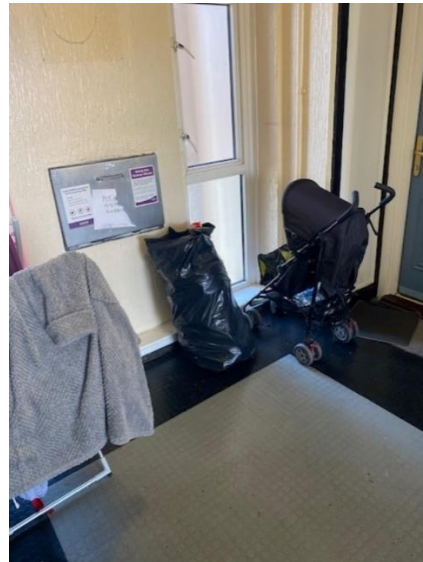
Figure 34. In the 5th floor lobby.
