EWS1 report

Bridge Place

30th April 2021

Croydon Borough Council

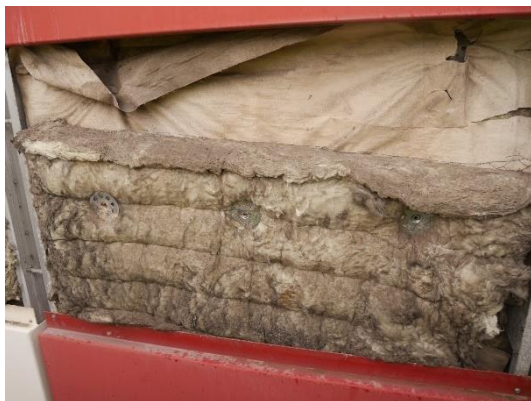
Figure 10. Location 1.1 horizontal cavity barrier at floor level, barrier has not been folded over and is not in compression against the cladding.

The barriers were mineral wool type product reinforced with wire, which were common at the time of installation. This cavity barrier has to be folded over in order to ensure that the barrier fills the full depth of the cavity to reach the rear of the cassette panel, however, the barriers were found in some cases to be poorly fitted with gaps appearing next to the façade carrier system, it was not under compression so it may allow fire to bypass the compartment line here, which is not permissible.

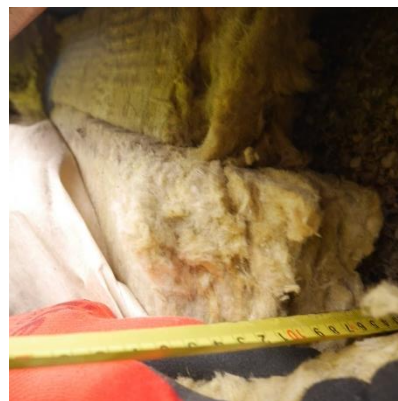
Figure 11. Location 1.1 100mm mineral wool insulation.

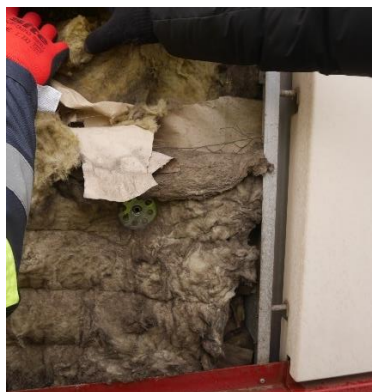
Figure 12. Location 1.1 Gaps identified at side of cavity barrier against cladding support rail, a further gap exists within the insulation behind the rail.

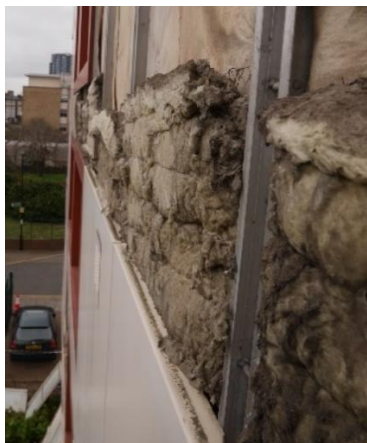
Figure 13. Location 1.2 line of horizontal cavity barrier at floor level, barriers are not folded over and only in partial compression.

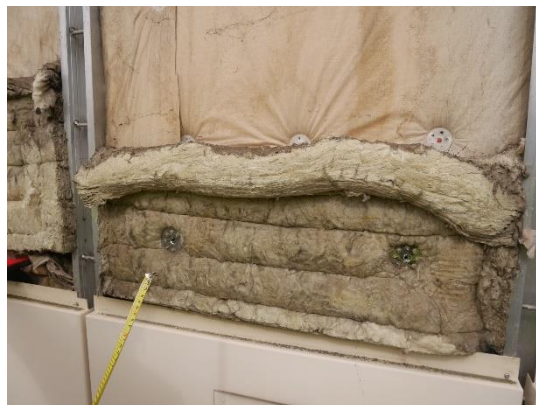
Figure 14. Location 1.2 line of horizontal cavity barrier at floor level, barrier is not folded over and only in partial compression at the head.

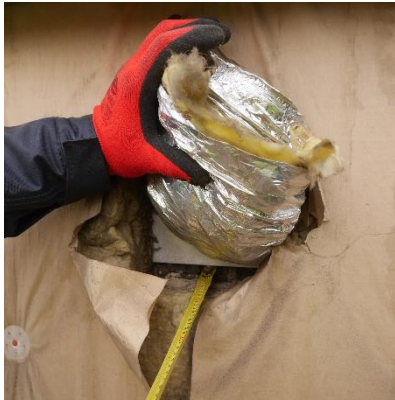
Figure 15. Location 1.3 ventilation duct and back plate surround. Building paper facing is visible over mineral fibre insulation.

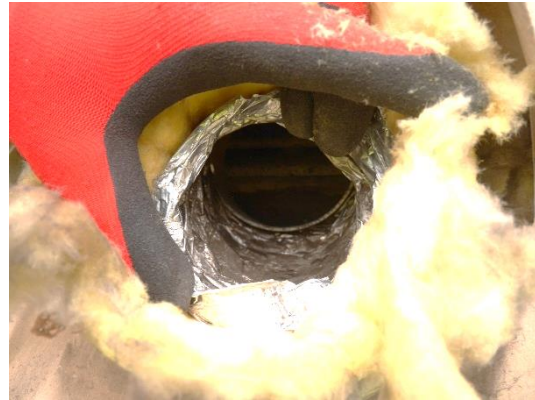
Figure 16. Location 1.3 Ventilation duct passes straight through walling to louvre behind.

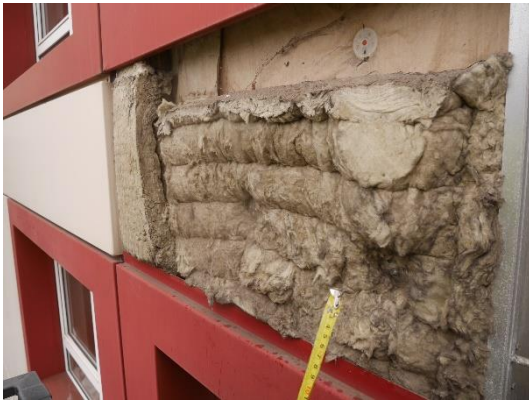
Figure 17. Location 1.4 Horizontal cavity barrier at floor level, a vertical compartment barrier is located on the left hand side of the panel opening.

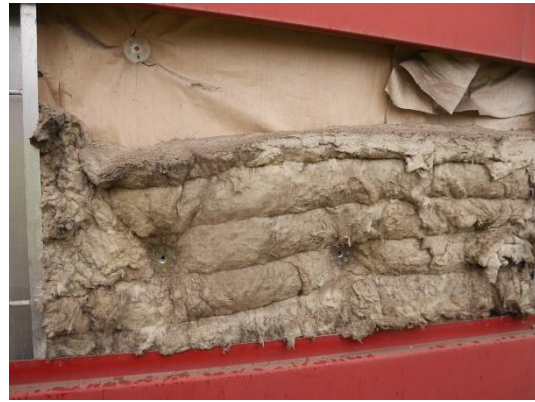
Figure 18. Location 1.4 Horizontal cavity barrier at floor level under window. The vertical aluminium rails offer a pathway through the cavity barriers in the 'u' of the rails. This is however minimal in sectional area.

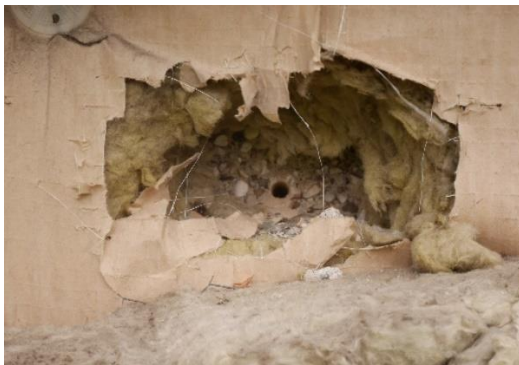
Figure 19. Location 1.4 View showing the original concrete cladding panel with a drilled hole to verify the concrete depth of 100mm without a cavity. Arisings from drilling appeared to be masonry dust only. It would be expected that a layer of EPS insulation has been incorporated within the external wall material although this could not be verified by drilling.

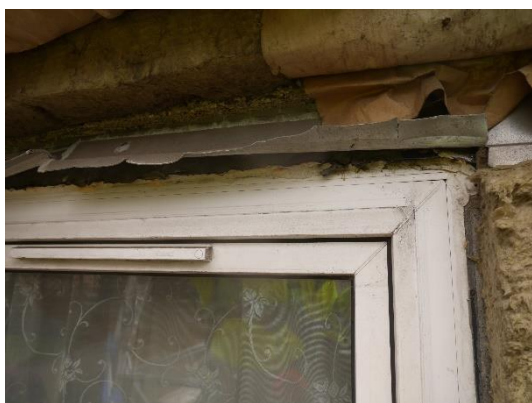
Figure 20. Location 1.5 The original head flashing has been peeled back to allow window replacement.

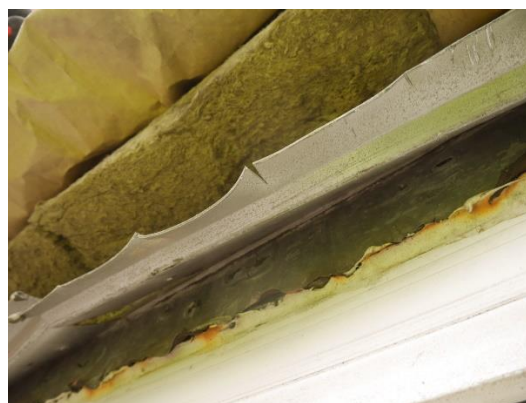
Figure 21. Location 1.5 The mastic seal at the window head appears intact behind the flashing, but is unlikely to be fire resistant.

Around windows it was noted that a mastic that isn't fire rated has been used to seal the windows in. Cavity barriers were not a requirement around windows on blocks of flats until the year 2000, therefore assuming the re-clad occurred in the late 1990's the lack of barriers would have been Building Regulations compliant.

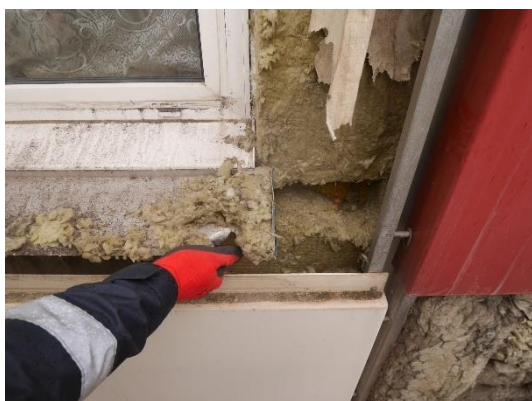
Figure 22. Location 1.5 Windows are UPVC units with additional metal weather flashings, these have 'v' cuts for drainage which appear to drain into the cladding cavity. There is evidence of water damage to the insulation. There was also a vermin hole at this location.

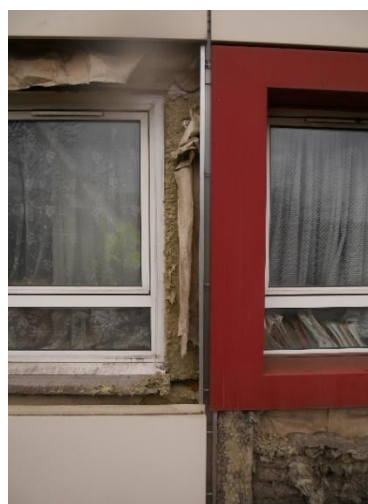
Figure 23. Location 1.5 A vertical compartment barrier is shown at the right-hand side of the party wall location. There is evidence of water damage to the insulation on the left-hand side. Cavity barriers around windows have not been installed but were not required by building regulations at the time of the over cladding works.

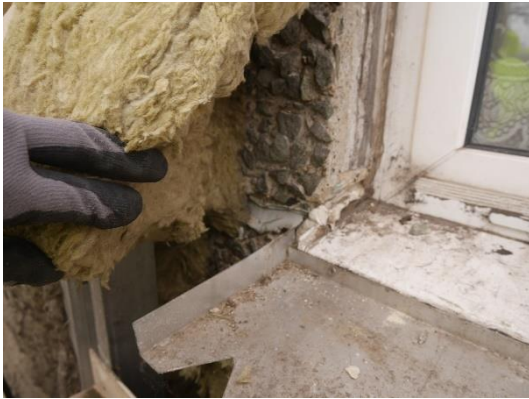
Figure 24. Location 1.6 Window jamb, shows original concrete panels with panel joint seal intact, mastic seal around window is from the time of replacement and not thought to be a fire seal.

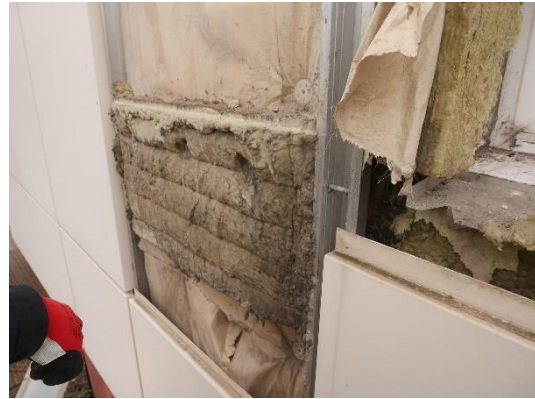
Figure 25. Location 1.6 cavity barrier at side of window (horizontal barrier), this is located at a higher level above the slab level but against concrete panels. It is not folded over and provides only minimal compression against the cladding at the head.

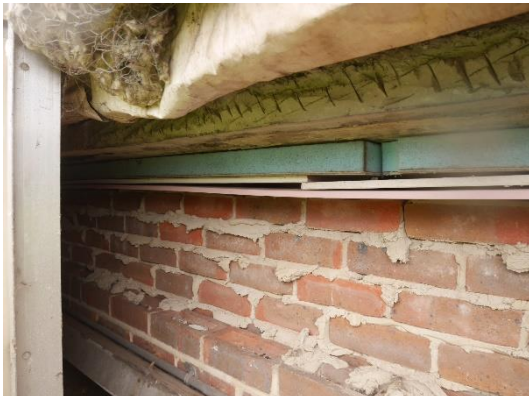
Figure 26. Location 1.7 The first-floor slab is apparent at the top of the image, brickwork infill to the ground floor has been added at a later refurbishment. Vermin droppings are evident on top of the brickwork and top of the metal soffit panel.

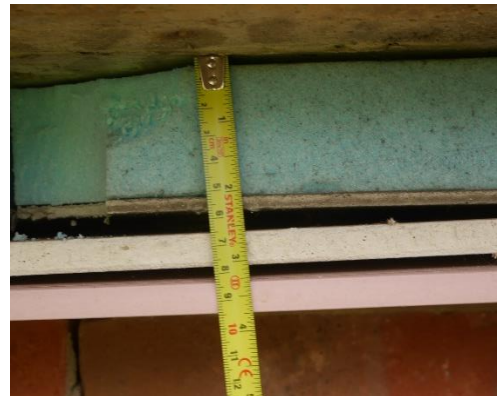
Figure 27. Location 1.7 The first-floor slab has been underdrawn with a cement particle board backed with foam insulation, further underclad with two layers of what appear to be pink plasterboard.

The underside of the first-floor slab has been underclad with a cement particle board which has a combustible foam insulation backing. The cement board is further over boarded with 2 layers of 12.5mm pink fire plasterboard for further protection, although these are poorly installed with gaps between joints and are not taped and jointed to achieve their full fire rating.

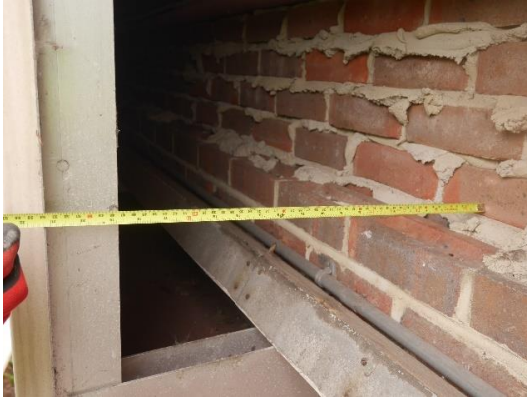
Figure 28. Location 1.7 The soffit provides what appears to be an undivided gap around the building of 470 - 500mm wide x 750mm high.

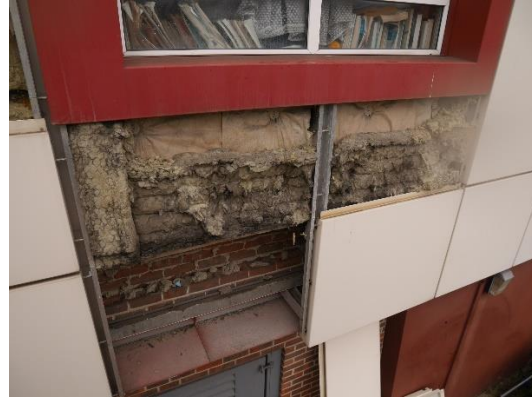
Figure 29. Location 1.7 Cavity barriers at this location are positioned above floor slab level against the cladding. They do not form compression against the cladding panels. The soffit is a 2mm metal panel.

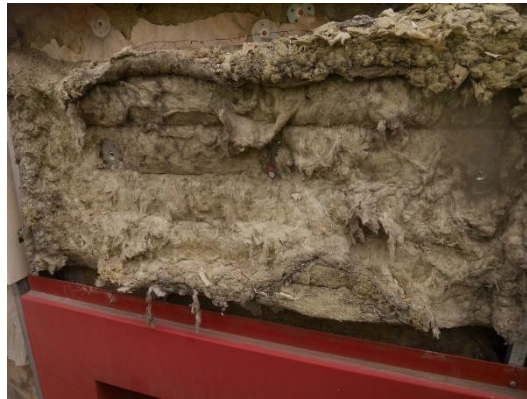
The barriers were mineral wool type product reinforced with wire, which were common at the time of installation. This cavity barrier has to be folded over in order to ensure that the barrier fills the full depth of the cavity to reach the rear of the cassette panel, however, the barriers were found in some cases to be poorly fitted with gaps appearing next to the façade carrier system, it was not under compression so it may allow fire to bypass the compartment line here, which is not permissible.

Figure 31. Location 2.1 Horizontal cavity barrier at second floor level which does not provide compression against the cladding panel face. Evidence of vermin route across the top of the barrier.

- Damaged insulation and cavity barriers within the external walling system caused by vermin ingress should be remediated and further steps taken to prevent vermin movement within the external walling cavity.

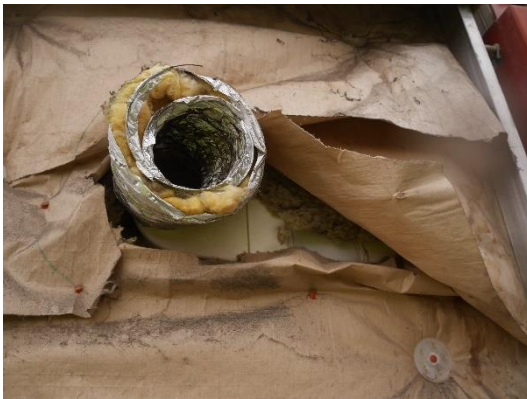
Figure 32. Location 2.2 Kitchen extract tracks horizontally within the insulation depth using a plastic extract duct. The point of entry into the RC structure could not be found and was therefore not surveyed.

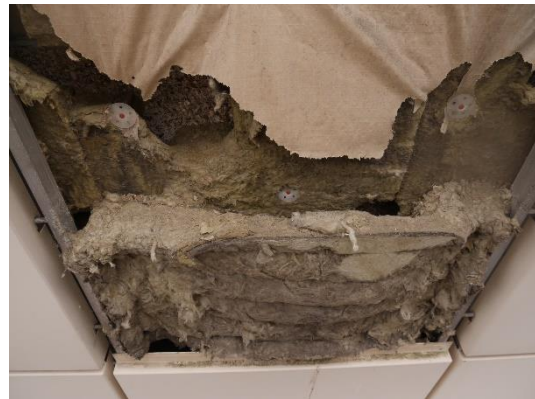
Figure 33. Location 2.2 Cavity barrier shown at first floor level below the kitchen extract. The barrier and insulation above is damaged due to vermin infestation.

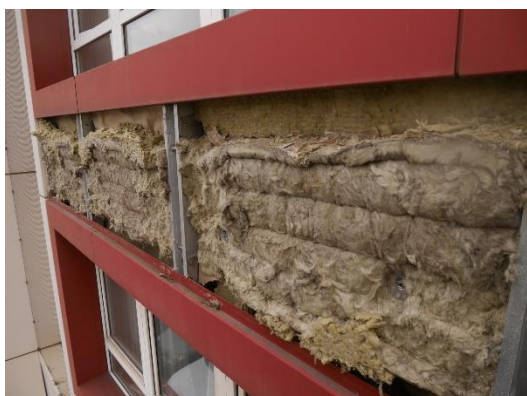
Figure 34. Location 2.3 Horizontal cavity barrier at first floor level, there is little or no compression against the cladding panels.

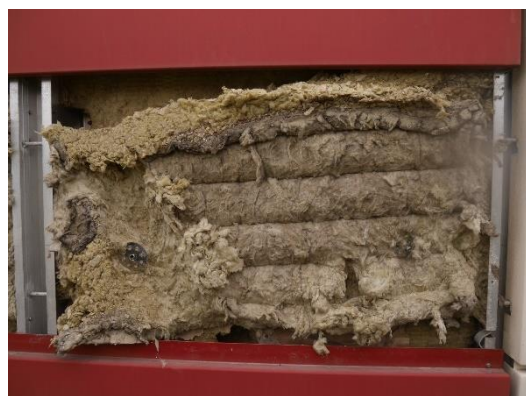
Figure 35. Location 2.3 Section of barrier shows vermin routes both horizontally and vertically against the cladding panel.
