# **EWS1 Report**

**551- 637 Lodge Lane**

**Croydon**

**30<sup>th</sup> April 2021**

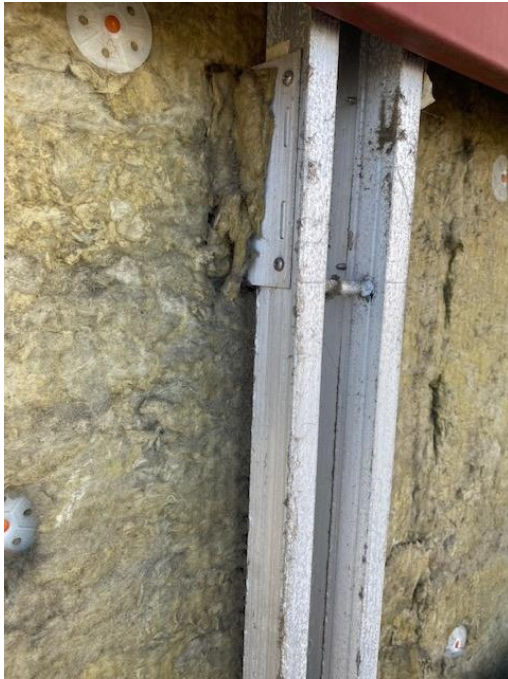
Within all three locations an aluminium bracket passes through the cavity barrier. The bracket is 100mm thick and the aluminium cladding panels fix onto it. The bracket is fixed to the underlying substrate. There is little concern that the brackets break the cavity barriers because the recessed opening in the brackets, where the cladding fixes into, is open to external air. There are also some brackets that are hidden behind panels that provide a central fixing for wider cladding panels. These are typically located below and above windows. The fixing bracket is hidden completely, so is not open to the atmosphere. This means that the cavity barrier is broken where the fixing bracket passes through it.

**Figure 12.** Location 1.1 - Location 1.1 - 100mm break in cavity barrier for an aluminium bracket

cavity barriers are provided at all compartment wall and floor lines where they are found to be missing, and defective barriers should be replaced where found.

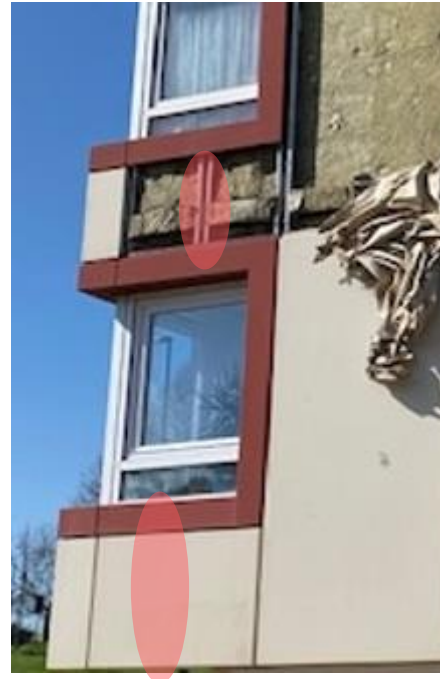
**Figure 13.** Location 1.1 – the highlighted areas show where the panel is fixed over the rail.

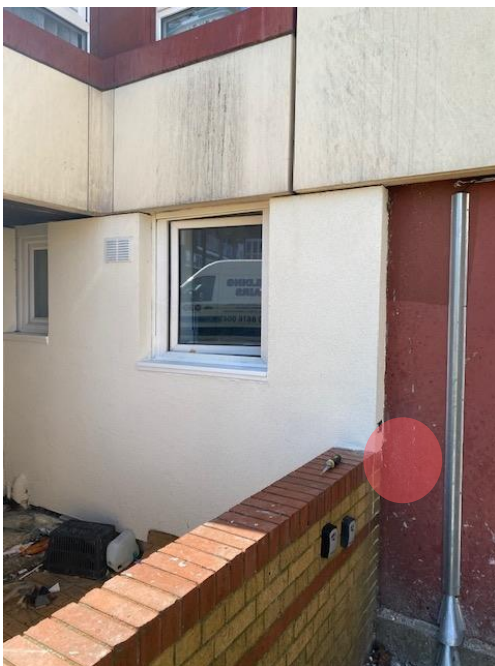
Recent works to create new dwellings at lower ground floor, these have been provided with insulation consisting of rendered polystyrene panels mounted to masonry. The extent of the new panelling does not extend beyond the new works. The remainder of the ground floor external walls were found to be the original concrete finish. EPS is a Euroclass E combustible PIR insulant.

**Figure 14.** Location 1.2 – extent of render

The system contains a 100mm thick layer of combustible expanded polystyrene insulation under the render. A **BRE** report number: P111324-1019 (M9D12V1) commissioned for the Ministry of Housing Communities and Local Government in December 2019 cites a number of fires around the world in which cladding systems using expanded polystyrene were a significant factor. Due to the combustible nature of the product, it is recommended that the polyurethane foam insulation at ground-floor level is replaced with insulation that is non-combustible.

- Cavity barriers are to be fitted in line with compartment floors and walls.
- Due to the combustible nature of the product, it is recommended that the expanded polystyrene foam insulation at ground-floor level is replaced with insulation that is non-combustible.
- Reinststate the exit route leading from the base of the stairs through the lower ground floor corridor to open air.

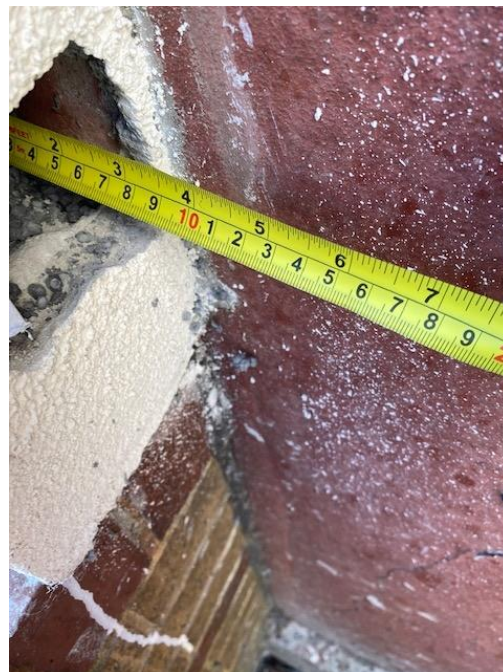
**Figure 15.** Location 1.1 – view of system

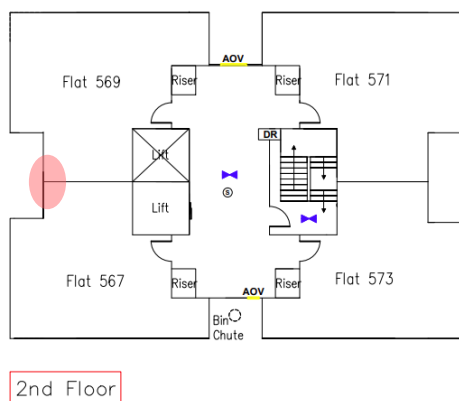
A single panel was removed in line with the partition between two flats. In addition to the lateral barriers that should be in place with the compartment floors, vertical barriers are required to align with the flat boundary walls. Each flat consists of a 60 minute 'box' the boundaries of which are required to be followed by the cavity barriers incorporated in the over cladding. Figures 16 indicates where a vertical barrier should be. Figure 17 clearly shows no barrier in place, the impact of this is an increase chance of lateral fire spread on via the external façade

**Figure 16.** Location 1.3 – the highlighted areas indicate the areas where vertically aligned barrier should be in place.

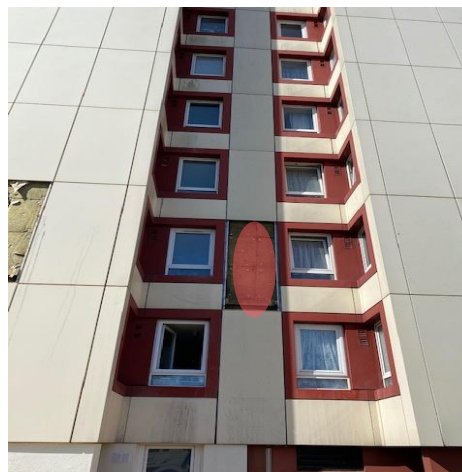
**Figure 17.** Location 1.3 – no vertical barrier in place

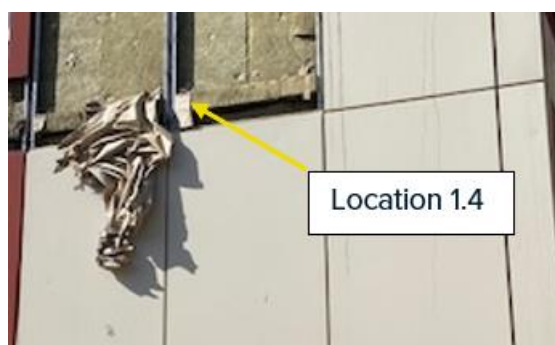
This location shows the cavity barrier in line with the compartment floor, although the insulating material is broken by a vertical rail used affix the aluminium panels the method by which the panels are hung creates closure ensuring a continuous horizontal barrier. The horizontal barrier appears to be an off cut of insulation rather than an intended cavity barrier product. The barrier is not under compression to the rear of the panel, as such it will not inhibit fire and smoke spread.

**Figure 18.** Location 1.4 – Cavity barriers are in place but are not under compression

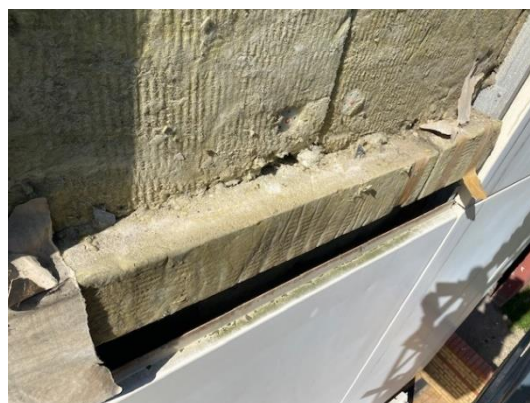
**Figure 19.** Location 1.4 – Close up of what appears to be a cut off section of material rather than an intended barrier product.

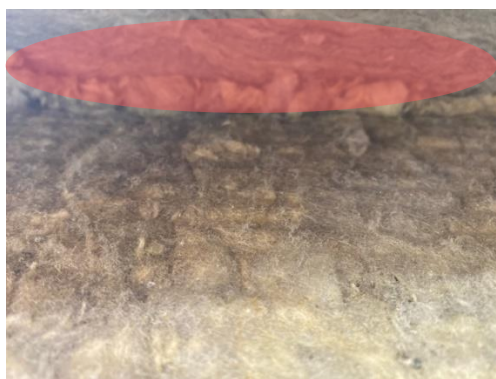
Location 2.1 was on the third floor there is an expectation that where over cladding is carried out cavity barriers are put in place to inhibit fire spread over the façade of the building. These should be fitted in line with the compartment floors and walls inside which are in place to facilitate the stay put strategy, in addition to satisfy the functional requirement of the Building Regulations which states that the building, shall be designed and constructed so that the unseen spread of fire and smoke within concealed spaces in its structure and fabric is inhibited. Barriers were in place.

**Figure 21.** Location 2.1 the barrier between the third and fourth floor in highlighted.

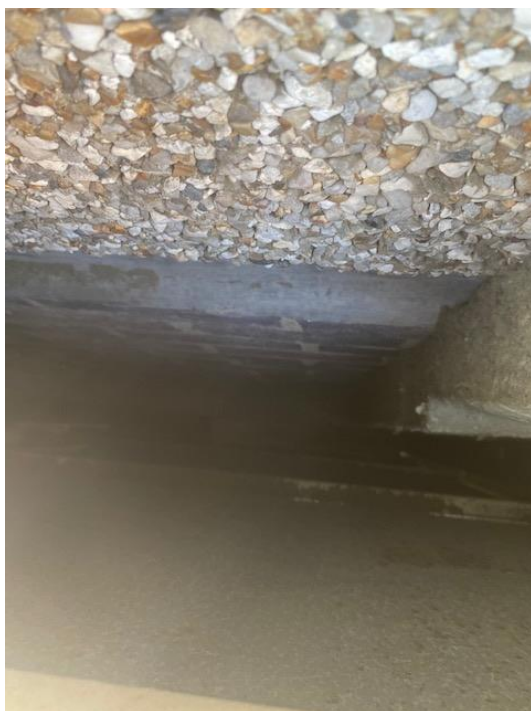
**Figure 22.** Location 2.2

Looking down from the third to the second floor which in this case not only shows missing cavity barriers but also shows that no insulation was originally fitted. Figure 21 shows the upper extent of the missing insulation, it can be seen that some of the insulation fitted is made up patches which may indicate the stocks of the material were low and previous offcuts were used. Facing brickwork could be seen below this location as per Figure 22.

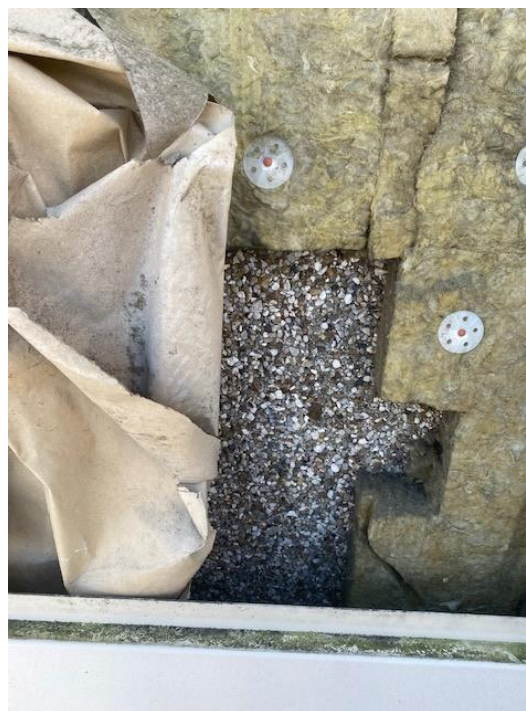
**Figure 23.** Location 2.2 showing the upper extent of the missing insulation

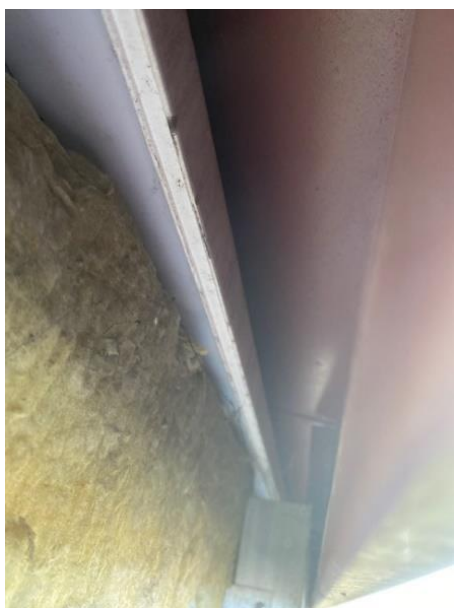
Missing cavity barriers around the windows looking up at the areas beneath a fourth floor window. The operatives not able to remove the window surrounds for fear of causing damage to the aluminium panelling. Window barriers were not required at the time of the re-clad (assuming late 90's) and as such would have been permissible at the time.

**Figure 24.** Location 2.3 looking up at the areas beneath a fourth floor window.

Building Regulations at the time of the over cladding work did not require cavity barrier around and the regs are not retrospectively enforceable. From an EWS1 perspective the lack of barriers around the windows would be acceptable providing compression barriers at compartment floor lines were in place at compartment floor levels. These were found to be missing in more than one location, an issue that will these will need to be resolved in order for

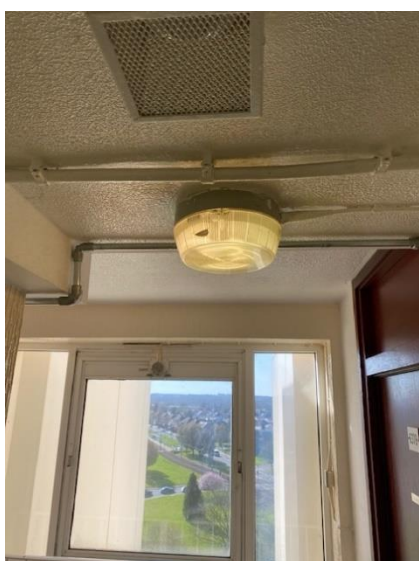
**Figure 27.** AFD (in wire cage) which operates the AOV in the lobby

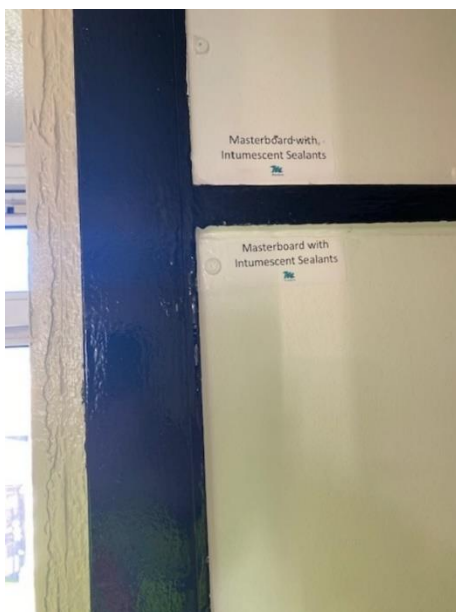
There were service risers in the protected stair. The majority were provided with 'Masterboard with Intumescent sealant' fire stopping and, although the stair should be kept sterile and remain free of fire load, the riser is not considered to prevent a significant risk.

**Figure 29.** View of Masterboard

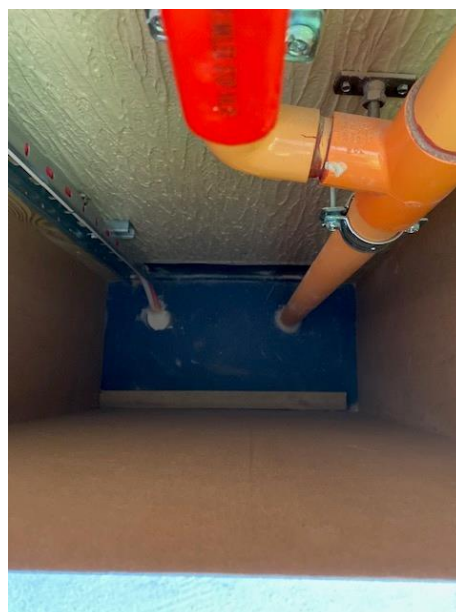
**Figure 30.** showing where the sprinkler pipe passes through the compartment floor.

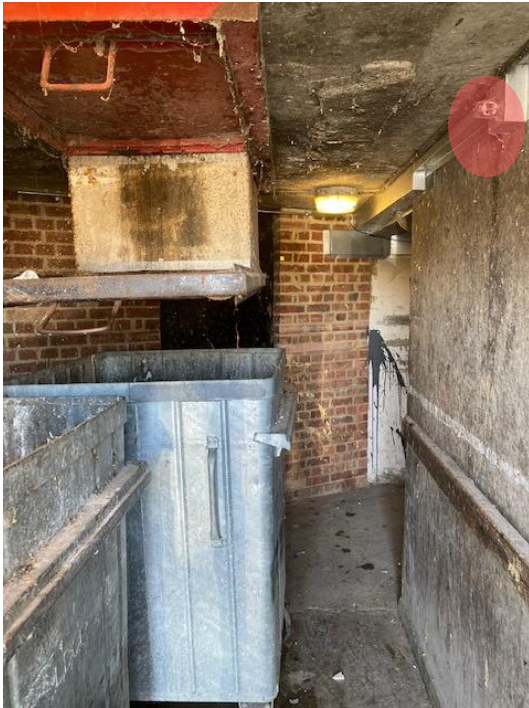
In the refuse store at ground level a standalone single sprinkler head is fixed to the wall near the wheelie bin, it is activated when the quartzoid is burst by heat; the bulb is coloured red indicating actuation at 68°C. A spring loaded shutter held open by a fusible link is positioned at the base of the chute, the bin store on the ground floor directly accessed from the outside at ground floor level. The sloping site has facilitated a lower ground floor which is accessed directly from the stair. It is likely that this was the original final part of the escape route, now however signage directs occupants back through the ground floor lobby which goes against the principle that once the stair is entered occupants should not have to re-enter the comparatively higher risk of the flat lobby area. It is recommended that the exit signage is changed to indicate the route from the base of the stairs passes through the lower ground floor and not the ground floor lobby. This change will require that the door that currently used to prevent access to that route is opened for escape purposes.

**Figure 31.** Showing sprinkler head (highlighted) and the spring loaded fire shutter over the wheelie bin

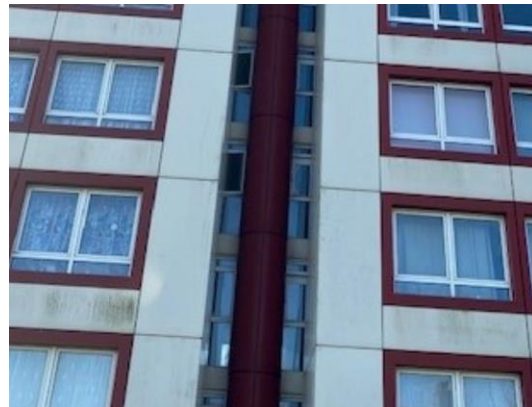
**Figure 34.** The internal faces of the of the chute recess are clad in the same material as the rest of the building.

The internal faces of the bin chute recess are clad in the same material as the rest of the building, spandrel panels are glazed. This combination offers very low risk of fire spread of its surface.

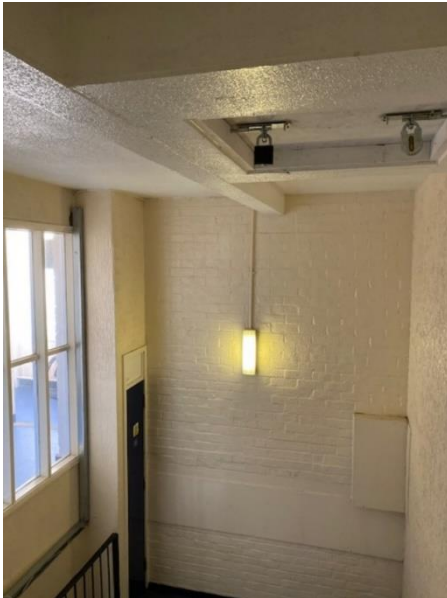
**Figure 35.** Showing where the permanent ent should be.

what may have been a permanent vent (PV). The original design code in force at the time of construction was CP3, this would have recommended a PV at the head of the stairs. **It is recommended that the PV is reinstated at the head of the stair.**

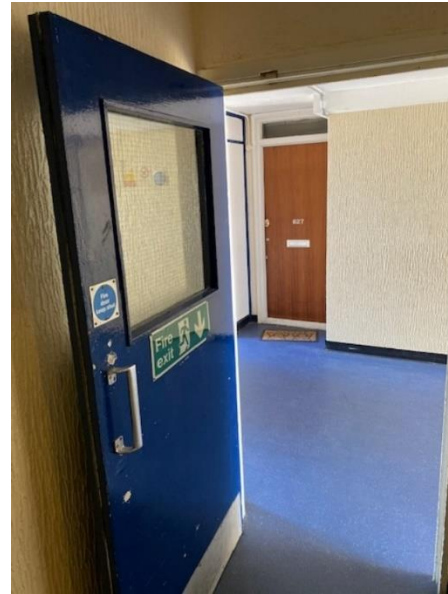
**Figure 36.** Lobby door on the ninth floor with a missing self closer.
