# **EWS1 Report**

**58-108A Regina  
Road, Croydon**

**27 April 2021**

**Croydon Borough Council**

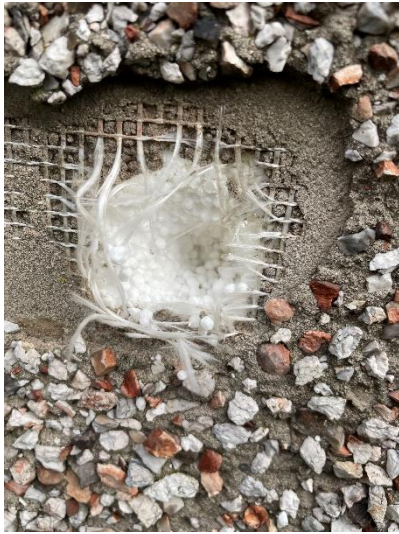
This location was surveyed due to the presence of the render system. The EPS exists at all points on the ground floor level and is continuous in nature. The system returns into the bin store and also the buildings entrance. No cavity exists as part of this system.

**Figure 12.** View of cladding and render system

EPS Insulation was found to the ground floor of block 58-108A Regina Road. This insulation was placed on top of the existing RC structure, with a render finish. Small areas of this render have been damaged exposing the insulation behind where it has become slightly damaged.

EPS has a Euroclass E rating meaning that it is highly flammable. Unfortunately, no branding could be observed, and many EPS insulations are white in colour. Due to the high combustibility of these products and their behavior in fire which supports fire spread BB7 do not consider that any testing is required to determine the material properties.

The outer portion of the system where EPS cladding is mounted onto the outer skin of RC structure is not considered to be significantly high risk but it will likely exhibit fire spread to a degree. On that basis to ensure the life safety of occupants the EPS render system should be removed and replaced with a non-combustible alternative.

We have identified high-risk materials at low level in the block with EPS insulation noted at low level, which is defined as high risk within the government guidance. This material should be removed and replaced with a non-combustible alternative.

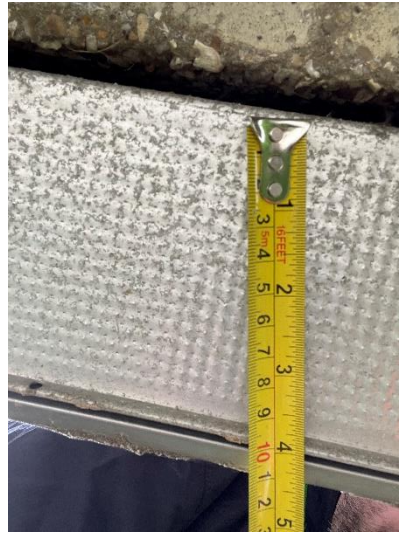
**Figure 13.** measurement of cladding where lintel was provided at base

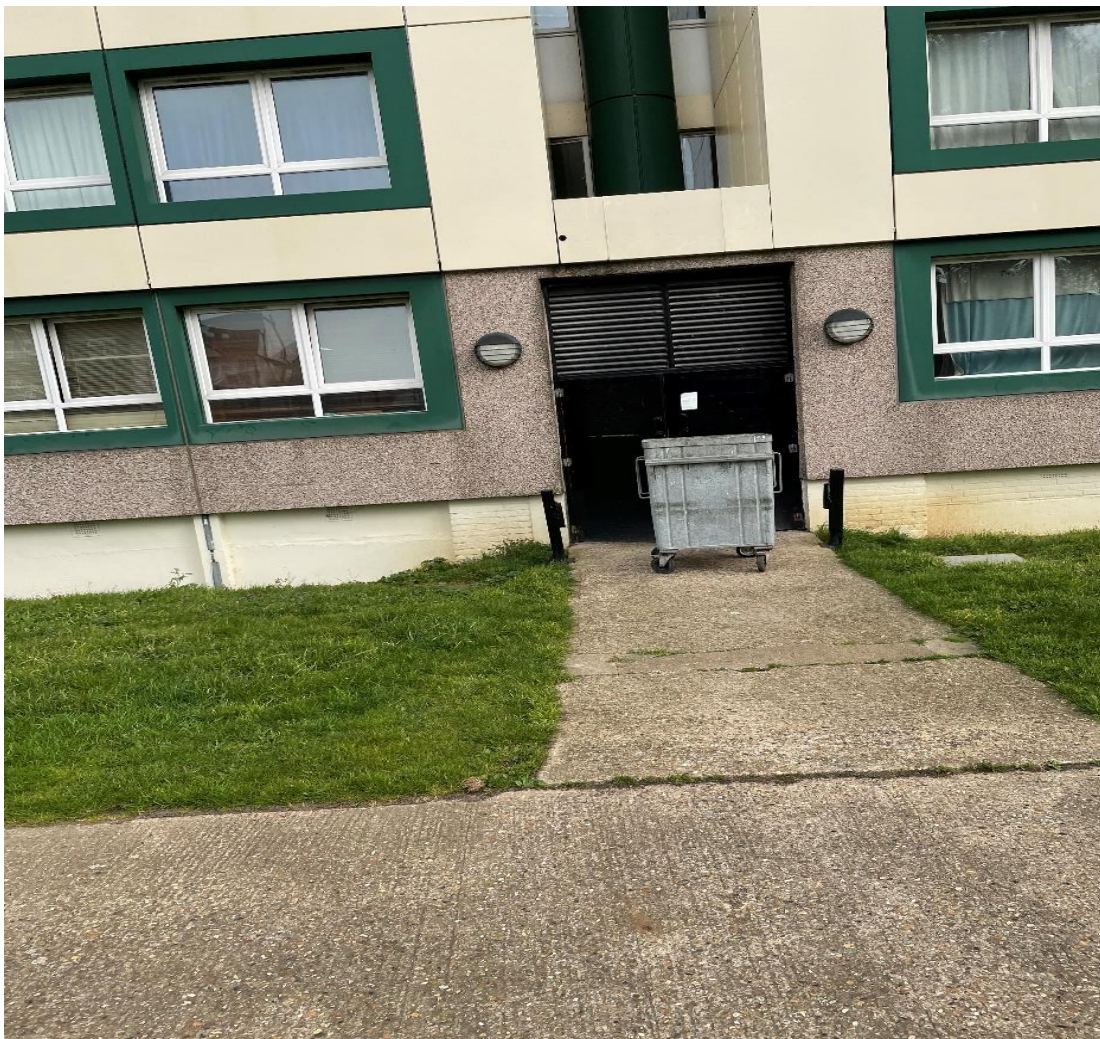
- 10mm render
- 100mm EPS insulation a Euroclass E combustible thermoplastic.
- 130mm solid concrete. A hole was drilled through the concrete in some locations to determine the thickness, however, it could not be further determined what was behind the concrete without potentially compromising the integrity of the structure and causing damage internally. Based on the style of construction the LPS panel would be substantially larger than 110mm. This was also confirmed based on a view underneath the external walls at ground floor level.

**Figure 14.** Cladding location at lower part of block

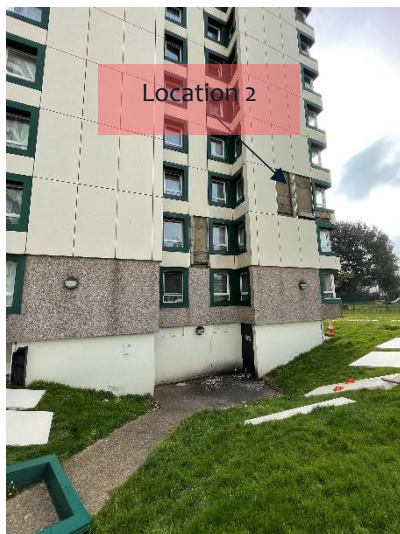
- 50mm metal cassette panel cladding formed of 5mm aluminium.
- 40mm cavity
- 100mm mineral wool
- 130mm solid concrete. A hole was drilled through the concrete in some locations to determine the thickness, however, it could not be further determined what was behind the concrete without potentially compromising the integrity of the structure and causing damage internally. Based on the style of construction the LPS panel would be substantially larger than 110mm.

**Figure 15.** Metal cladding at 3<sup>rd</sup> floor corner

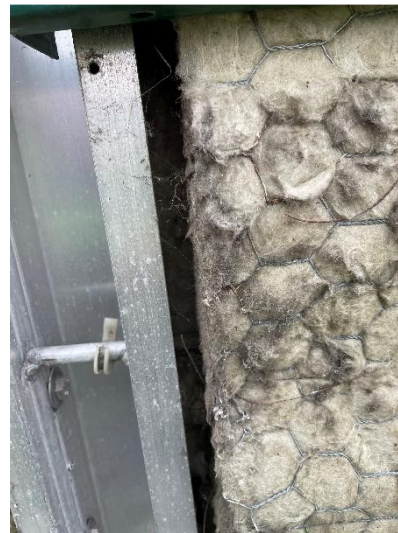
A vertical and horizontal cavity barrier was found in the cavity in this location. The horizontal barrier was in line with the compartment floor. However, the vertical barrier was not at the compartment line and therefore, we assume this is provided for an effective lateral break. The barriers were mineral wool type product reinforced with wire, which were common at the time of installation. This cavity barrier has to be folded over in order to ensure that the barrier fills the full depth of the cavity to reach the rear of the cassette panel, however, the barrier was found to be poorly fitted with gaps appearing next to the façade carrier system, it was not under compression so it may allow fire to bypass the compartment line here, which is not permissible.

**Figure 16.** Gaps around cavity barrier at carrier system

Cavity barriers would be required between the mineral wool insulation and the external metal covering. Considering the extent of the metal cladding in this location, BB7 would have expected full cavity barrier provisions as per Approved Document B although at the time of installation, cavity barriers would not have been required around openings. A cavity barrier should exist across the whole system from RC structure to the inside face of the aluminium cladding which was not found in this case. However, this could be considered acceptable as both the mineral wool and metal cladding are non-combustible and would not likely contribute to a façade fire. In addition to this, as the mineral wool is the same material as the cavity barriers, this would reduce the likelihood of the cavity barrier being flanked by fire.

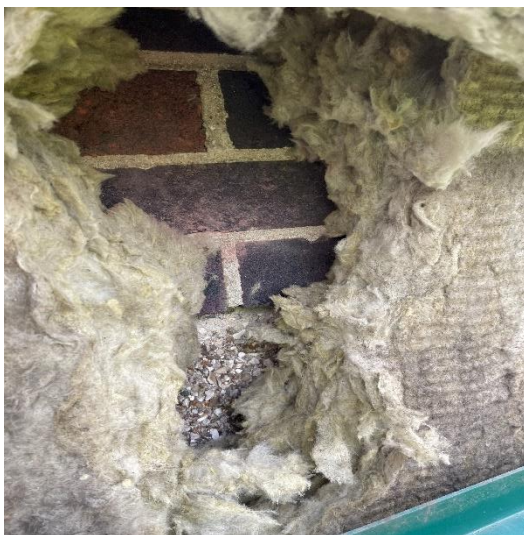
**Figure 17.** View behind metal cladding and mineral wool

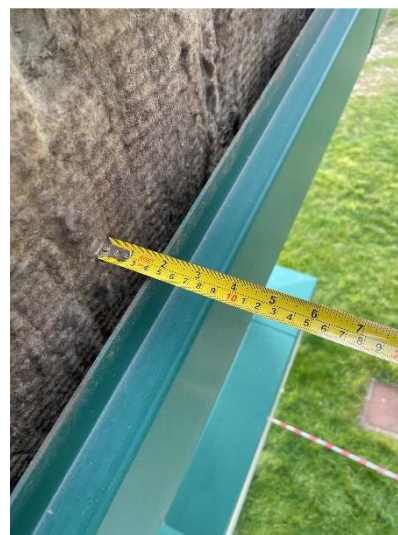
**Figure 18.** Measurement of cavity

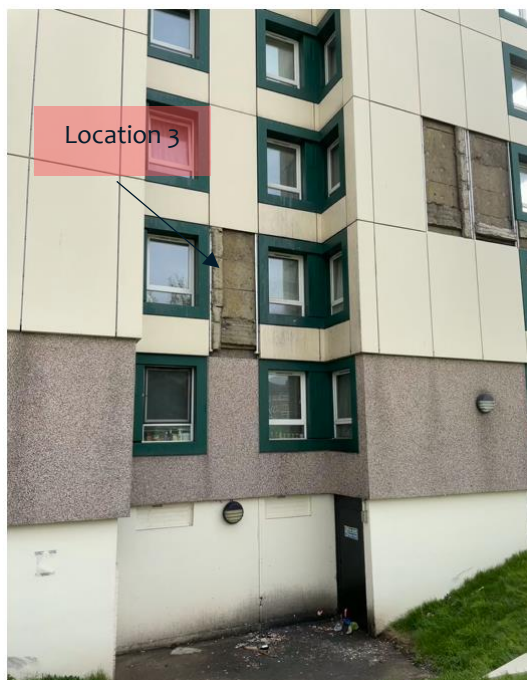
This location was surveyed due to the presence cladding and the vertical and horizontal compartment lines, cavity barriers would not be expected at the window openings as they are not a requirement of the guidance at the time of design & construction. There is one cavity at this location. An outer cavity between the metal cladding and the mineral wool. At this location it was also noted that the insulated render system stops and does not carry up the full height of the building.

**Figure 19.** View of location

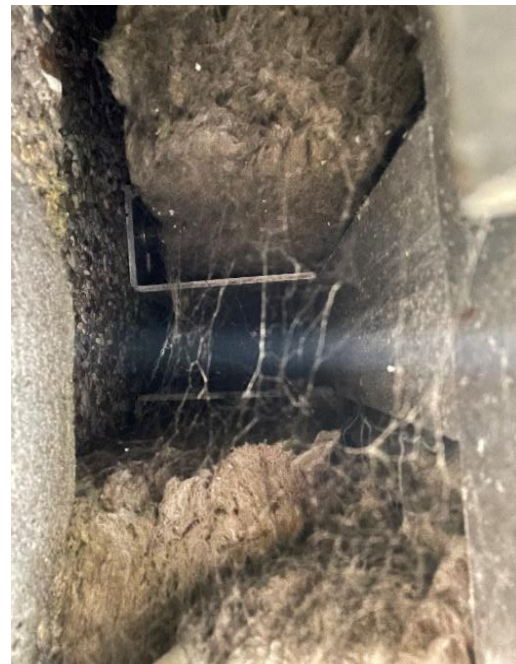
Cavity barriers appear to be present fixed to the mineral wool at compartment floor and wall areas. The vertical cavity barriers will inhibit uncontrolled fire spread within the cavity as they are folded correctly filling the full depth of the cavity. However, the horizontal barriers are poorly fitted as they will not fill the full depth of the cavity and therefore do not provide an effective break against fire.

**Figure 20.** View behind cladding

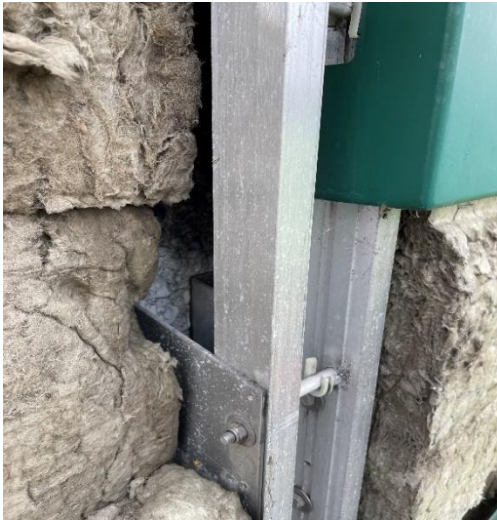
**Figure 21.** Gap in rockwool at carrier system

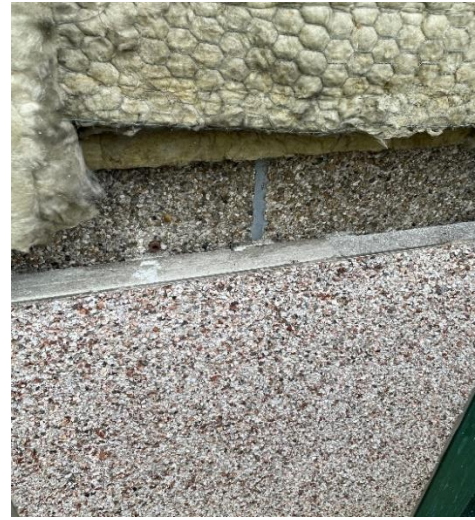
**Figure 22.** EPS insulation stops with RC structure behind

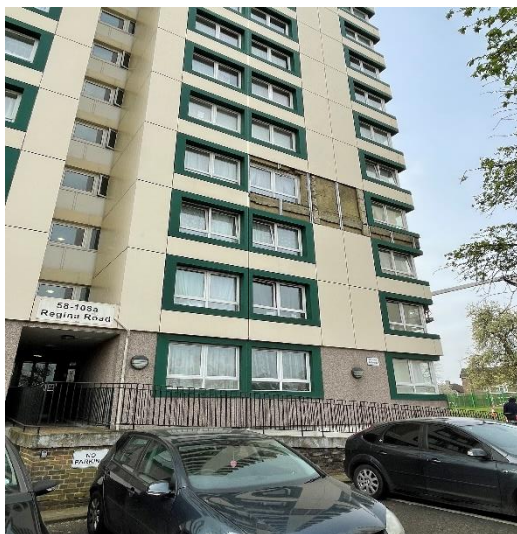
This location was surveyed due to the presence of the compartment line and the window. The cavity barrier was a reinforced mineral wool product, however they not folded in areas to fill the metal cladding completely and therefore do not provide an effective break against fire.

**Figure 23.** View of location

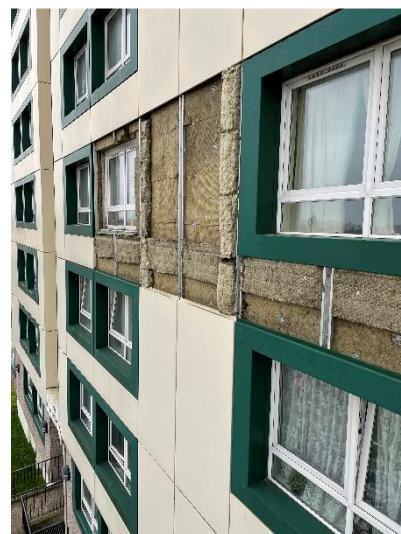
**Figure 24.** View of vertical and horizontal barriers. Non-folded horizontal barrier

- cavity barriers were found at compartment lines in the cladding systems. Some barriers were found under good compression; however, most areas were not under compression meaning that the barrier is not fulfilling its function of inhibiting smoke and fire spread.

In all locations surveyed the barriers were noted to not be under compression at compartment floor lines meaning that there is potential for fire to bypass the cavity barriers. Whilst this would be considered to be low risk if limited instances were found, on this building BB7 did not find evidence of compartment floor barriers being folded and fully filling the cavity to the rear of the cassette panels. On that basis BB7 recommend that the cavity barriers are upgraded to ensure that they will inhibit the unseen spread of fire and smoke. This can be done in one of two ways:

Whilst there are issues with uncontrolled fire spread due to the cladding materials, BB7 consider the external walls do not effectively inhibit the unseen spread of fire and smoke, contrary to Part B3(4) of the Building Regulations. BB7 recommend that the cavity barriers at vertical and horizontal compartment lines are checked in all locations and were found to be poorly installed they should be replaced. This also includes around windows, and ventilation penetrations. BB7 consider that the horizontal cavity barriers should be replaced wholesale for a tested 30-minute cavity barrier which is of a mineral wool style.

- The EPS insulant and render at lower floors needs to be replaced with a non-combustible alternative.
- Cavity barriers in the Aluminium cladding system should be either remedied such that they are under compression or new barriers provided.
- The infill panels at windows should be removed and replaced with a non-combustible.

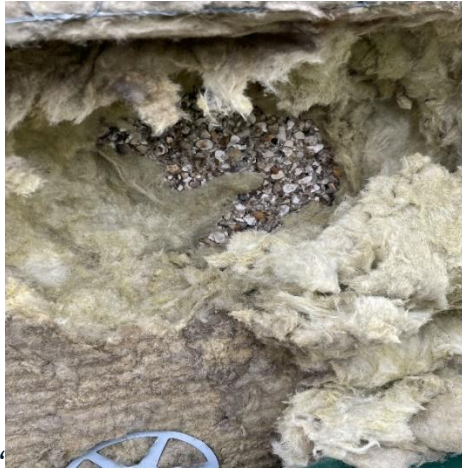
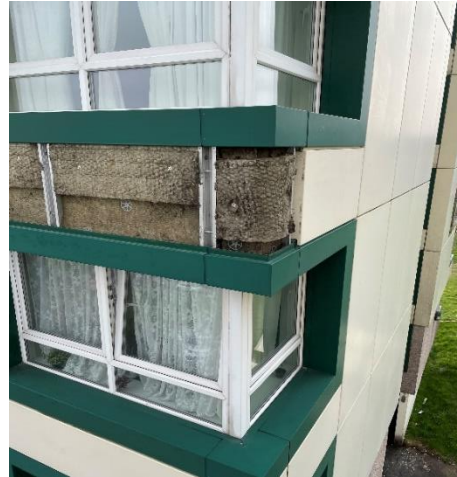
**Figure 25.** Render behind rockwool**Figure 26.** View of corner under window

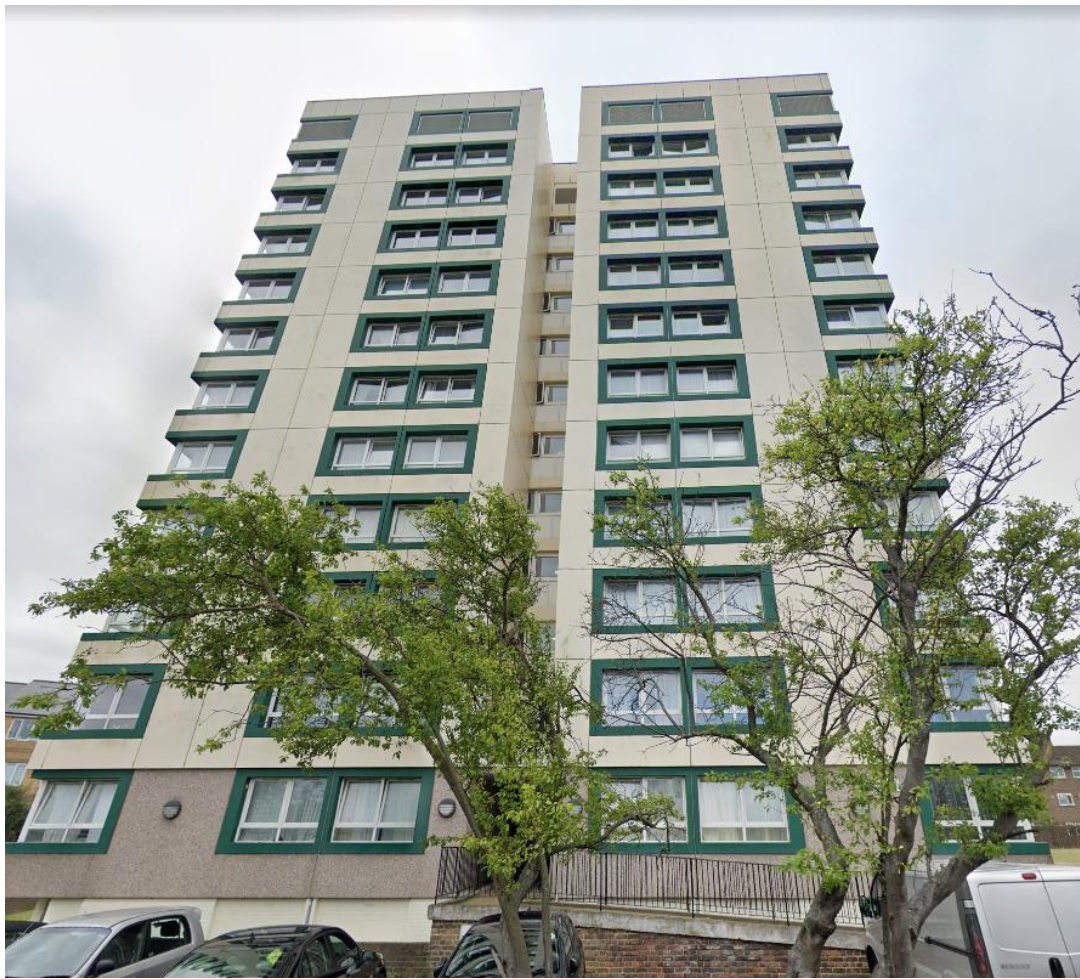
Infill panels are noted to exist on either side of the building forming the external wall system to the common areas. Figure 27 below shows the panels location and that they stack full height. The infill panel below a glazed window was opened up to identify its construction on a number of similar buildings. It was found that the infill panel is a composite panel consisting of an unknown thermoplastic material sandwiched between two thin layers of steel. The panels appeared to be the same from a visual survey on this block.

**Figure 27.** Infill panels

Material	Combustibility	Volume	Comments	Recommendations
Thermo plastic infill between two layers of steel.	Typically Euroclass E - F to BS EN 13501-1	Front and rear elevations	Combustible thermo plastic sandwiched within two layers of steel between windows. Presumed to be typical on each floor.	All window infill panels are to be replaced for non-combustible alternatives on the common area sections.

Similarly, the infill panels, which are considered high risk combustibles, should be removed and replaced with a non-combustible alternative.

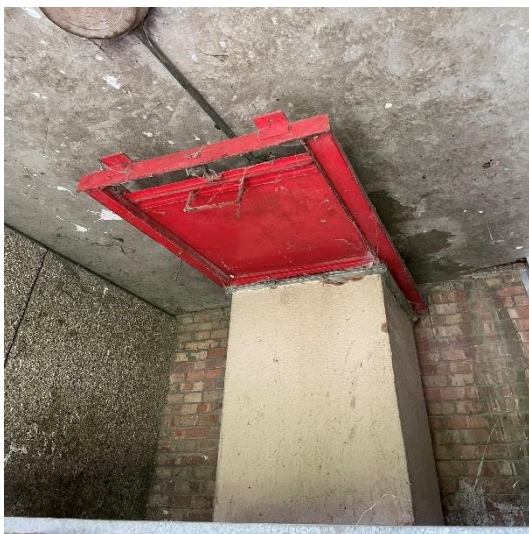
**Figure 28.** Bin chute damper with fusible link in bin store

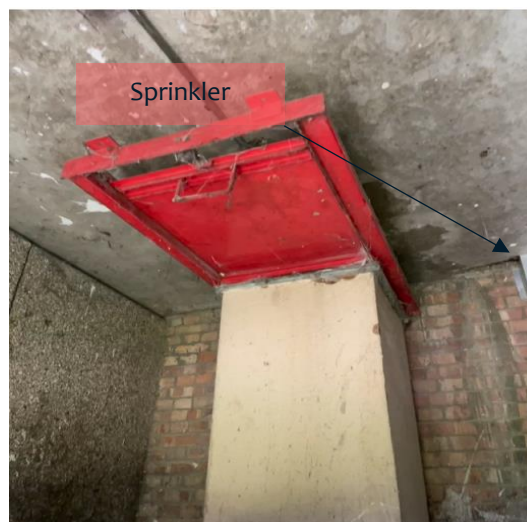
**Figure 29.** View of sprinkler

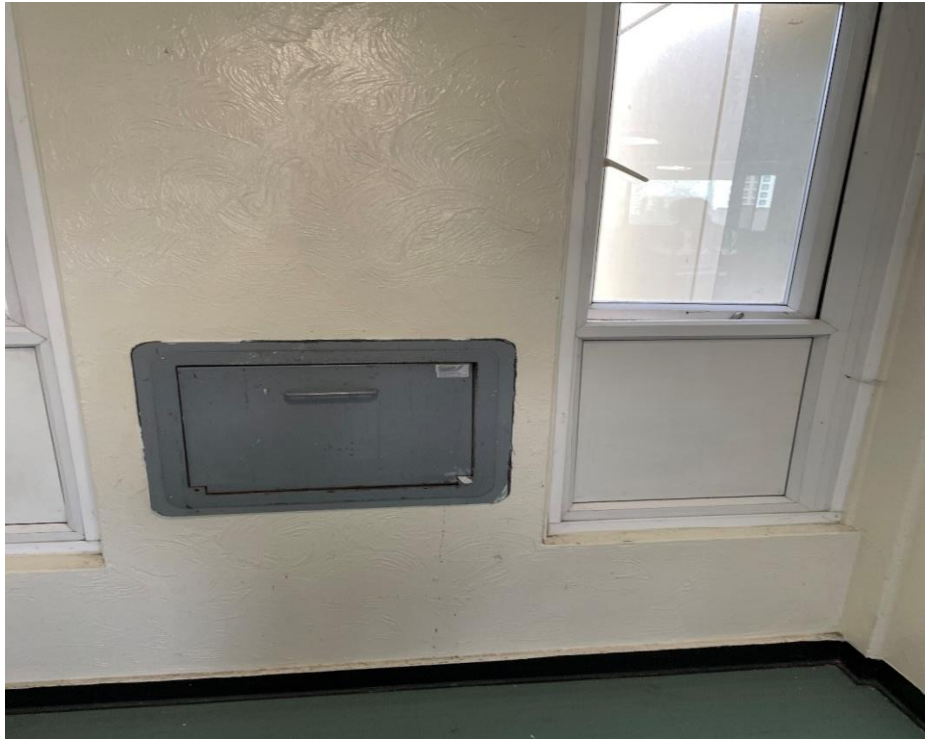
connected to the common area serving the protected stair and AOV windows. The infill panels stack one above the other there is potential that fire could “jump” from one to the other. In order to remove this risk, these infill panels should be removed and replaced with a non-combustible alternative. Figure 32 shows a typical infill panel.

**Figure 32.** Typical infill panel
