EWS1 Report

1-44 Keeling Court

30th April 2021

12125BB

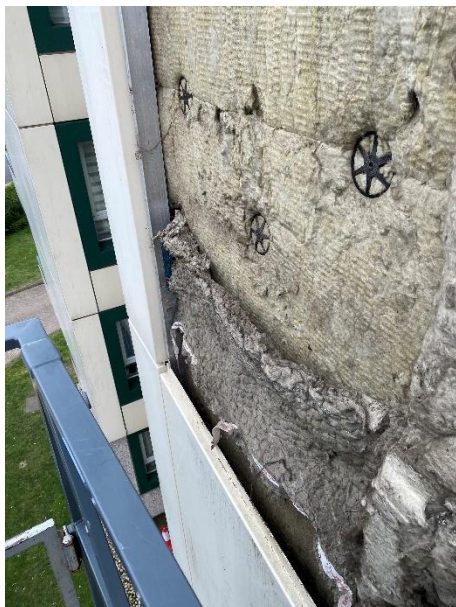
Location 1.1. was at the third floor inspecting two over cladding panels and the provision of cavity barriers. There is one horizontal cavity barrier behind one cladding panel that is interrupted by the aluminium cladding rail. This is not continued behind the adjacent cladding panel, nor is the cavity barrier folded and under compression.

Figure 10. Location 1.1 no vertical cavity barrier

- Any infill panels with thermo plastic insulation should be replaced with a non-combustible alternative.
- Cavity barriers should be provided under compression horizontally at floor levels and vertically at compartment walls where they are not installed.
- The render system at ground floor should be replaced for a non-combustible alternative.
- The fusible link on the damper serving the bin chute should be inspected and serviced regularly.
- All points raised on the Fire Risk Assessment should be adhered to.

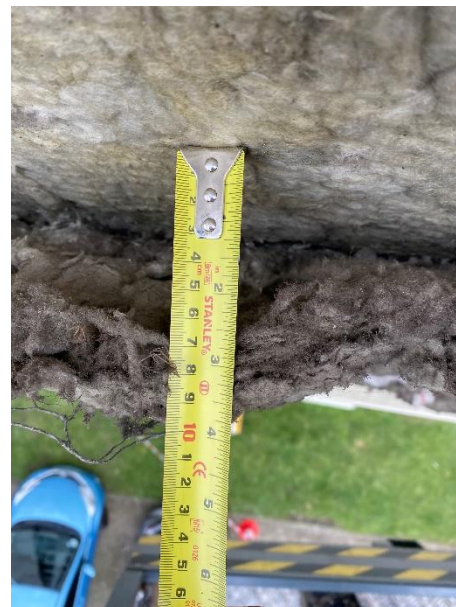
Figure 11. Location 1.1 cavity between insulation and cladding rails

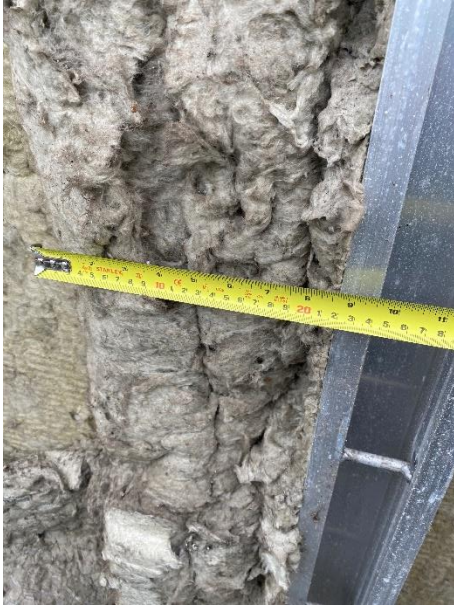
Location 1.2 was at the third floor where a folded cavity barrier has been installed not at a compartment line or around a window opening; its intent is unknown but it is not considered to pose a fire risk to occupants as the barrier does divide the cavity between the openings in the external wall and is fitted under compression.

Figure 12. Location 1.2 non continuous cavity barrier at floor level

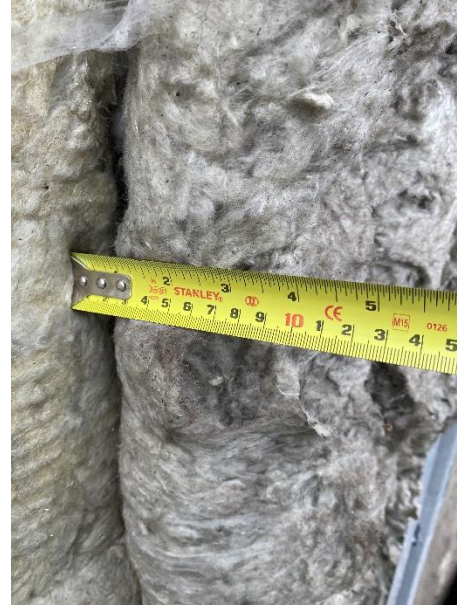
Figure 13. Location 1.2 – Rough stone cladding behind insulation

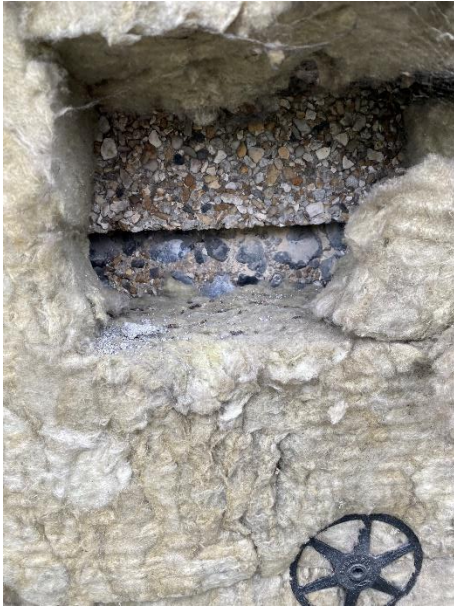
Location 1.3 shows the original RC LPS construction behind the overcladding but no joint seal between the panels. The panels were not drilled as the integrity of the panels without the seal was not known. It is understood to be formed of 100mm concrete, a narrow band of EPS or XPS insulation, and a further 100mm concrete leaf, per the assessment in Section 3. As discussed in Section 9.3, the RC is considered the relevant material when considering the risk due to its robustness and it being protected by mineral wool.

Figure 14. Location 1.3 original RC LPS construction behind overcladding and insulation

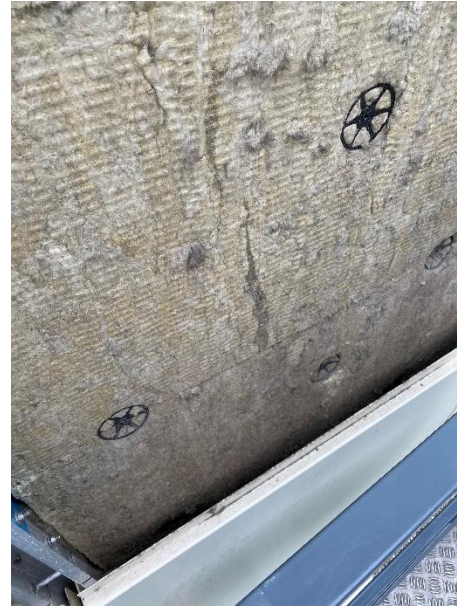
Figure 15. Location 1.3 no horizontal cavity barrier at slab level

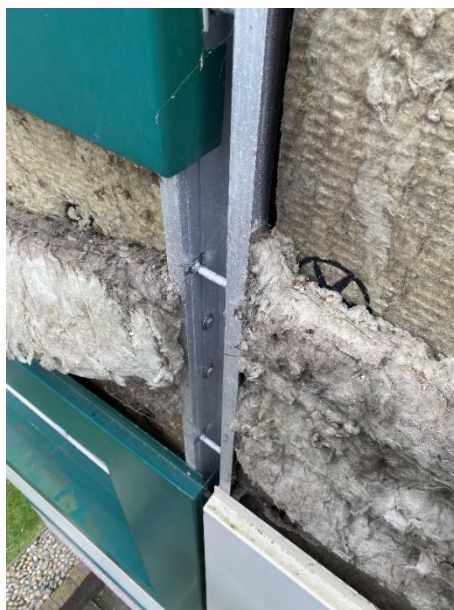
Location 2.1 was on the second floor below a window on the corner of the building. The windows have been installed into the original structural openings and, therefore, have not been moved to suit the cavity. Cavity barriers are not continuous either below windows or at slab level as they are interrupted by the cladding rails. The brackets centrally located along wider cladding panels, such as those under the window, are hidden completely, particularly on the left hand side of Figure 17, so are not open to the atmosphere. The cavity barrier is broken where the fixing bracket passes through it.

Figure 17. Location 2.1 horizontal cavity barrier around the corner

Again, the barriers were mineral wool type product reinforced with wire, which were common at the time of installation. This cavity barrier has to be folded over in order to ensure that the barrier fills the full depth of the cavity to reach the rear of the cassette panel, however, the barriers were found in some cases to be poorly fitted with gaps appearing next to the façade carrier system, it was not under compression so it may allow fire to bypass the compartment line here, which is not permissible.

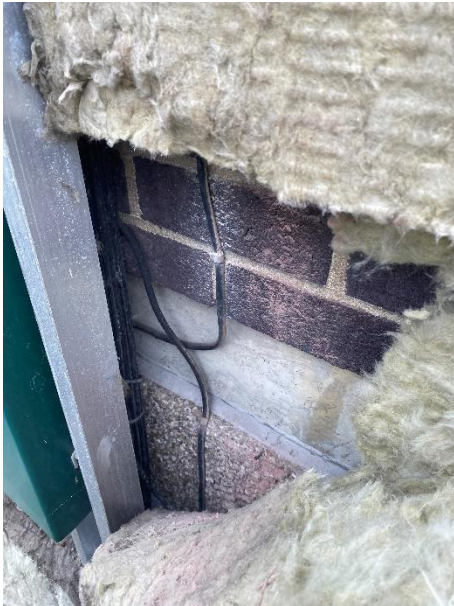
Location 2.2 was on the second floor between two windows of the same compartment. Horizontal cavity barriers are either not fully folded or not folded at all. Figure 18 shows where the original brickwork joins the original RC LPS construction which are separated by the metal coping.

Figure 18. Location 2.2 original brickwork external wall and metal coping

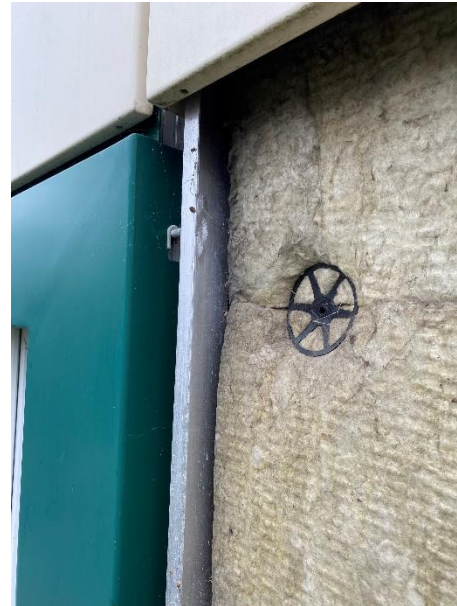
Figure 19. Location 2.2 vertical cavity barrier around the window

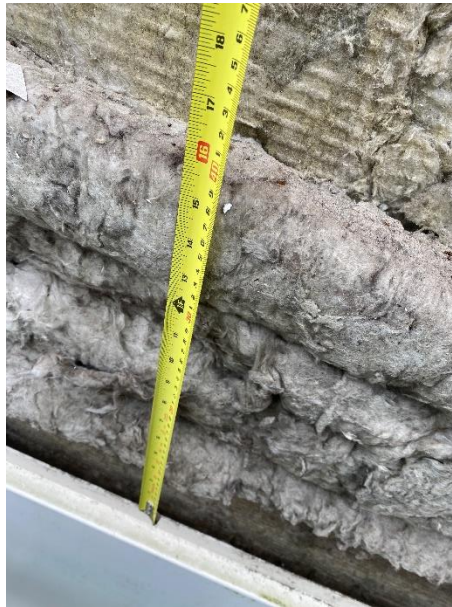
Figure 20. Location 2.2 horizontal cavity barrier at approximately slab level. The cavity barrier has not been folded and was not installed under compression.

Again, the barriers were mineral wool type product reinforced with wire, which were common at the time of installation. This cavity barrier has to be folded over in order to ensure that the barrier fills the full depth of the cavity to reach the rear of the cassette panel, however, the barriers were found in some cases to be poorly fitted with gaps appearing next to the façade carrier system, it was not under compression so it may allow fire to bypass the compartment line here, which is not permissible.

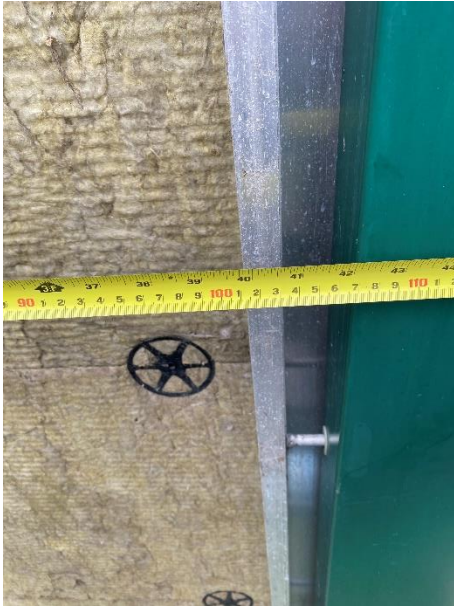
A vertical cavity barrier around the window opening was not expected, considering the relevant guidance in ADB at the time of the over cladding and therefore this is not considered to pose significant fire risk to occupants.

Figure 21. Location 2.3 no vertical cavity barrier around window

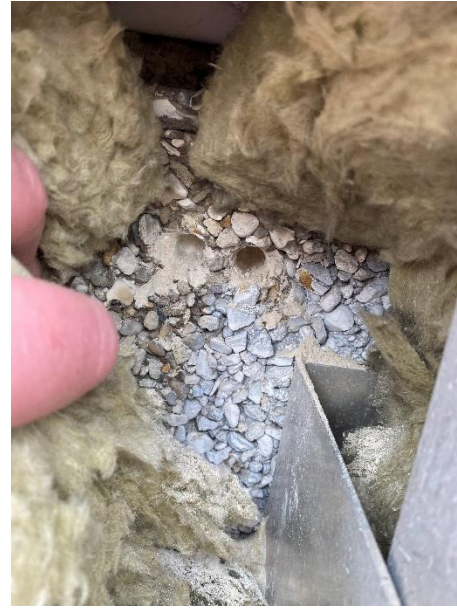
The RC LPS construction was drilled to a depth of approximately 25mm where the density prohibited further drilling, as per the assessment in Section 3.

Figure 22. Location 2.3 approximately 25mm drill holes to concrete

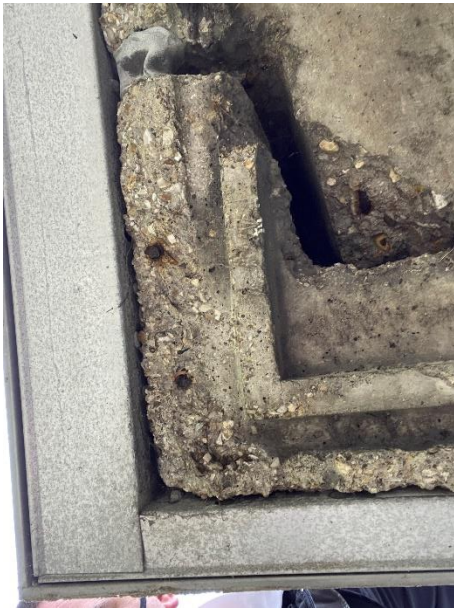
Figure 23. Location 3 structural beam

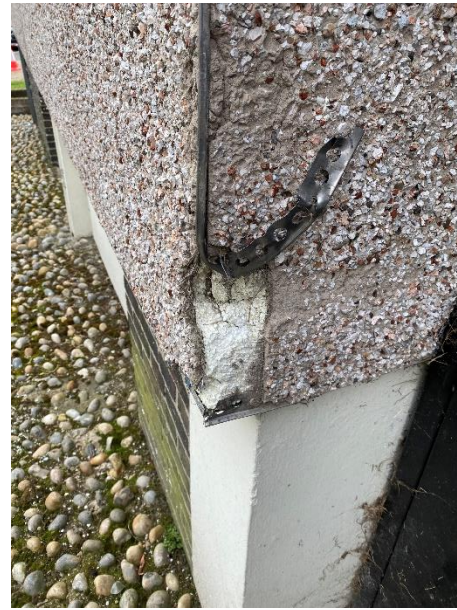
EPS Insulation was found at the ground floor of the building of all elevations. The insulation was installed over the original masonry external wall system, as shown in **Error! Reference source not found.**, with a rendered stone finish. Small areas of this render were damaged prior to the inspection which allowed inspection of the system. EPS has a Euroclass E rating meaning that it is a highly combustible material.

Figure 24. Location 3 exposed EPS behind stone render approximately 60mm deep to concrete.

The original skin of the external wall, i.e., RC LPS construction, is considered to be a low risk item. The presence of the combustible EPS insulation over the masonry is considered to be of low risk of uncontrolled fire spread as the system was found at low level only at ground floor. However, to enhance the life safety to the occupants BB7 recommend replacement of the insulation for a non-combustible alternative.

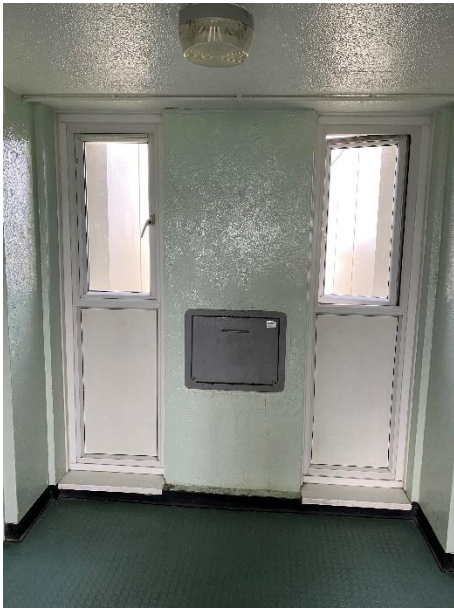
The refuse chute is accessed from the common residential lobby and passes the thermoplastic infill panels on either side of the chute to the refuse store at ground floor.

The refuse store is sprinkler protected and there is a damper operated by a fusible link across the base of the chute which should prevent vertical fire spread up the chute towards the infill panels.

Figure 25. Location 4 lobby windows and infill panels adjacent to refuse chute

Material	Combustibility	Volume	Comments	Recommendations
Thermo plastic infill between two layers of steel.	Typically Euroclass E - F to BS EN 13501-1	All locations	Combustible thermo plastic sandwiched within two layers of steel below common lobby windows.	All infill panels below windows are to be replaced for non-combustible alternatives on the common area sections.

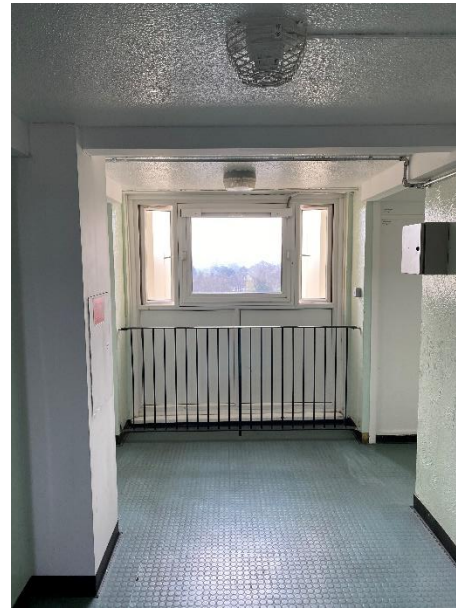
Figure 26. Location 4 lobby windows and infill panels below AOV

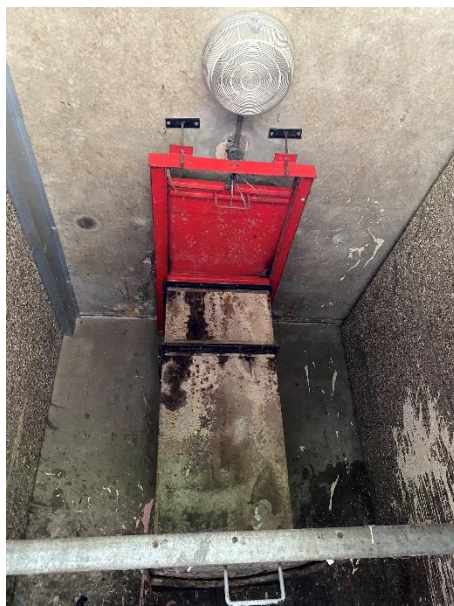
The bin store at ground floor was provided with a sprinkler head to reduce the potential fire size and a damper on a fusible link was provided at the end of the bin chute to reduce the chance of fire spread. This is shown in the following figure.

Figure 27. Bin chute fusible link

To further mitigate the risk, it would be recommended for doors to the bin store to be kept locked when not in use to limit unauthorised access.
