# **EWS1 Report**

## **Sevenoaks House**

30<sup>th</sup> April 2021

Croydon Borough Council

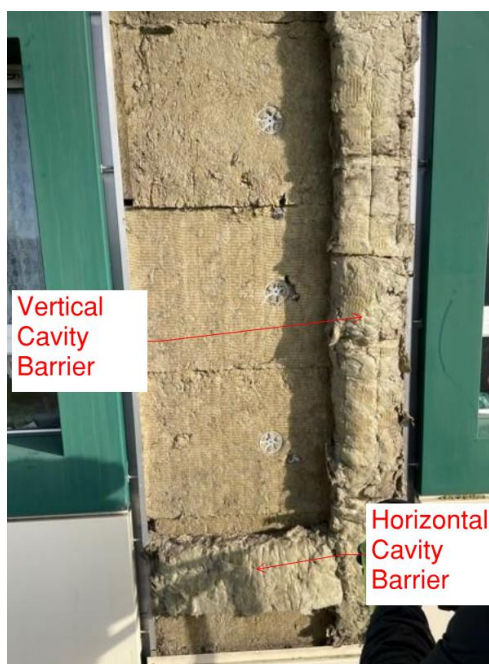
Location 1.1. was at the third floor party wall and both horizontal and vertical cavity barriers were identified. The cavity barriers at floor level sat between the aluminium rails (i.e. they were not continuous horizontally) and the vertical cavity barrier sat on the party wall between flats.

**Figure 10.** Location 1.1 cavity barriers

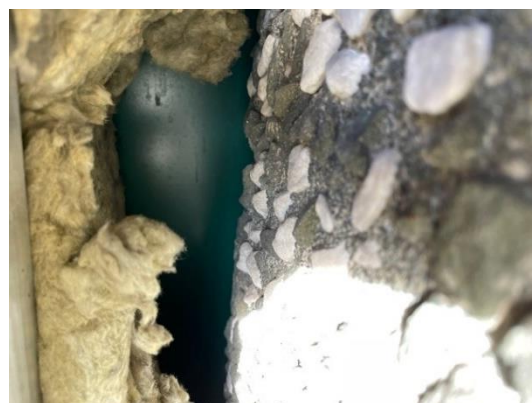
**Figure 11.** Location 1.1 cavity between solid concrete and aluminium panel

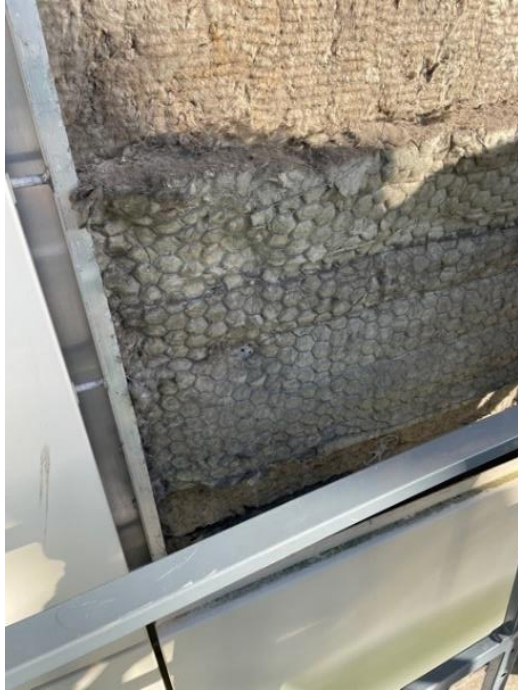
Location 1.2 was at the second floor slab level and a horizontal cavity barrier was identified. It was not continuous due to the aluminium rails and it was not folded back on itself, like other cavity barriers identified, so unlikely to be under compression fit. The concrete structure behind was also drilled into to identify the thickness, the thickness of the outer part of the panel was approx. 120mm.

**Figure 12.** Location 1.2 non continuous cavity barrier at floor level

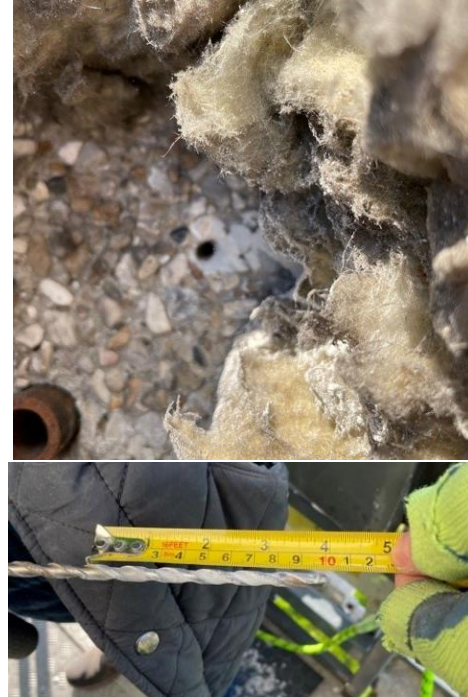
**Figure 13.** Location 1.2 - 100mm hole drilled in concrete

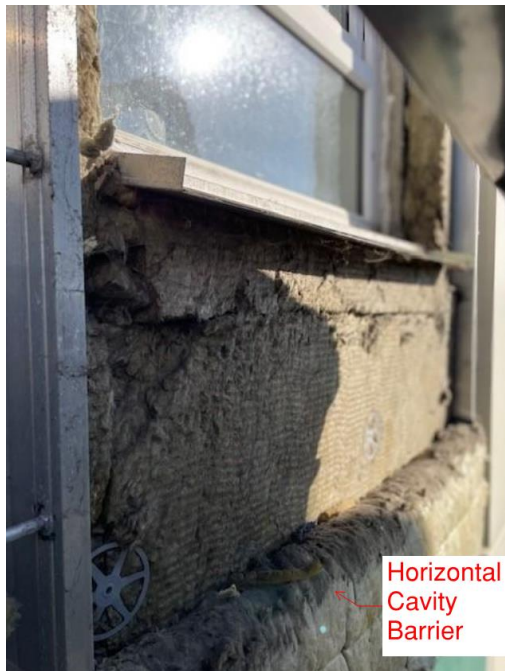
Location 1.3 was at the third floor above a flat window. No cavity barriers were identified around the window. There was one below at floor level in line with the compartment floor but nothing above. Based on the time of the re-clad it is unlikely that cavity barriers around openings were designed for, this was an addition to the standard fire guidance from the year 2000 onwards.

**Figure 14.** Location 1.3 horizontal cavity barrier

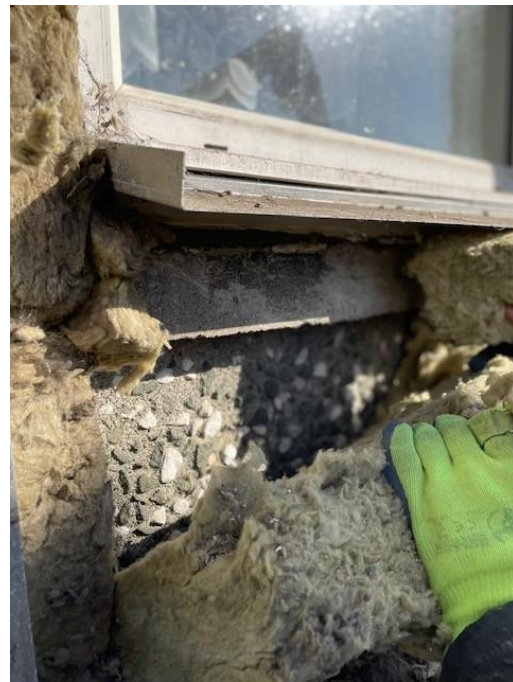
The windows have been installed into the original structural openings and, therefore, have not been moved to suit the cavity. It was also noted that a high degree of silicone sealant had been used around the openings which, as discussed in Section 3, is a risk however is considered to be mitigated.

**Figure 15.** Location 1.3 original window frame behind insulation. A drip tray from the window can be seen.

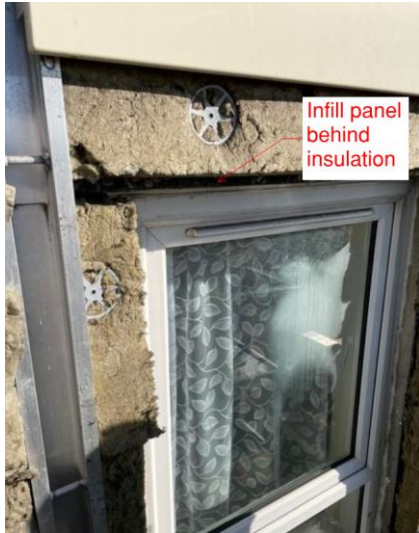
**Figure 16.** Location 1.3 no cavity barrier above window

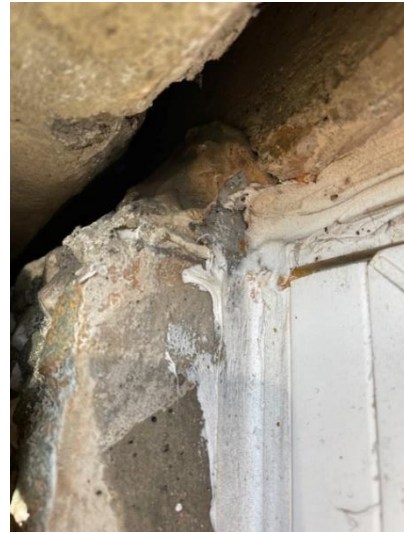
The infill panels were noted between windows on each floor level. It can be seen that there was a large gap behind the old concrete infill panel. A very small amount of expanded polystyrene (EPS) was also identified behind the panel in this location (Figure 19). This supports the style of panel referenced in section 3. The text in section 3 assumes that the EPS is well encapsulated and not readily accessible by fire. This stands true for the insulation potentially contained in the main part of the structural panel. The EPS insulation found appears to form part of a feature banding which sits proud of the main panel as seen in Figure 1. Due to the low volume, it being significantly vertically broken and hidden behind mineral wool insulation. BB7 consider its presence to be relatively low risk.

**Figure 17.** Location 1.3 gap between infill panel and structure behind

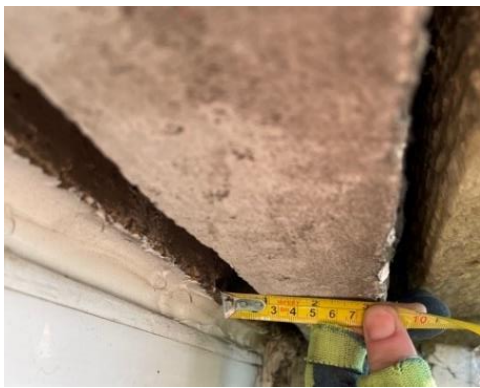
**Figure 18.** Location 1.3 30mm gap behind infill panel

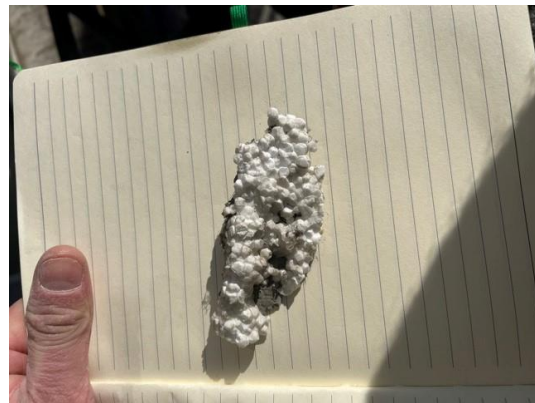
**Figure 19.** Location 1.3 EPS from behind the infill panel

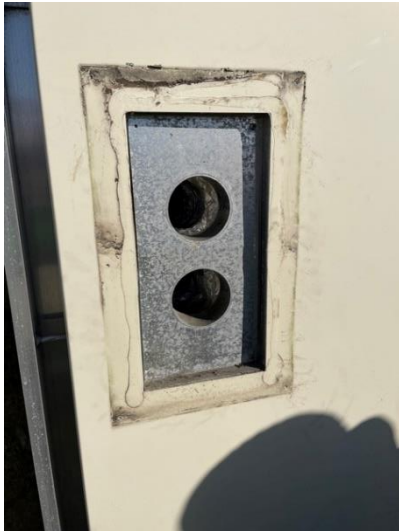
Location 1.4 is the kitchen extract duct from a flat on the third floor.

**Figure 20.** Location 1.4 extract duct

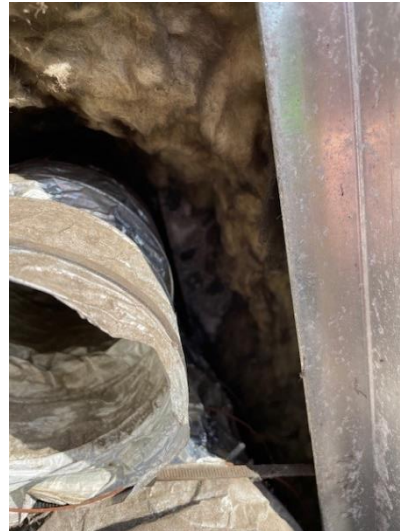
Reinforced mineral wool was identified around the opening to form a cavity barrier, furthermore, there was a steel 'letterbox' enclosing the cavity on the inside of the panel.

**Figure 21.** Location 1.4 cavity barrier

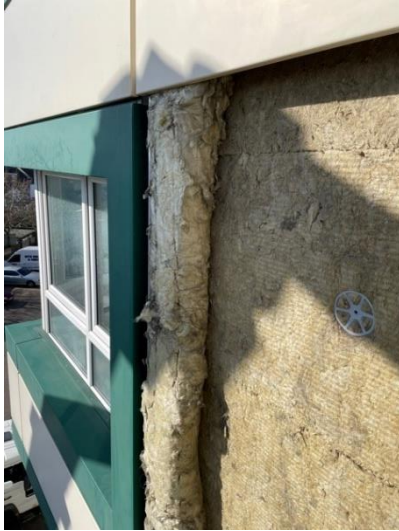
Location 2.1 was on the third floor and two panels between windows were removed. The aluminium panels run the full height of the building in this location forming a continuous strip of cladding up the building that is not naturally broken up by windows.

**Figure 23.** Location 2.1 vertical cavity barrier between window and continuous strip of cladding

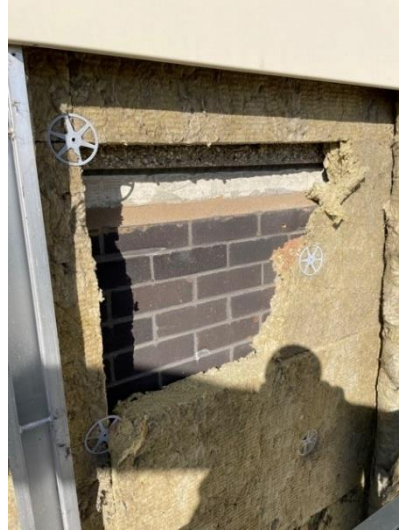
**Figure 24.** Location 2.1 masonry construction behind mineral wool insulation

As per Figure 24, it was noted that there was a gap in the structure and it was filled with a silicone sealant, where two elements of the structure connect.

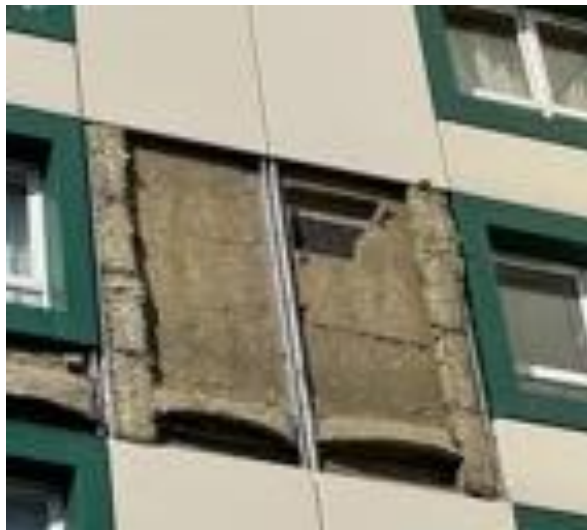
**Figure 25.** Location 2.1 vertical cavity barriers on either side of the continuous strip of cladding between windows

Although a compartment line does not exist here, the vertical cavity barriers on either side provide an additional lateral break.

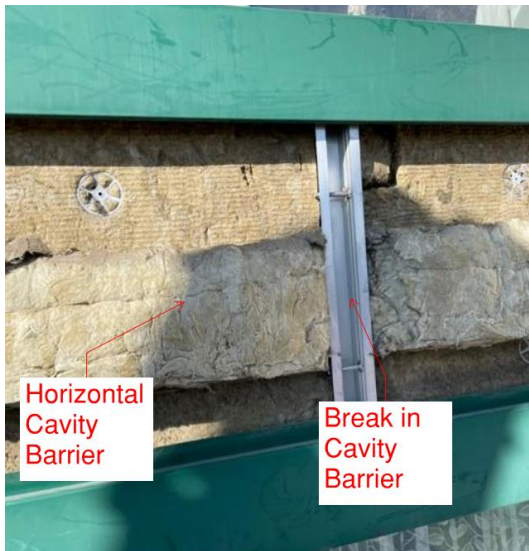
Location 2.2 was under a third floor window and horizontal cavity barriers were identified; however, they did not form a continuous horizontal fire break. It can however be noted that the Aluminium frame sits tight against the mineral wool insulation which is unlikely to degrade during a fire.

There were also no cavity barriers around the window opening.

**Figure 26.** Location 2.2 cavity barrier under window

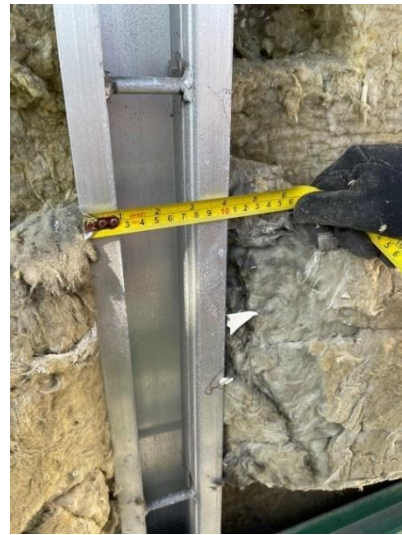
**Figure 27.** Location 2.2 100mm gap between cavity barriers

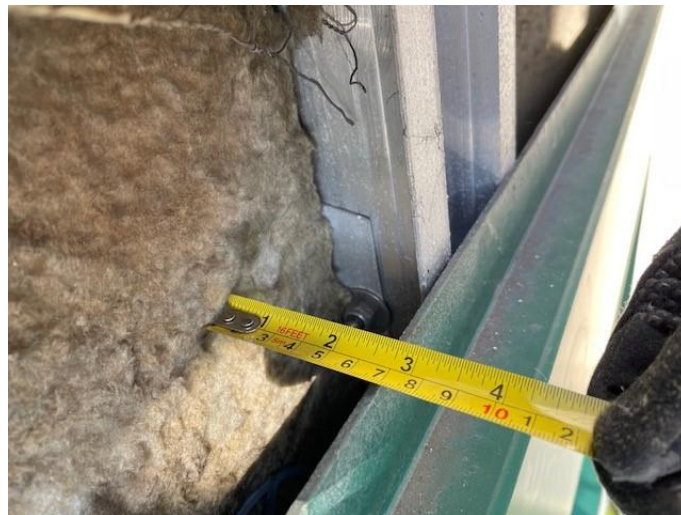
**Figure 28.** Location 2.2 60mm cavity

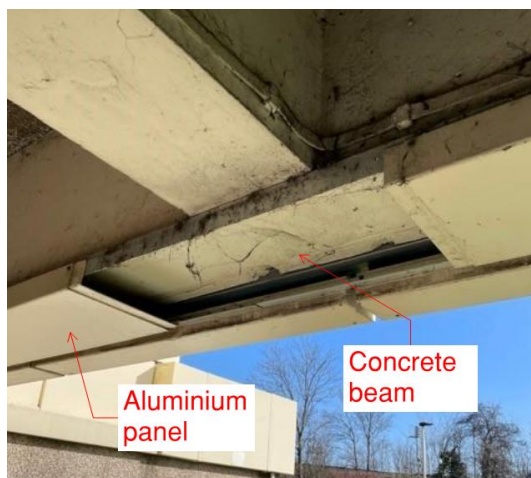
**Figure 29.** Location 3 structural beam enclosed in aluminium panel

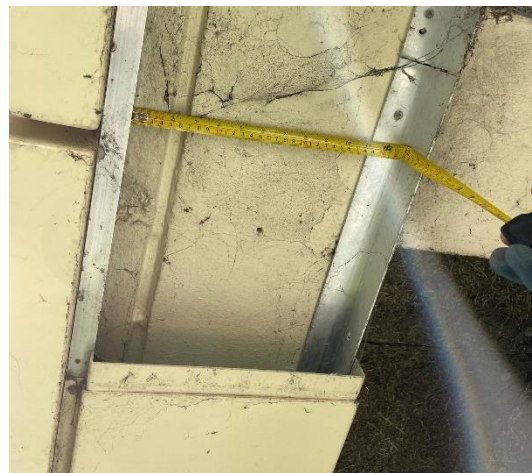
**Figure 30.** Location 3 300mm concrete beam

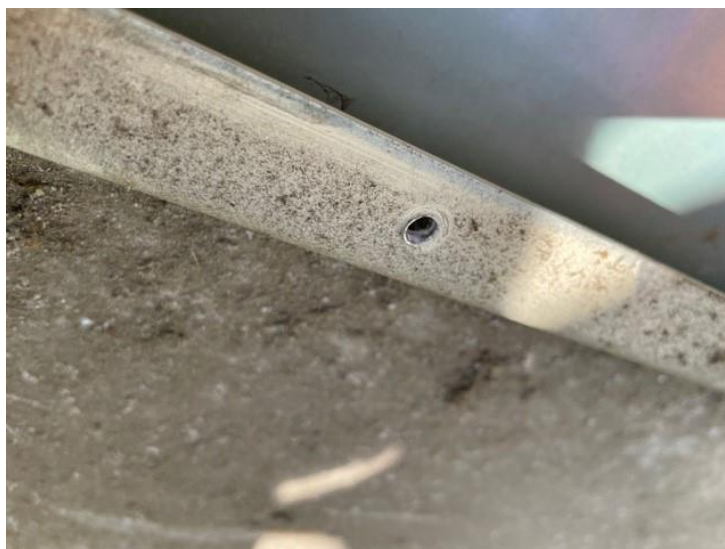
**Figure 31.** Location 3 solid aluminium panel 3-5mm thick

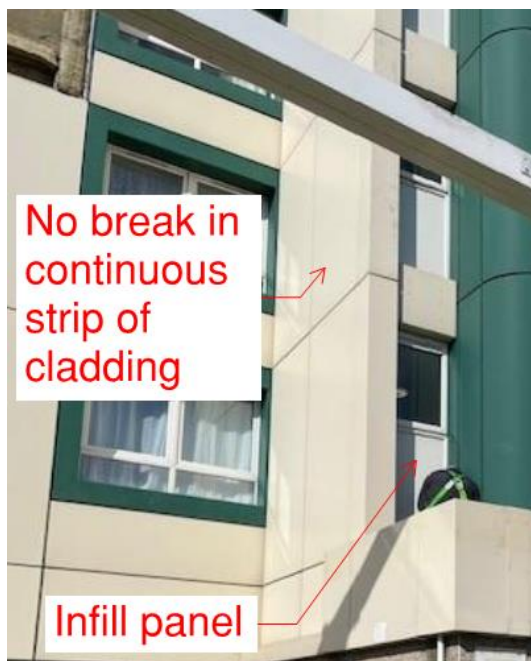
**Figure 32.** Location 4 – no horizontal barriers were found in this section of the cladding.

- Any infill panels with thermo plastic insulation should be replaced with a non-combustible alternative.
- Cavity barriers should be provided at floor level to the bin chute external wall build up.
- The fusible link on the damper serving the bin chute should be serviced regularly.
- All points raised on the Fire Risk Assessment should be adhered to.

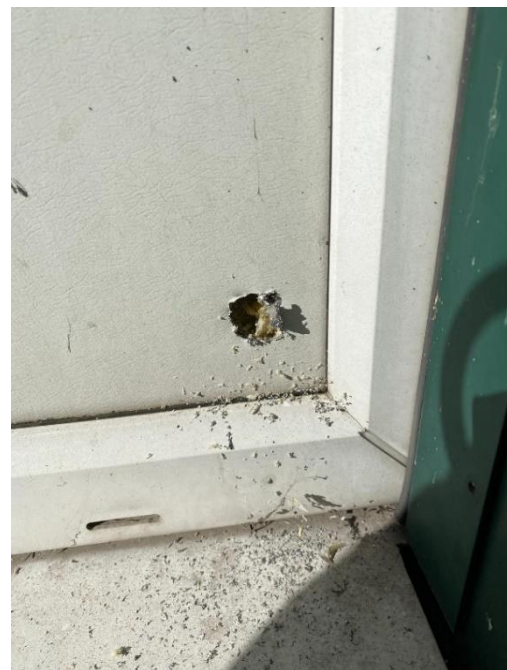
**Figure 33.** Location 4 hole drilled. It appeared to be a thermo plastic infill between two layers of steel.

Material	Combustibility	Volume	Comments	Recommendations
Thermo plastic infill between two layers of steel.	Typically Euroclass E - F to BS EN 13501-1	All locations	Combustible thermo plastic sandwiched within two layers of steel between windows. Presumed to be typical on each floor.	All window infill panels are to be replaced for non-combustible alternatives on the common area sections.

**It is recommended that all window infill panels are to be replaced for non-combustible alternatives on the common area sections.**

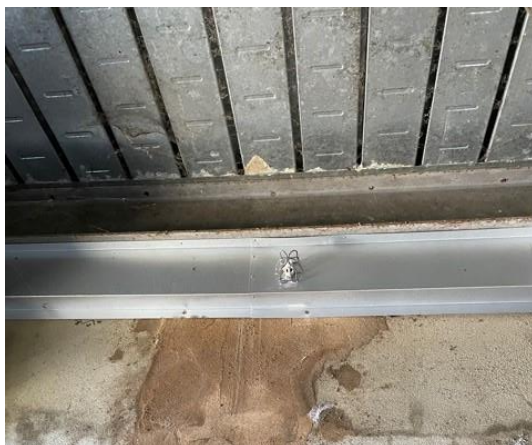
**Figure 34.** Bin store sprinkler

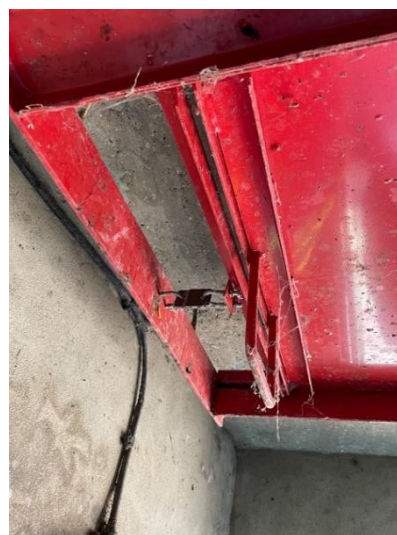
**Figure 35.** Bin chute fusible link
