# **EWS1 report**

## **Tonbridge House**

30 April 2021

Croydon Borough Council

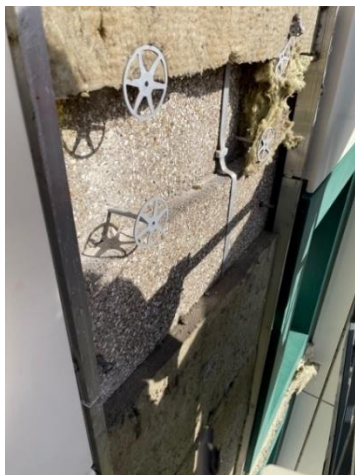
Location 1.1 was on the South elevation at fourth floor slab level. No horizontal or vertical cavity barriers were identified.

**Figure 10.** Location 1.1 no horizontal or vertical cavity barrier

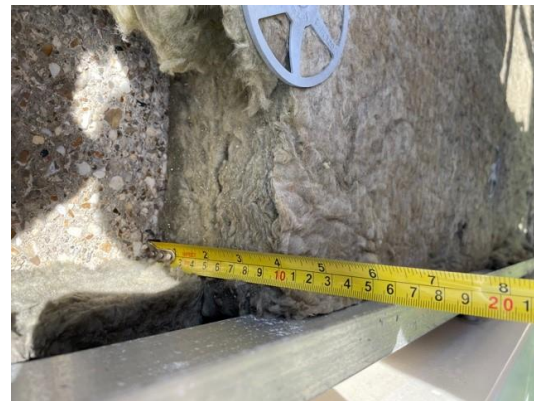
**Figure 11.** Location 1.1 100mm mineral wool insulation

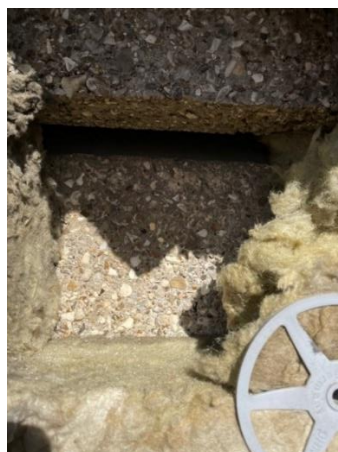
**Figure 12.** Location 1.1 gap identified behind existing infill panel

The infill panels were noted between windows on each floor level. It can be seen that there was a large gap behind the old concrete infill panel. A very small amount of expanded polystyrene (EPS) was also identified behind the panel in some locations. This supports the style of panel referenced in section 3. The text in section 3 assumes that the EPS is well encapsulated and not readily accessible by fire. This stands true for the insulation potentially contained in the main part of the structural panel. The EPS insulation found appears to form part of a feature banding which sits proud of the main panel as seen in Figure 1. Due to the low volume, it being significantly vertically broken and hidden behind mineral wool insulation. BB7 consider its presence to be relatively low risk.

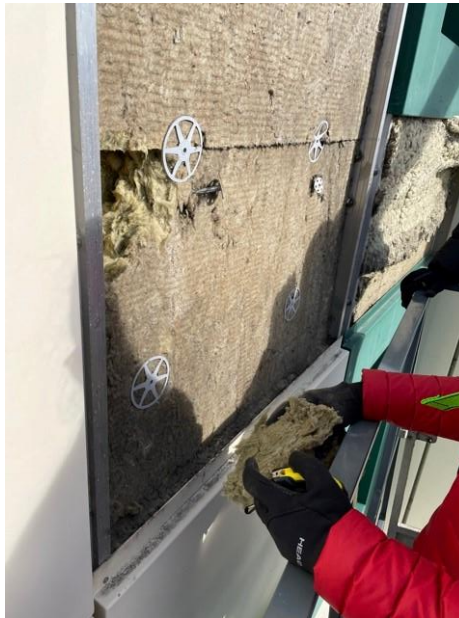
Location 1.2 was on the South elevation at second floor slab level. There was no cavity barrier identified at this location.

**Figure 13.** Location 1.2 there was no horizontal cavity barrier identified at floor level.

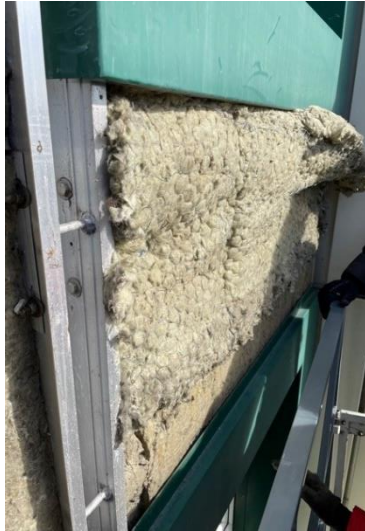
Location 1.3 was at 2<sup>nd</sup> floor below a flat window. The horizontal cavity barrier under the window was not continuous due to the aluminium rails and it was not folded back on itself, so unlikely to be under compression fit.

**Figure 14.** Location 1.3 horizontal cavity barrier under flat window

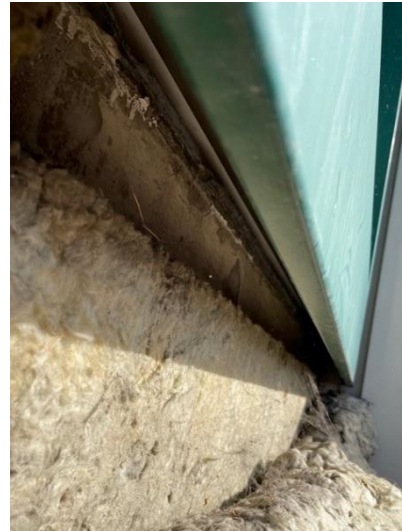
**Figure 15.** Location 1.3 existing window frame behind aluminium cladding

No cavity barriers were identified around the window. There was one below at floor level in line with the compartment floor but nothing above. Based on the time of the re-clad it is unlikely that cavity barriers around openings were designed for, this was an addition to the standard fire guidance from the year 2000 onwards.

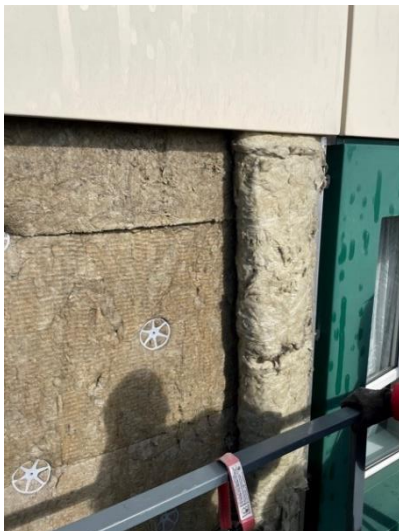
**Figure 16.** Location 1.4 vertical cavity barrier in place

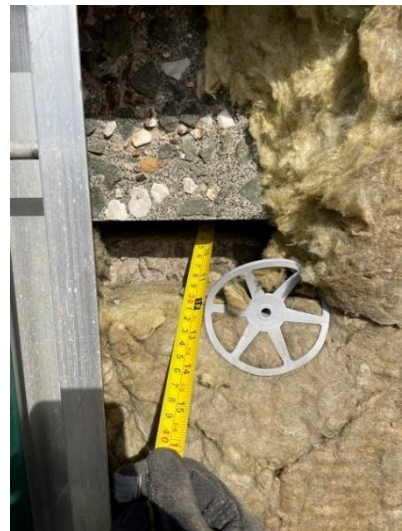
**Figure 17.** Location 1.4 gap identified behind concrete infill panel

The infill panels were noted between windows on each floor level. It can be seen that there was a large gap behind the old concrete infill panel.

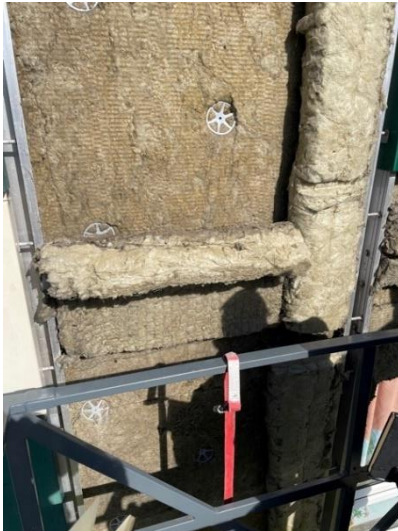
**Figure 18.** Location 1.4 horizontal cavity barrier at floor level – not folded over completely

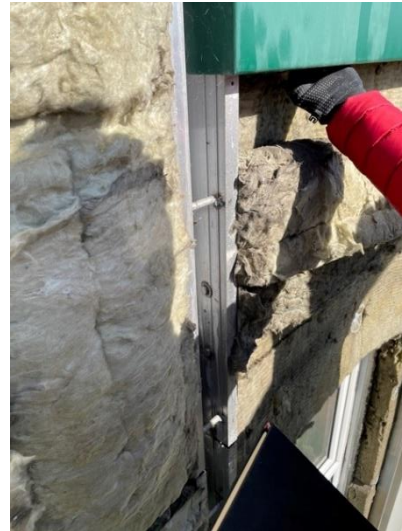
**Figure 19.** Location 1.4 horizontal cavity barrier under window

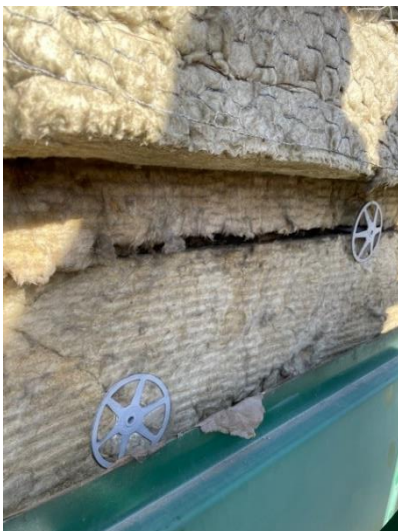
**Figure 20.** Location 1.5 horizontal cavity barrier

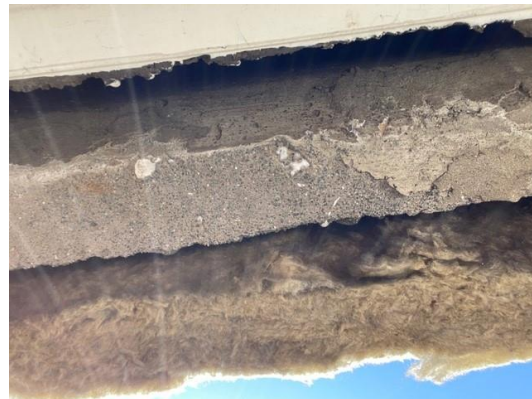
**Figure 21.** Location 1.5 gap identified behind concrete infill panel above window

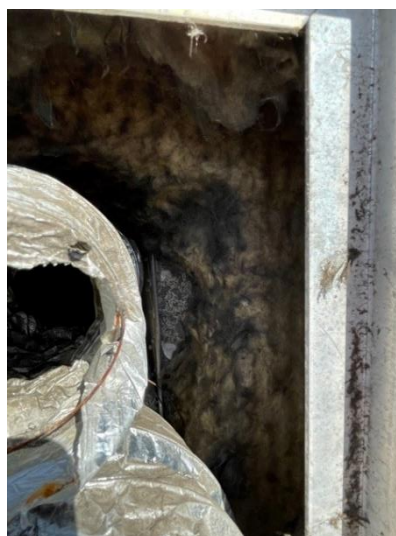
Location 1.6 was at the third floor kitchen extract. Reinforced mineral wool was identified around the opening to form a cavity barrier, furthermore, there was a steel 'letterbox' enclosing the cavity on the inside of the panel. .

**Figure 23.** Location 1.6 cavity barrier enclosing ductwork (reinforced mineral wool)

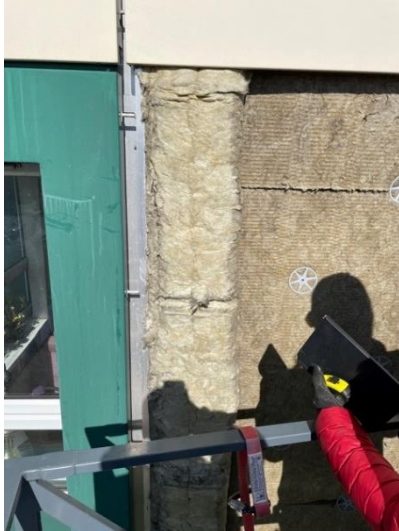
**Figure 25.** Location 1.7 vertical cavity barrier between window and continuous strip of cladding

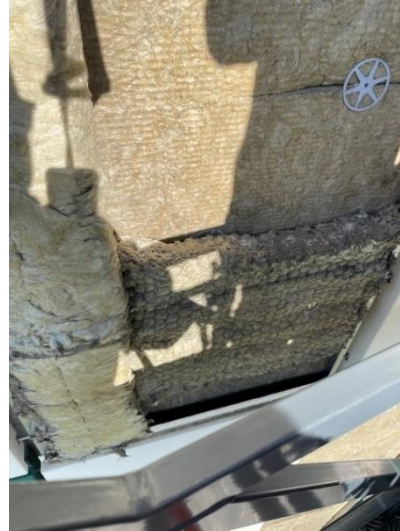
**Figure 26.** Location 1.7 horizontal cavity barrier at floor level

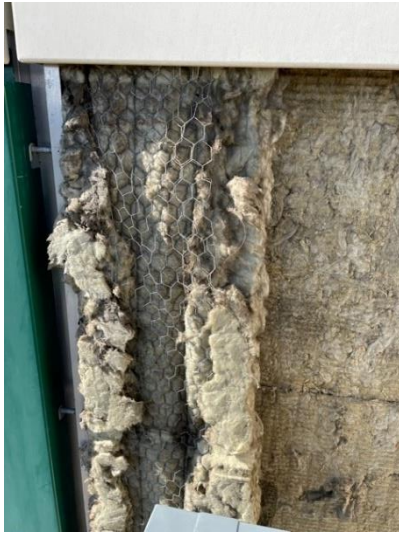
**Figure 30.** Location 2.1 damaged vertical cavity barrier unlikely to be under compression

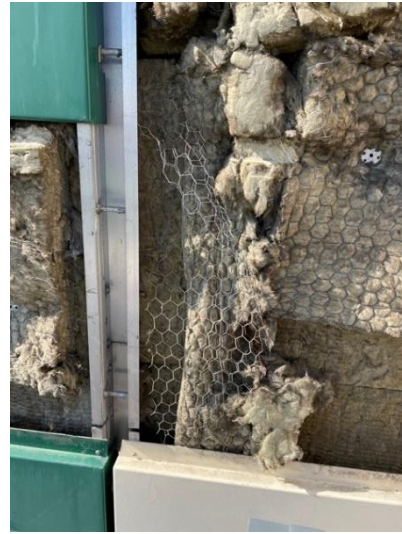
**Figure 31.** Location 2.1 damaged vertical cavity barrier not full fill and unlikely to be under compression

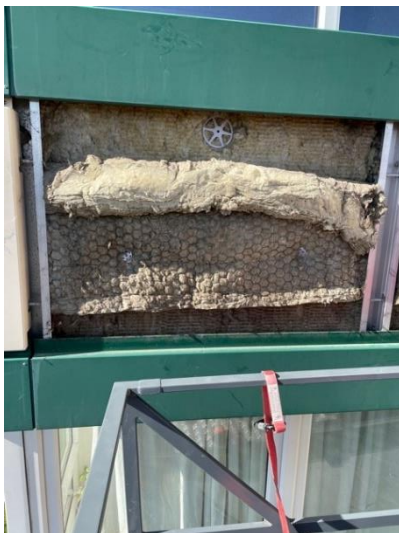
Location 2.2 was below the flat windows on the East elevation. Under the window, horizontal cavity barriers were identified; however, they did not form a continuous horizontal fire break due to the aluminium rail system. It can however be noted that the Aluminium frame sits tight against the mineral wool insulation which is unlikely to degrade during a fire.

**Figure 32.** Location 2.2 horizontal cavity barrier

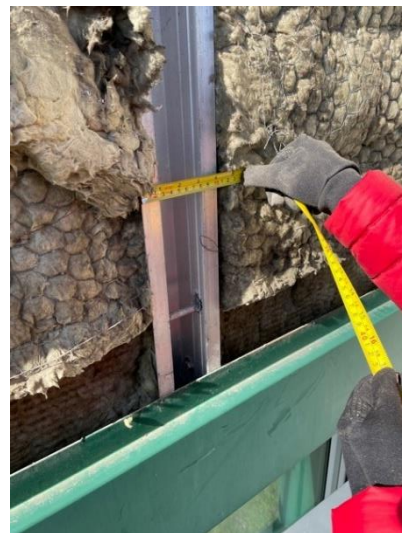
**Figure 33.** Location 2.2 100mm gap between cavity barriers

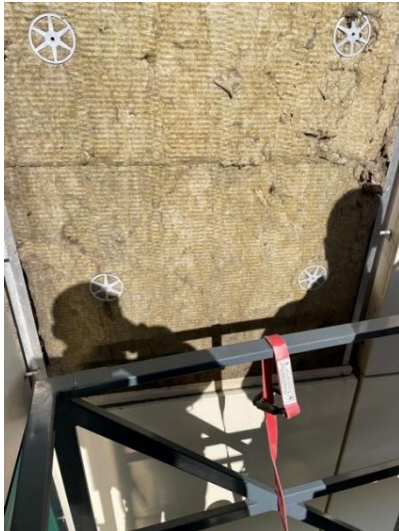
Location 3.1 was on the side elevation of the bin chute structure where a continuous strip of the aluminium cladding runs the full height of the building. No cavity barriers were found in this location.

**Figure 34.** Location 3.1 no horizontal cavity barrier at floor level

There were no cavity barriers or breaks identified at floor level or vertically in the continuous strips of cladding that ran the full height of the building. BB7 recommend that barriers are provided in these locations to prevent the unseen spread of fire and smoke.

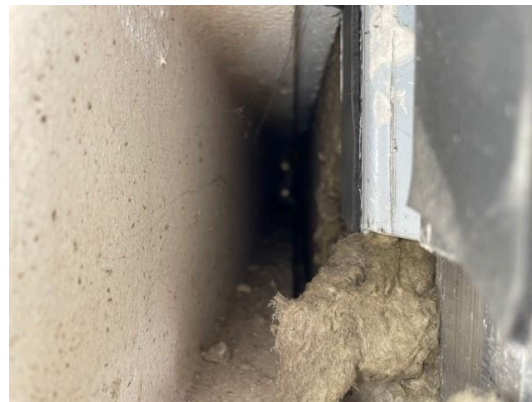
**Figure 37.** Location 3.1 steel beam (left) with insulation and panel (right) and unbroken cavity

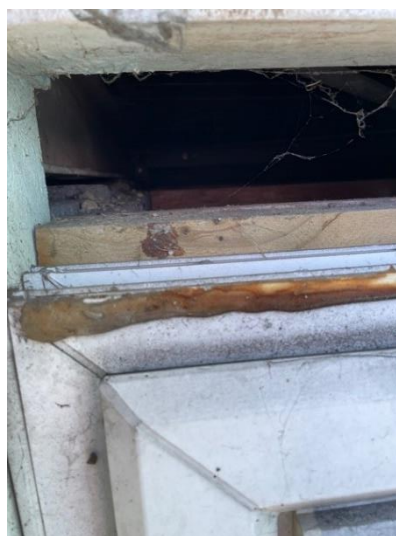
**Figure 39.** Location 3.2 open ceiling void
