Heat Loss & Insulation Survey

| 1- | 1-87 Regina Road, Croydon, SE25 4TY | | |

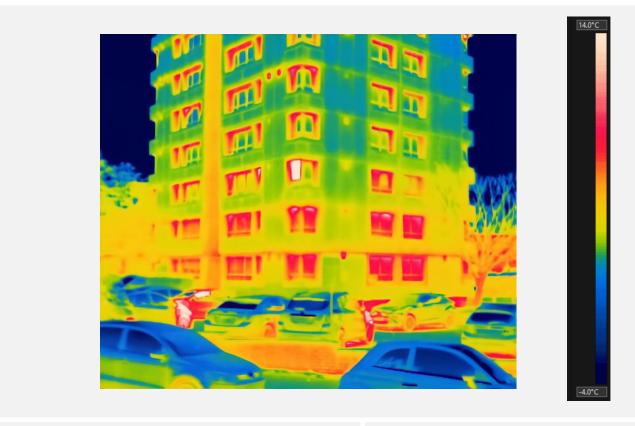
6: External – South and East Elevation
