Croydon Flood Investigations January - March 2014

Caterham Bourne Flood
Investigation

Final:
October 2014

Prepared for:
Croydon Council

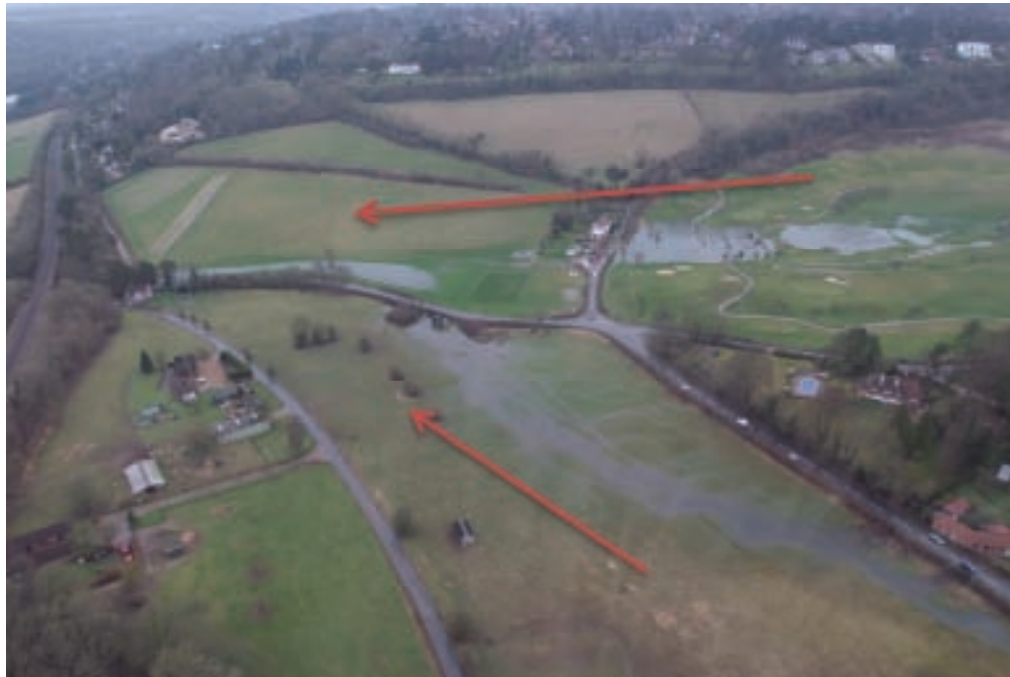
Figure 2.3: Groundwater emergence paths in Woldingham, February 2014

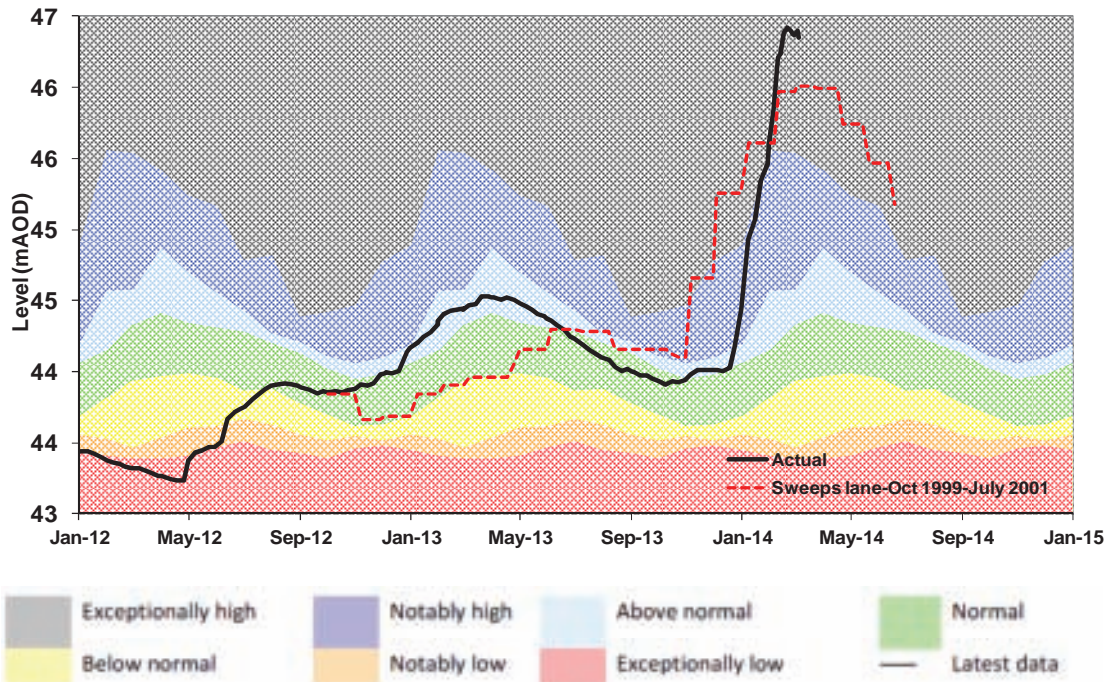
Figure 3.2: Hydrograph at the Sweeps Lane OBH indicating groundwater patterns in the Caterham Bourne area (Source: Environment Agency)

Weekly situation groundwater reports produced by the EA for the South London Boroughs include hydrographs illustrating the groundwater levels at EA groundwater observation boreholes (OBH). Figure 3.2 illustrates the rapid rise in groundwater in the Caterham Bourne area. The coloured section gives average data and shows how the groundwater normally behaves. The black line shows the rising levels experienced in early 2014 and the red dotted line shows the 2000/2001 groundwater levels (the last recorded major flood from the bourne).

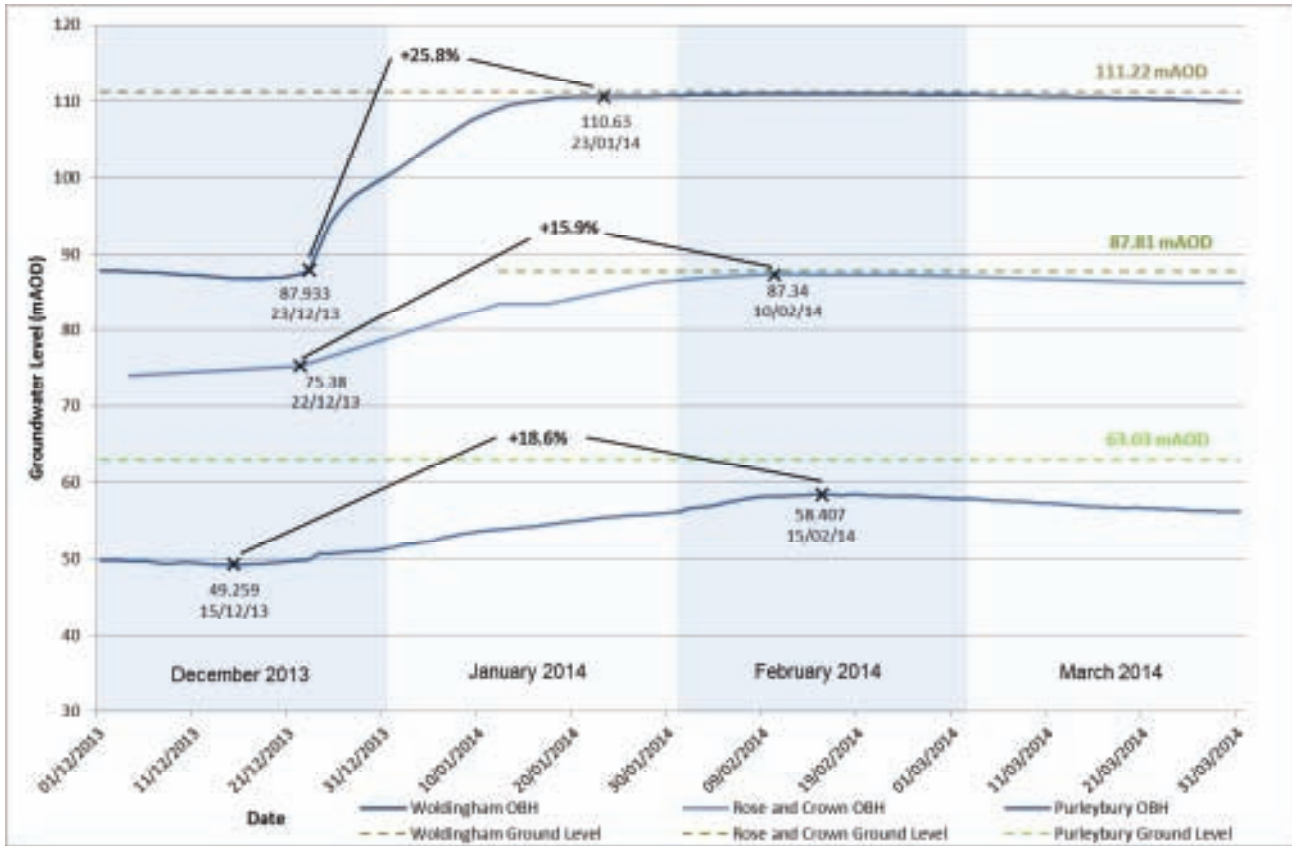
Figure 3.3: Groundwater Levels measured at the Rose and Crown, Woldingham OBH and Purleybury OBH

Figure 3.3 shows the groundwater level recorded at both OBHs, alongside readings from the Rose and Crown and demonstrates the rapid rise in water levels in the upper reaches of the catchment at Woldingham, where the water level rose by approximately 22.7m (26%) over the 32 day period from 23rd December 2013 to 23rd January 2014. The increase in groundwater level further down the catchment at the Rose and Crown and Purley Oaks was more prolonged, increasing by approximately 12m (16%) over 50 day period between 22nd December 2013 and 10th February 2014 at the Rose and Crown and approximately 9.2m (19%) over the 63 day period from 15th December 2013 to 15th February 2014 at Purley Oaks.

All three locations indicate elevated groundwater levels remained high throughout the period, up to and beyond March 2014. Whilst groundwater flooding subsided, the bourne continued to flow significantly until late April 2014. Some flow was observed alongside the Kenley Cricket Club during a site visit in July 2014, although upstream sections were dry through Bourne View Meadow.

The ground levels identified in Figure 3.3 are associated with the ground elevation at each of the boreholes. At these sites the data suggests that although close to the surface, the groundwater levels did not exceed ground level. It should be noted that the groundwater and ground level is as recorded at the borehole, and these will vary across the catchment. Therefore, whilst the borehole observations indicate that groundwater levels did not exceed ground level at these locations, there were reports of groundwater emergence at other non-monitored locations across the Caterham Bourne catchment during Winter 2013 / 14.

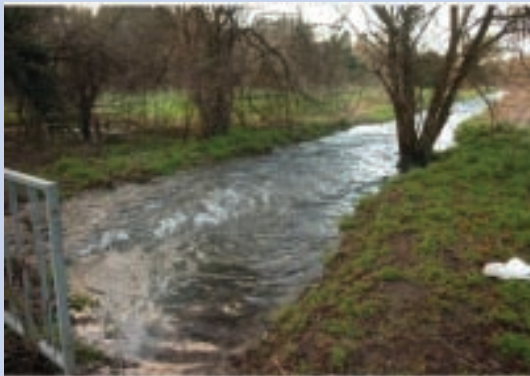
Open section of bourne flowing NW out of culvert at Bourne Park, February 2014

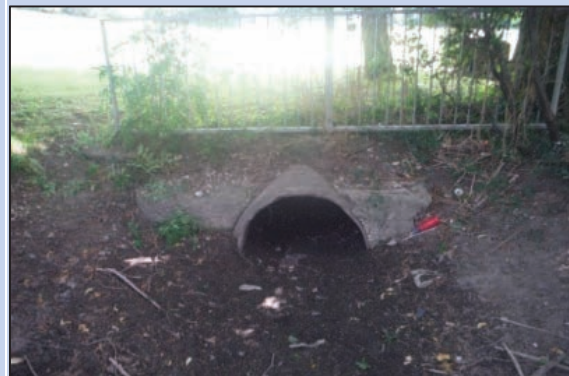
Silted culvert in Bourne Park following flood, July 2014

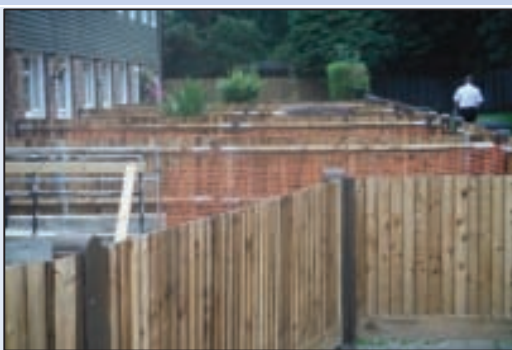
New fencing around gardens flooded by foul sewage in Bourne Park Close, July 2014

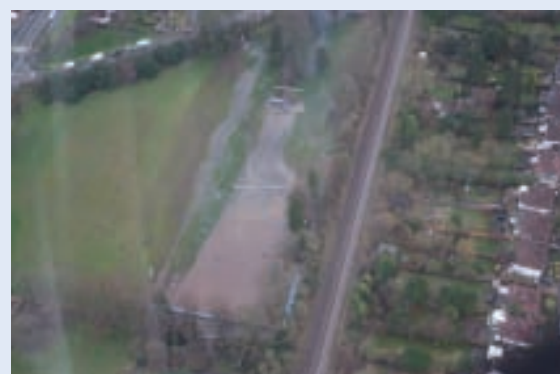
Aerial view of foul flooding in Bourne Park 14th February 2014

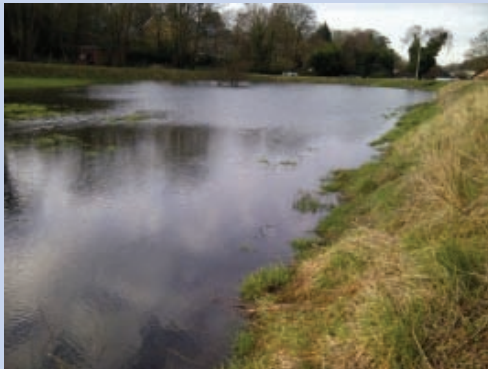
Bourne View flood storage area already filling up on January 18th 2014

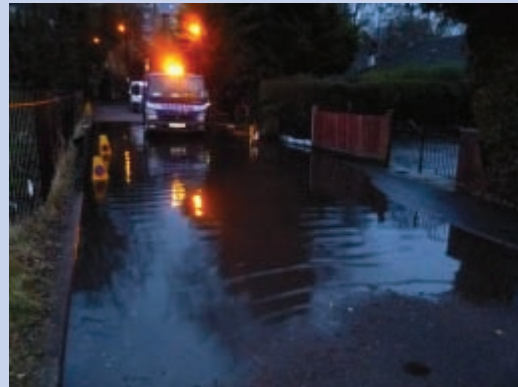
Bourne View on 9th February 2014

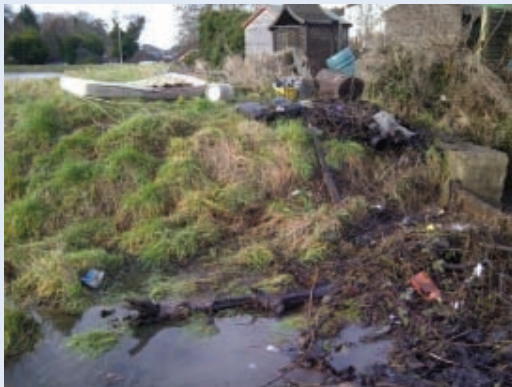
- The trash screen located before the bourne becomes culverted under Bourne View had to be regularly cleared to keep the Bourne flowing including removal of household waste items,

Fly tipping at Bourne View culvert on 18th January 2014

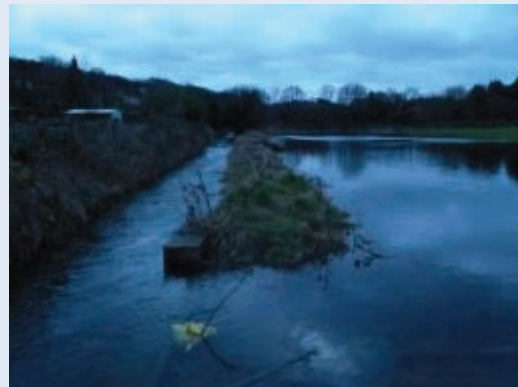
- The bourne has 2 sharp 90° changes as it enters the FSA. When the flow was very high, it flooded straight out of the bank, rather than following the channel. This may have been a measure originally put in to slow down flow before reaching Kenley WTW.

Water flowing from the bourne into the FSA on 9th February 2014

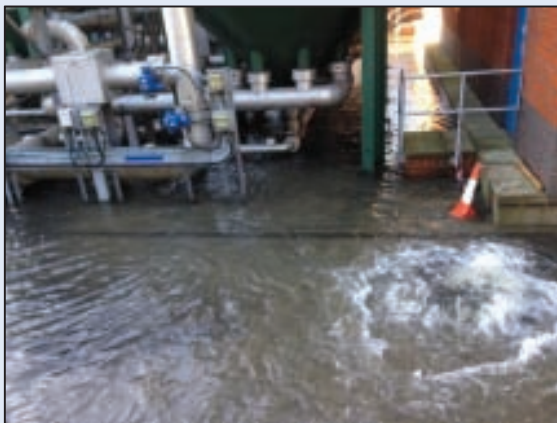
- Following flooding in 2000/1, SESW put in a new culvert in the previously open section between Bourne View and Kenley WTW,
- High flows in the bourne in February 2014 caused water to surcharge out of the culverted watercourse,
- Flooding from the bourne threatened to close down the WTW which supplies drinking water to 47,000 homes,
- Relief efforts were focussed on pumping water away from the works via pipes along Godstone Road, initially to the open section at the cricket club, then subsequently all the way to Purley Cross to an open section north of the railway line (see Box 4.8),
- It was estimated by gold command that if the works shut down, it would take 2-3 hours for the cone of depression to fill and thereafter an Olympic size pool of water would appear every couple of hours – potential for catastrophic flooding in Purley and Kenley.

Surcharging bourne culvert

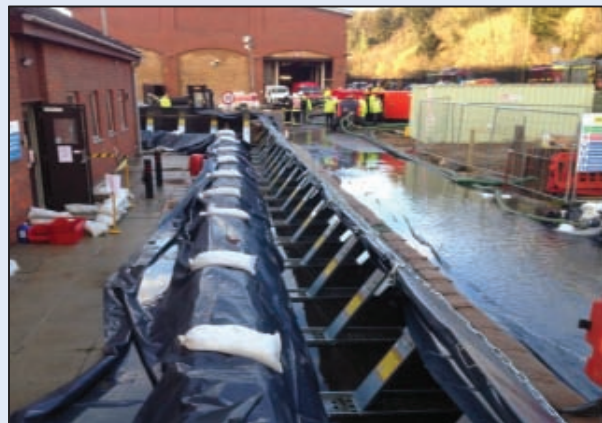
Demountable flood defences protecting the WTW

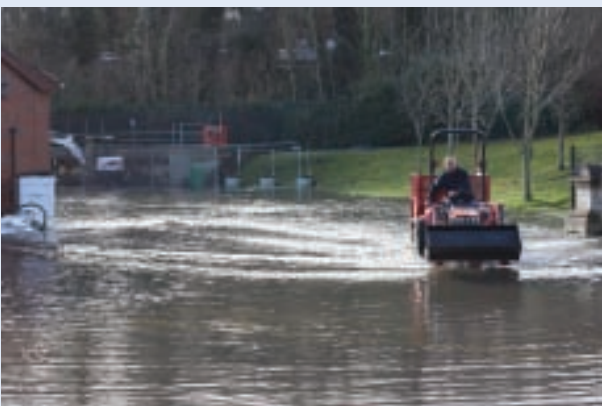
Floodwaters by main building at WTW in February 2014

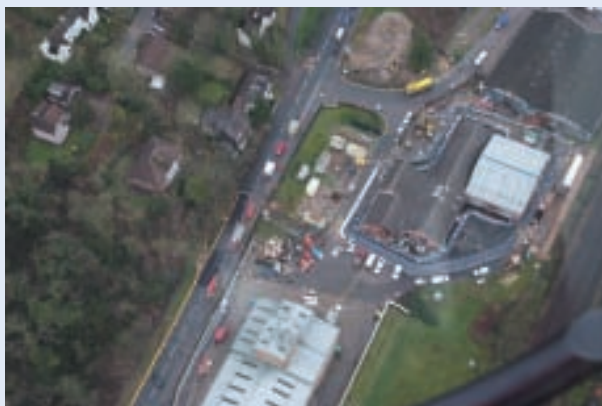
Aerial view of waterworks showing defences erected to protect infrastructure and pipes leading off down the A22 in February 2014

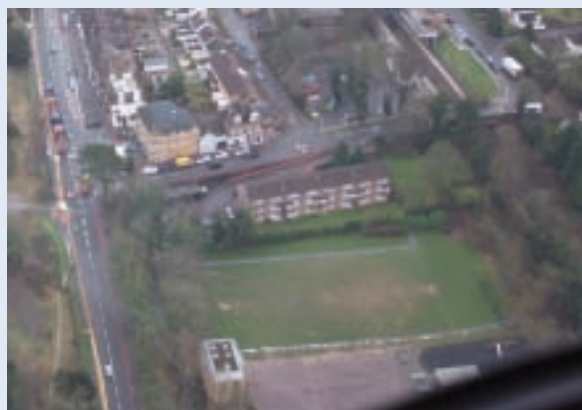
Temporary flood storage barriers set up around the school field

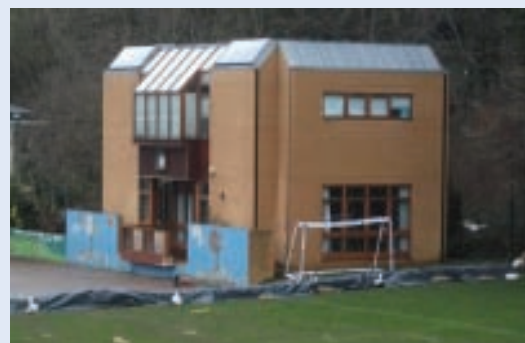
Temporary flood storage barriers set up around the school field

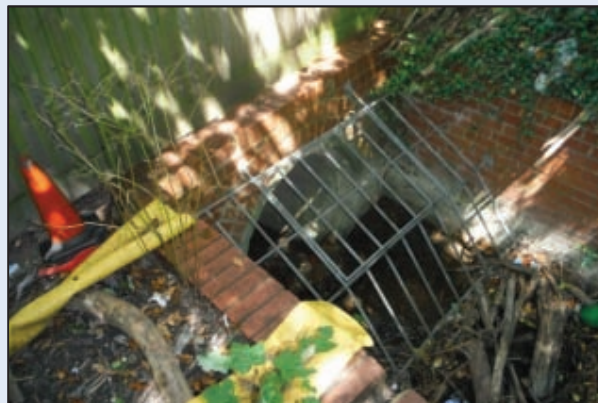
Culvert and Trash Screen downstream of Cricket Ground in January 2014

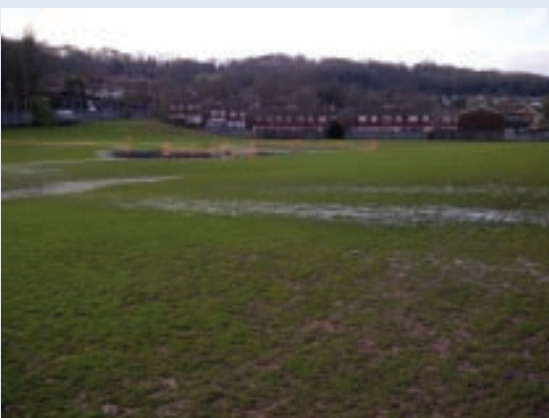
- Shallow flooding in cricket ground due to overtopping of the bourne and high groundwater,
- A sand bag wall was erected at the bottom of the north west sloping cricket ground,
- Flooding of the field was fairly shallow,
- A vented chamber to the foul sewer was observed along the western side of the field,
- Sewers were surcharging on Little Roke Road onto the highway only,
- Some surcharging from the bourne culvert where the route takes a sharp right angle turn between Lower Road and Little Roke Avenue but not considered significant.

Flooding to the Cricket Ground in January 2014

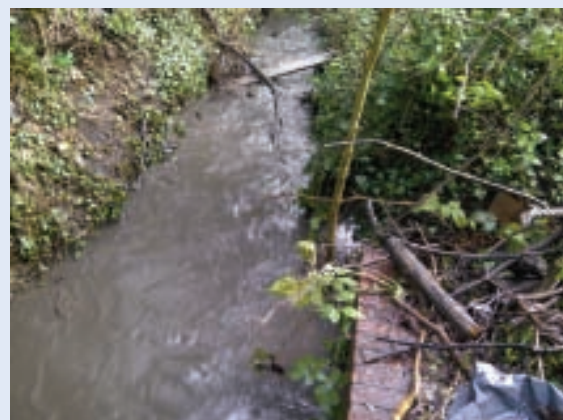
The bourne flowing alongside the Cricket Ground in January 2014

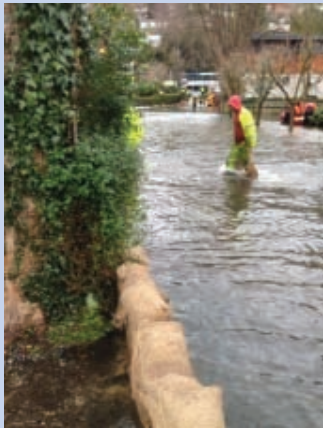
Response officers building sandbag walls in Dale Road in February 2014

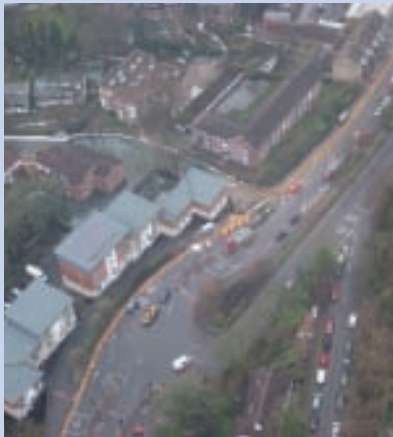
- Most significant flooding occurred in Dale Road,
- Approximately 56 properties were evacuated in this area,
- Depth of flooding was approximately 1m deep,
- A number of blocks of flats and surrounding parking and gardens were affected,
- The bourne culvert becomes smaller dropping from 900mm to 450mm. It is also a low point where a number of flow paths meet,
- The LFB pumped water intensively out of Dale Road to Purley Cross,
- Car park alongside the church was prepared to be used as a temporary FSA if evacuation plan were activated,
- The evacuation plan was temporarily commenced on 14th February 2014 when water levels became critical at the Waterworks. On this day, high floodwater flowed from Dale Road towards Foxley Hill Road leading to flooding of ground floor properties at Liddell Court.

Dale Road on 14th February 2014

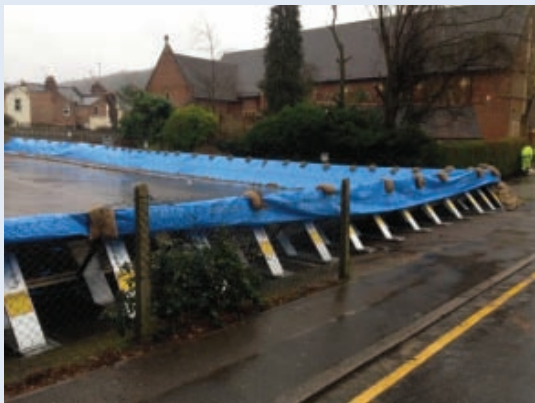
Church car park, emergency FSA

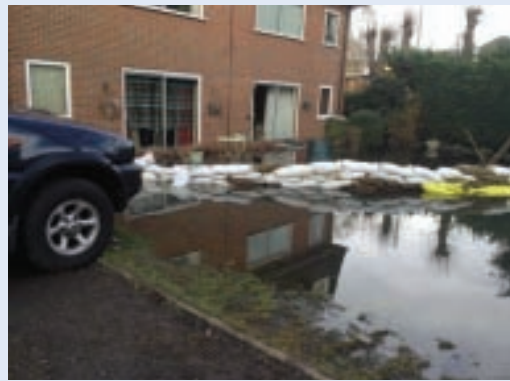
Flooding at rear of Liddell Court on Foxley Hill Road, February 2014

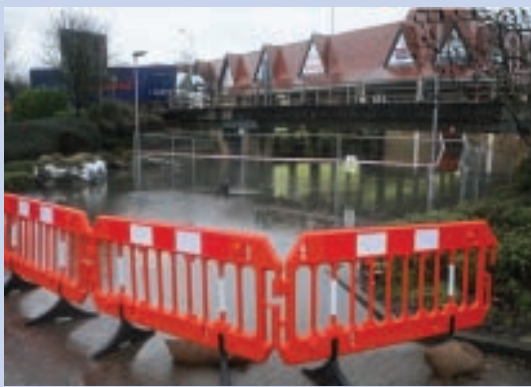
- Water being pumped out from Dale Road was diverted to a short open section of the bourne north of the railway line,
- The pedestrian underpass beneath Purley Cross roundabout was used as a temporary balancing pond to help manage the risk to Purley town centre and relieve pressure on Purley Oaks Pond further downstream,
- Water eventually drained away from the underpass through the existing system,
- Flooding of gardens and basements was reported to Croydon Council on Whytecliffe Road where the culverted route of the bourne continues north.

Inundation of the underpass at Purley Cross as a management measure to alleviate downstream flows towards Purley Oaks in February 2014

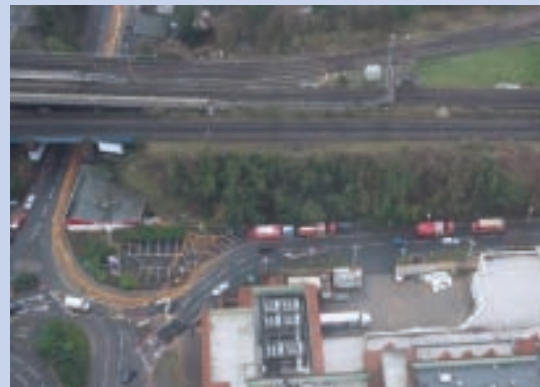
Water pumped from Dale Road and WTW around to an open section of the Bourne, north of the railway line in February 2014

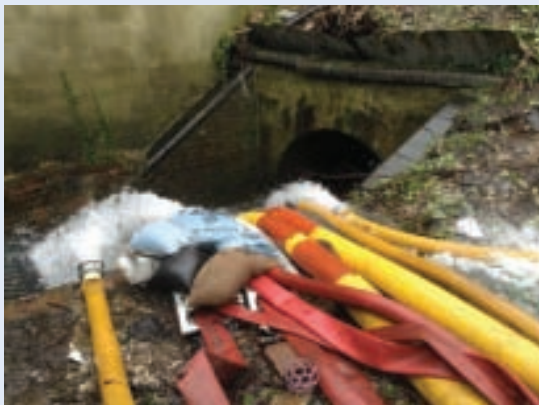
Water pumping into the bourne north of the railway line

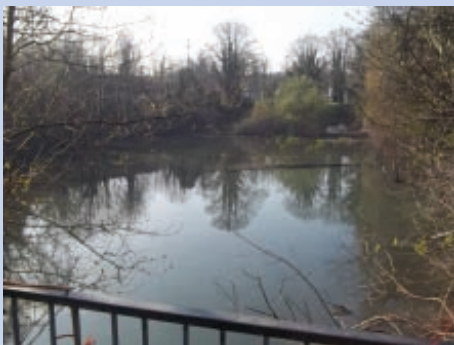
- The balancing pond at Purley Oaks quickly began to fill as flow in the bourne increased,
- Flows were fluctuating from upstream for a variety of reasons which were difficult to predict,
- There was uncertainty regarding how the pond should be functioning. It was determined that the pond was not draining as it was meant to and pumping operations were required to pump water out and back into the downstream drainage system,
- The pond overtopped onto the highway on one occasion on the 14th February 2014 causing shallow flooding,
- Temporary defences were erected along the western edge of the pond,
- There are inconsistencies at this site over ownership of assets between TWL and CC,
- It was later discovered the outlet pump was not functioning properly due to a missing power connection.

Balancing pond full during flood in February 2014

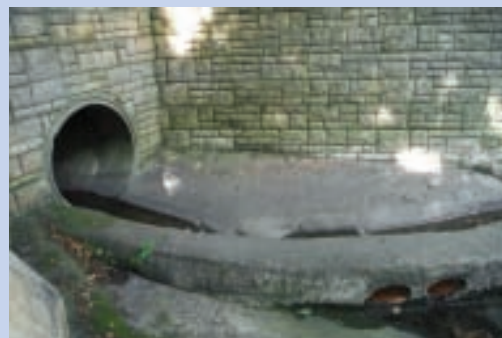
Culvert inlet to balancing pond after flood in July 2014

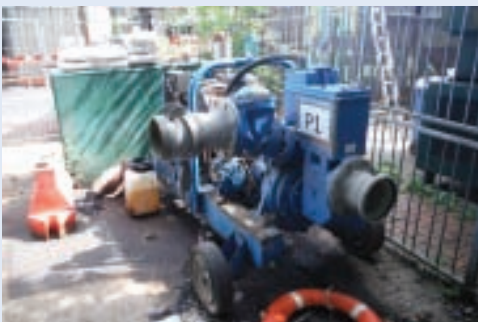
Pump provided by EM (CC contractor) used at Purley Oaks pond

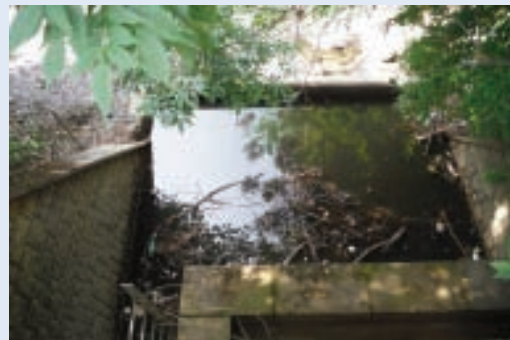
Sump area at north end of pond (July 2014)
