Croydon Flood Investigations Jan-Mar 2014

Merstham Bourne Flood
Investigation: Final report

February 2015

Prepared for:
Croydon Borough Council

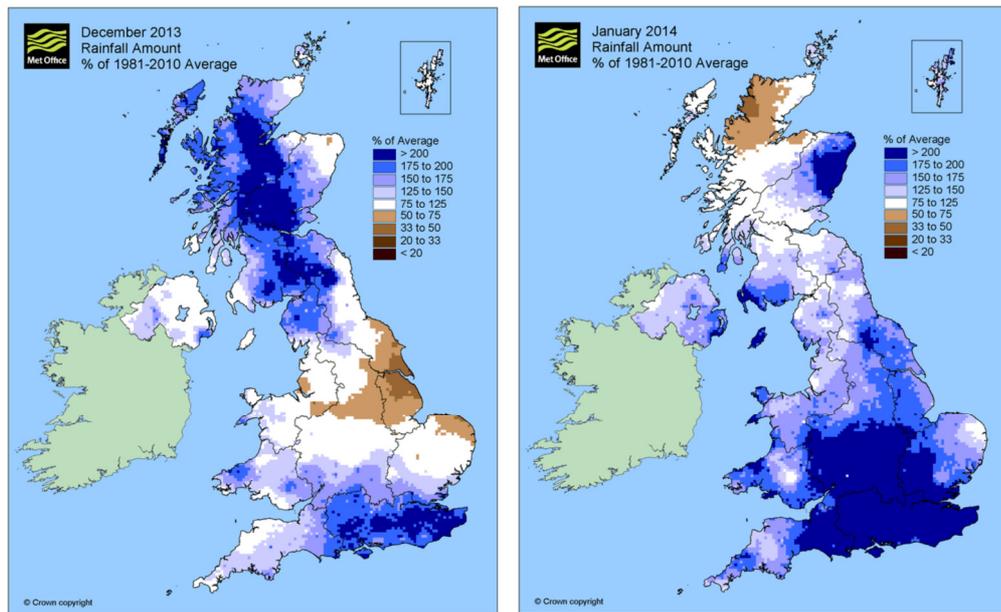
Figure 3.1: Rainfall for December 2013 and January 2014, showing the distribution of rainfall anomalies as a % of the long-term average from 1981-2010¹⁸

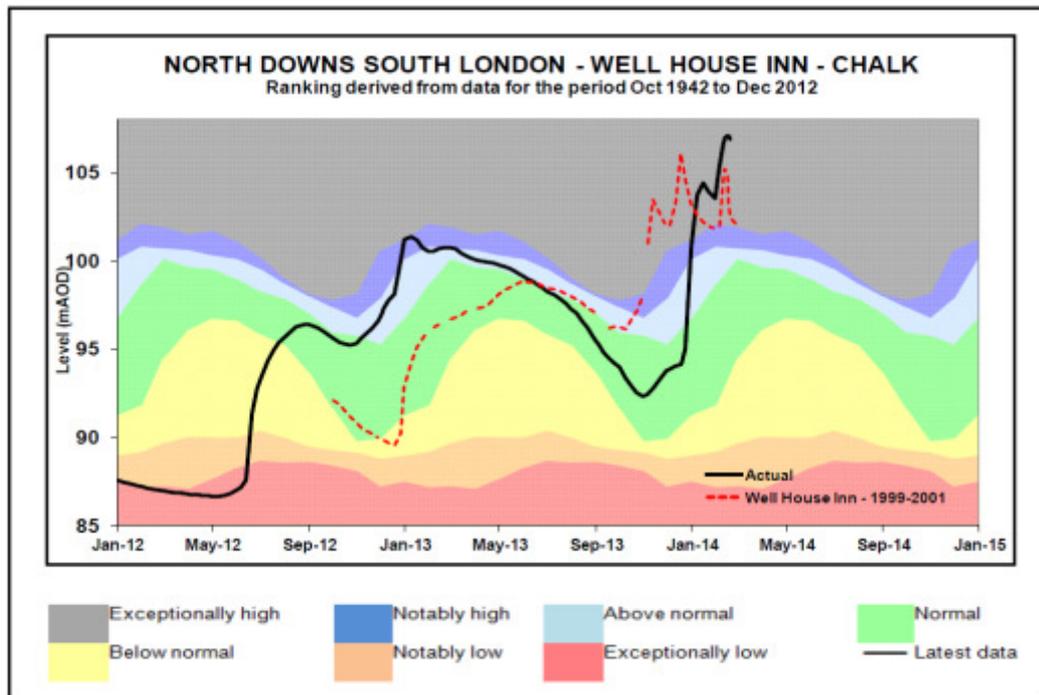
Figure 3.2: Hydrograph at the Well House Inn OBH indicating groundwater patterns in the Merstham Bourne area (Source: Environment Agency)

Figure 3.2 shows the groundwater level recorded at Well House Inn OBH, located South West of Coulsdon, and demonstrates the rapid rise in water levels from December 2013 to January 2014, followed by a brief drop in levels before continuing to rise in February 2014. The borehole indicates elevated groundwater levels remained high in March 2014.

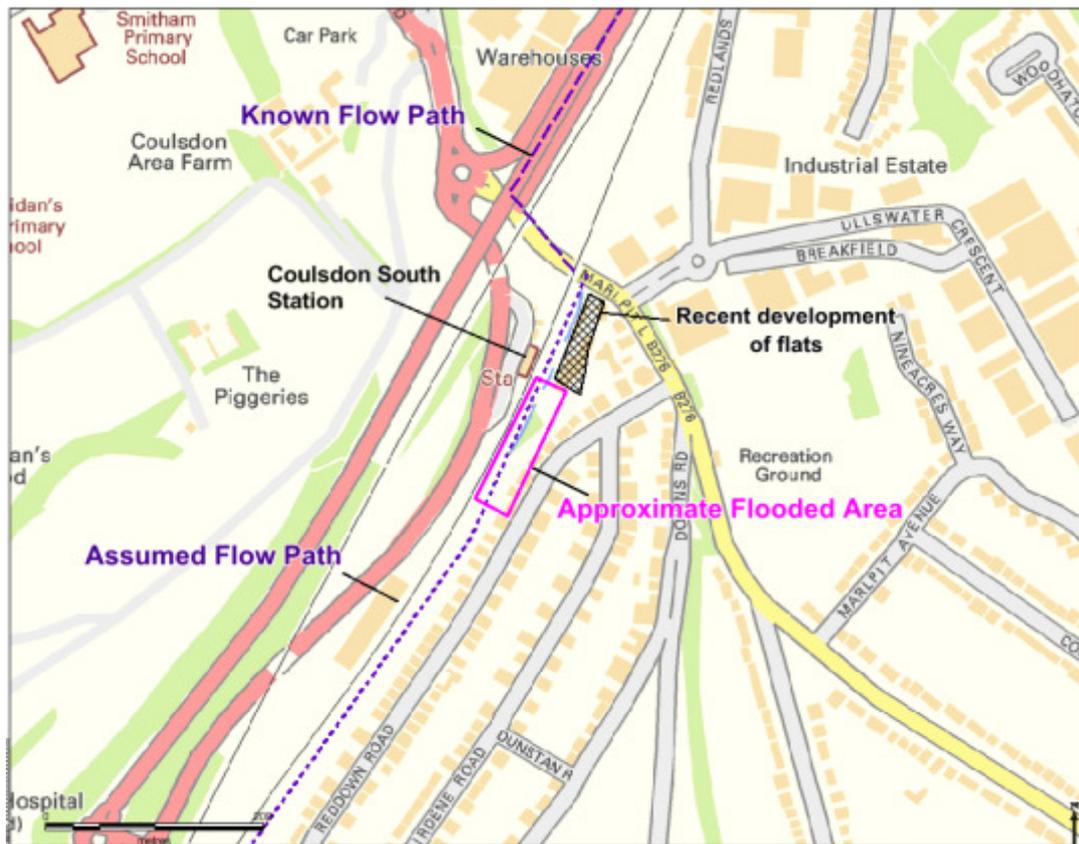
Figure 4-1: Approximate location of flooding in relation to the presumed route of the Merstham Bourne based on best available evidence.

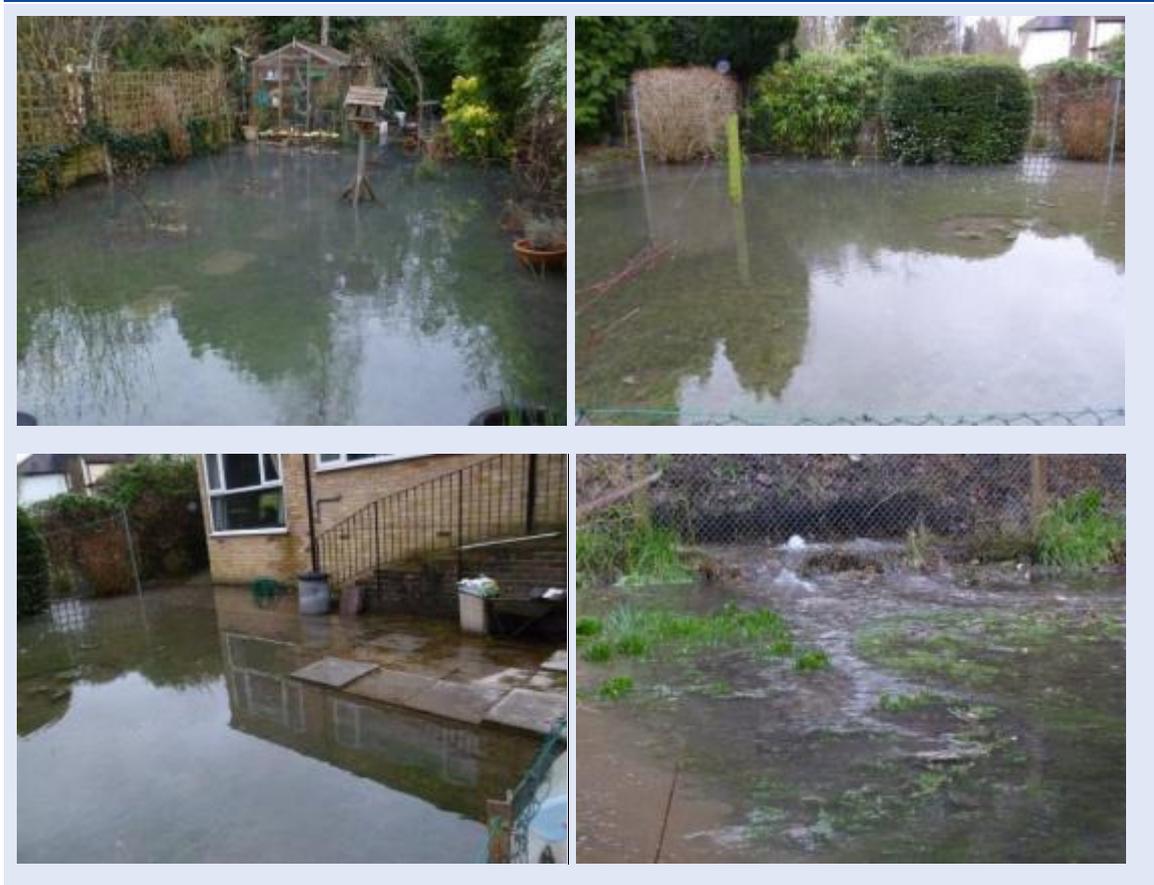
Box 4.1: Photos of flooded gardens on Reddown Road (Source: Croydon Council, February 2014)

Residents of Reddown Road in Coulsdon, whose properties back on to Network Rail (NR) land near Coulsdon South Station reported to Croydon Council that they were experiencing flooding in their back gardens during February 2014. It is understood that water began flowing into the gardens of numbers 20, 20A and 18 Reddown Road on 13th February, which coincided with a heavy rainfall event.

Water was observed gushing out of the ground in one spot by the railway embankment attributed to damage or crack to the culvert through which the Merstham Bourne flows underground. Water flowed along the back of the gardens of No.s 16 and 8A before draining into an open section of the Bourne. Water was observed at depths of up to 30cm. Flood waters remained for a number of weeks, and were not fully receded till late March 2014.

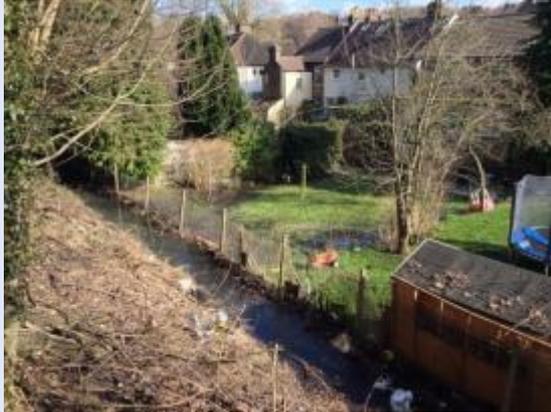
Merstham Bourne flowing between gardens of Reddown Road and the Railway embankment

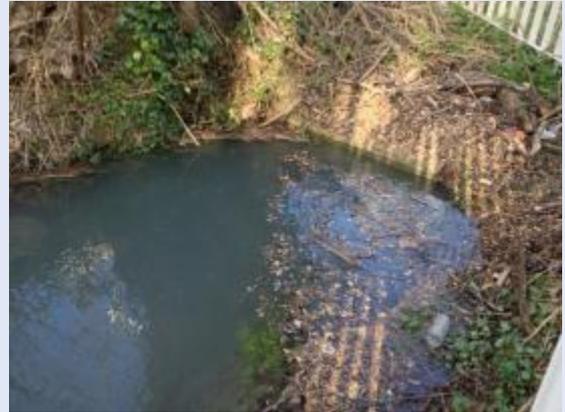
Overwhelmed culvert at open section of Bourne near Coulsdon South Station

NR has since advised that they have carried out widening work to the open ditch and created an additional channel above the damaged culvert to direct water to the open ditch section of the Bourne. They are also carrying out an ongoing investigation on the condition and size of a culvert following the railway lines.

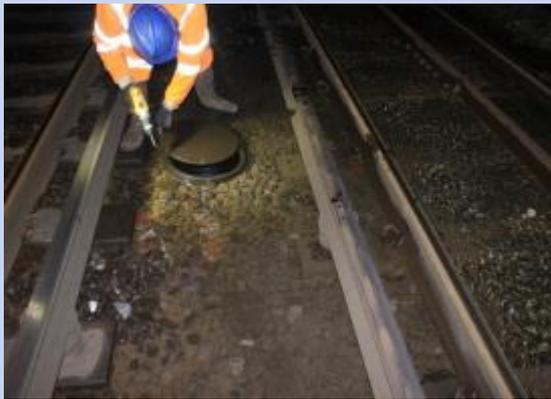
- A 530 metre length of railway was flooded between Woodplace Lane and Star Bridge (Nethern Drive) due to an overwhelmed culvert flowing north to Coulsdon South station, and,
- Flooding was experienced South of the Borough boundary near the north end of the Merstham Tunnel in Surrey.

Flooding of the track from culvert running beneath the railway line
