EWS1 Report

1-44 Bramley Hill

30th April 2021

Croydon Borough Council

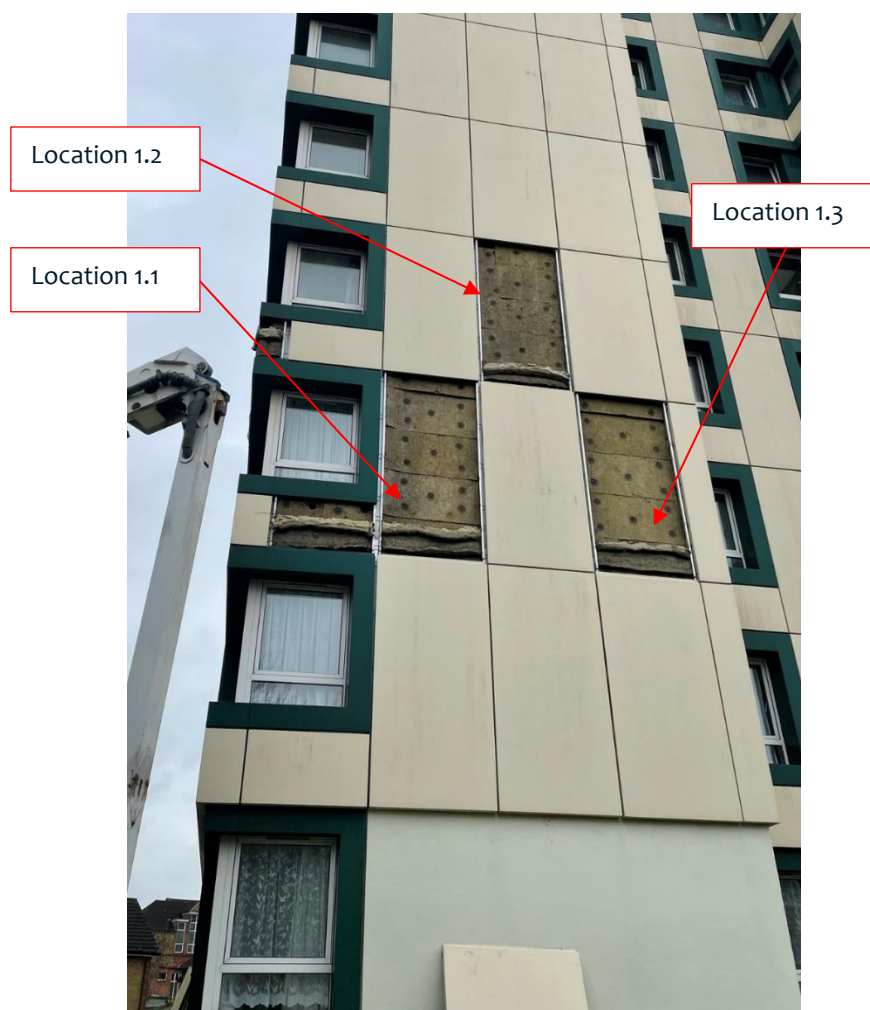
Figure 9. Location 1 areas inspected.

Location 1.1 was at the second-floor level where the cavity barrier between the first and second-floor level was identified. A horizontal cavity barrier was found in this location. The cavity barrier was found to abut the cladding support bracket.

Location 1.2 was at the third-floor level where the cavity barrier between the second and third-floor level was identified. A horizontal cavity barrier was found in this location. The cavity barrier was found to abut the cladding support bracket.

Location 1.3 was also at the second-floor level where the cavity barrier between the first and second-floor level was identified. A horizontal cavity barrier was found in this location. The cavity barrier was found to abut the cladding support bracket.

Cavity barriers at locations 1.1, 1.2 and 1.3 were found to consist of mineral wool, reinforced with wire, fixed to the underlying mineral wool insulation with metal fixings. One edge of the mineral wool cavity barrier is folded over so that it compresses onto the aluminium cladding to fill the full width of the cavity. One edge of the cavity barriers is folded over to achieve the compression. Cavity barriers should be fully folded, but only a lip has been folded over, or an edge. This is considered to be suitable because good compression is achieved and the barrier creates a good seal. It is considered that the cavity barriers folded like this would be effective in reducing the migration of fire and smoke.

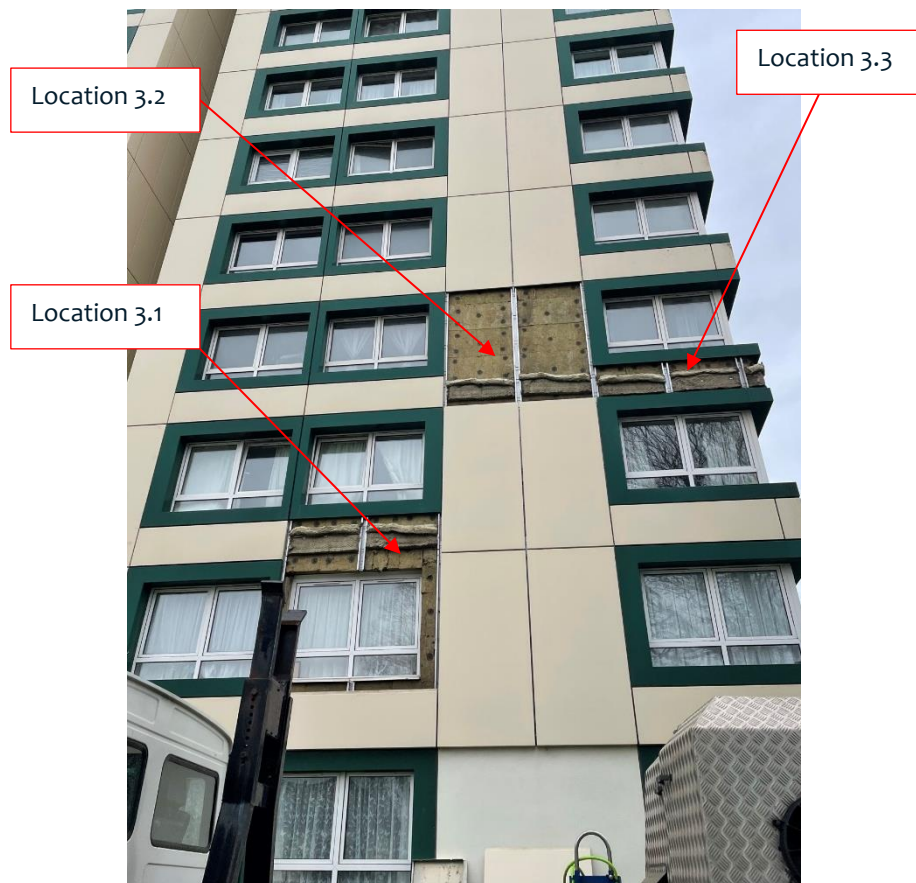
Figure 15. Location 1 areas inspected.

Location 3.2 was at the third-floor level where the cavity barrier between the second and third-floor level was identified. The underlying substrate, consisting of large panel system, was drilled to gauge the thickness of the concrete. It was found that the concrete was at least 100mm thick.

Consistent with location 1, cavity barriers were found to consist of mineral wool, reinforced with wire, fixed to the underlying mineral wool insulation with metal fixings. One edge of the mineral wool cavity barrier is folded over so that it compresses onto the aluminium cladding to fill the full width of the cavity.

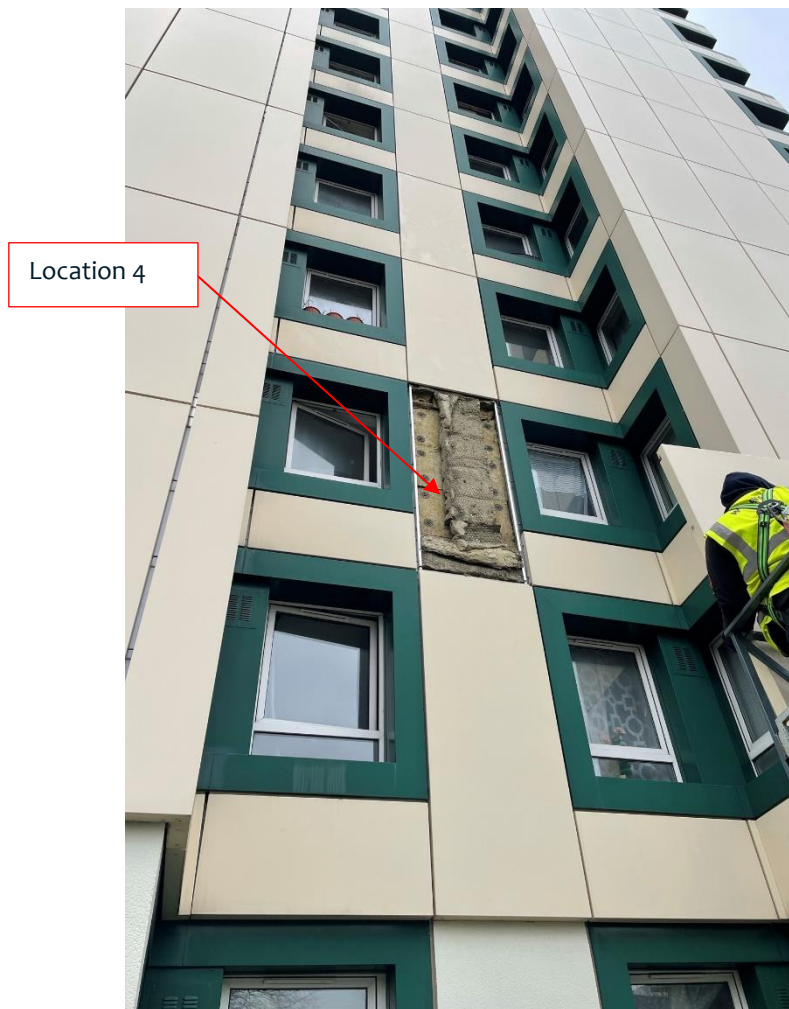
Figure 22. Location 4 inspected.

The vertical cavity barrier consists of the same mineral wool reinforced with wire. However in this location, as shown in figure 23 below, the cavity barrier is not folded along a section of it. This means that the cavity barrier would not fit compressed against the aluminium cladding panel, leaving a gap for fire and smoke to spread horizontally within the cavity. The risk is considered to be tolerable considering that it is only the vertical cavity barrier and the critical direction is vertically and not laterally. Horizontal cavity barriers were found to be compressed, meaning that any fire/smoke spread would be restricted to the cavity of the adjacent flat only and not flats above.

There was also one issue identified concerning a vertical cavity barrier seen. As shown in figure 23, the cavity barrier is not folded along a section of it. This means that the cavity barrier would not fit compressed against the aluminium cladding panel, leaving a gap for fire and smoke to spread horizontally within the cavity. The risk is considered to be low and tolerable considering that this only relates to the vertical cavity barrier, and lateral fire spread is less critical. Horizontal cavity barriers were found to be compressed, meaning that any fire/smoke spread would be restricted to the cavity of the adjacent flat only and not flats above.

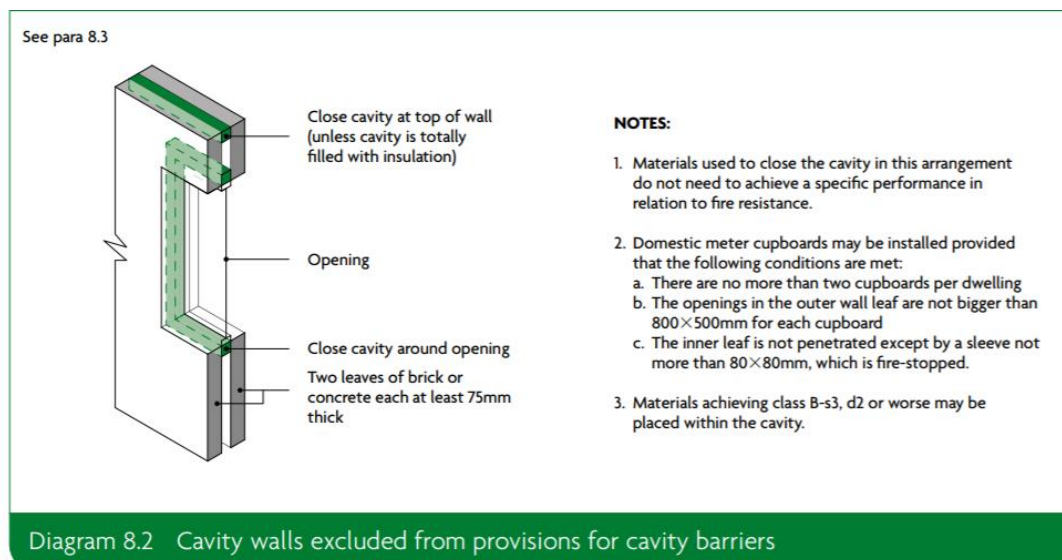
It was noted that there were panels wrapped around the building above the flat windows. This created a gap between the concrete panel of approximately 30mm. In one location, a small amount of EPS was found behind the panel, however, this was not typical.

The risk of the limited amount of combustible insulation is considered to be low due to the robustness offered by the masonry. This is considered to be justifiable based on the following figure which permits combustible insulation within the cavity between two leaves of masonry.

Figure 29. Diagram 8.2 - ADB
