EWS1 Report

1-44 Grosvenor Road

30 April 2021

12125BB

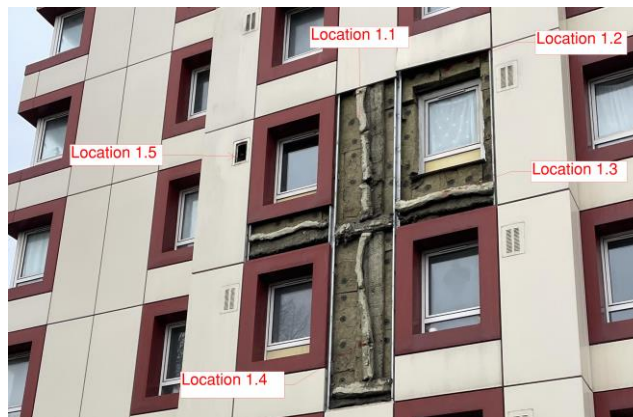
- 5mm solid aluminium cassette panel attached to aluminium rail system.
- 100mm horizontal (floor level) and vertical (party wall) mineral wool cavity barrier reinforced with wire. The cavity barrier sat on top of the insulation (i.e. did not break the insulation) and was under compression.
- 60-70mm clear cavity.
- 110mm mineral wool insulation with metal fixings.
- 100mm RC structure. A hole was drilled through the concrete to determine the thickness in a number of locations, however, it could not be further determined what was behind the concrete without potentially compromising the integrity of the structure and causing damage internally. Please refer to Section 3 for further details.

Figure 9. Location 1 areas inspected

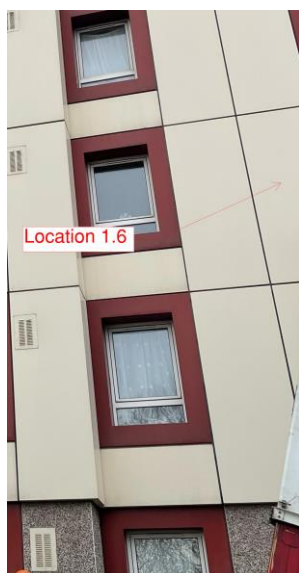
Location 1.6 was further over on the East elevation.

Figure 24. Location 1.6 area opened up

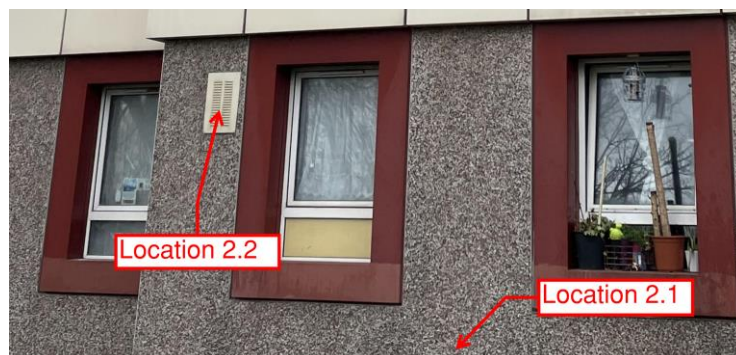
- 3-5mm render
- 100mm yellow PIR style rigid insulation
- No cavity or cavity barrier identified
- Original RC structure.

Figure 26. Location 2 areas reviewed

It is recommended that the render systems should be replaced with a non-combustible system.

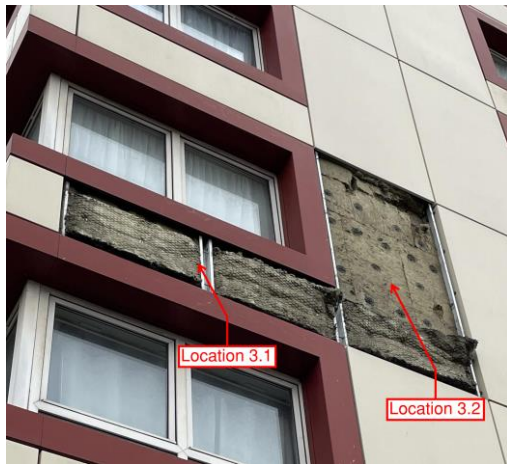
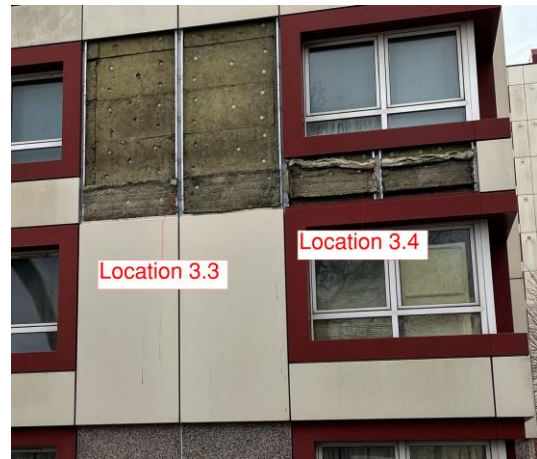
- 5mm solid aluminium cassette panel attached to aluminium rail system.
- 100mm horizontal (floor level) and vertical (party wall) mineral wool cavity barrier reinforced with wire. The cavity barrier sat on top of the insulation (i.e. did not break the insulation) and was under compression.
- 60-70mm clear cavity.
- 110mm mineral wool insulation with metal fixings.
- >100mm RC structure.

Figure 31. Location 3 areas reviewed

Figure 32. Location 3 areas reviewed
