EWS1 Report

1-44 Messer Court

30th April 2021

Croydon Borough Council

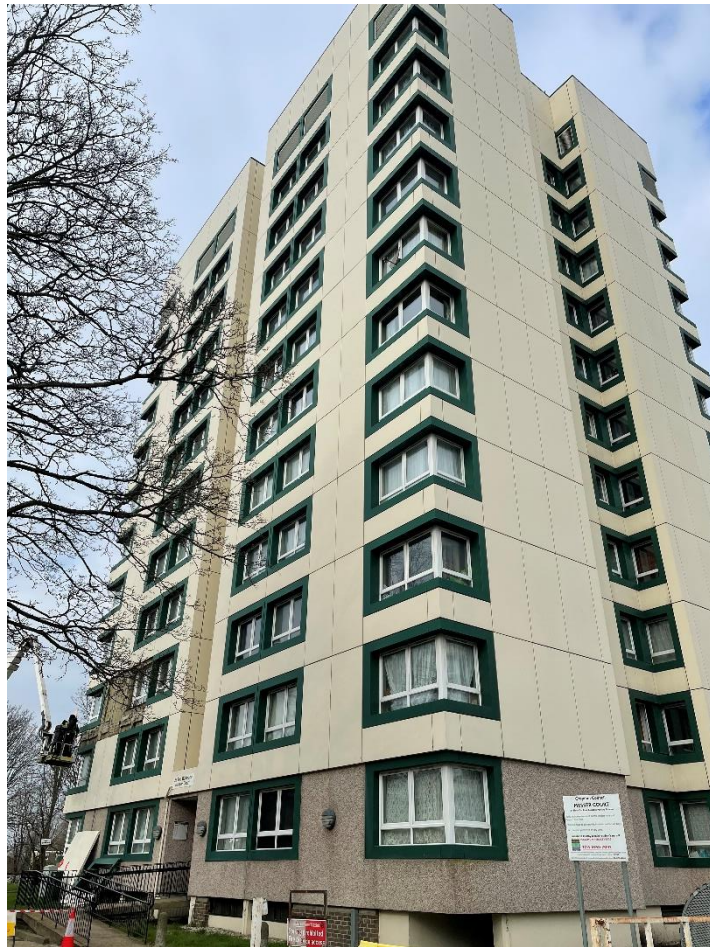
Figure 1. Block overclad. Presumed circa late 1990's

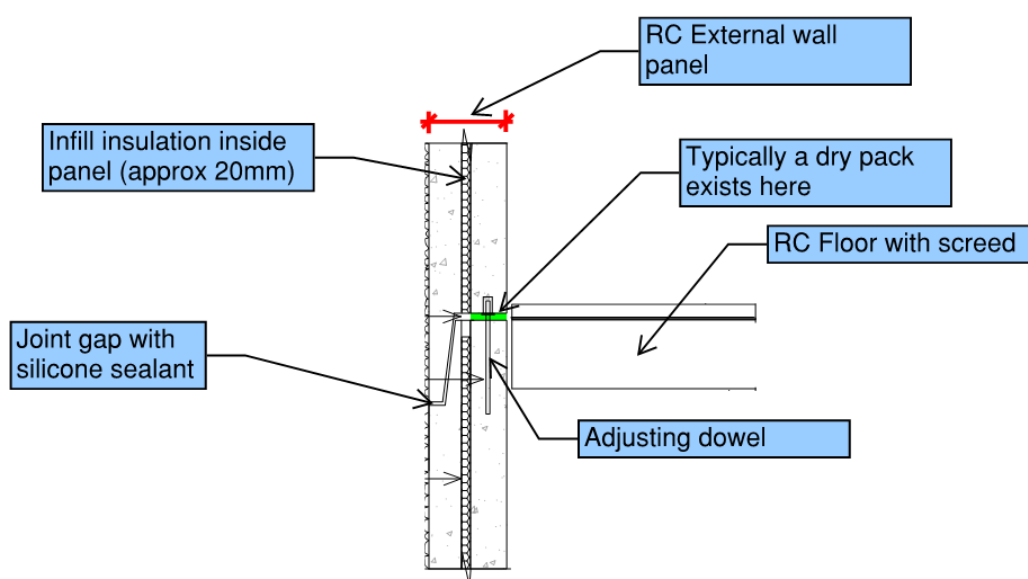
Figure 4. Typical composition of external walls

It can be seen that there is a thin insulation layer within the panel itself and there is a path to this cavity from outside at the joint gap. This insulation is typically a form of EPS or XPS which is a highly combustible substance, however, it is encapsulated between two >100mm leaves of RC which means it is offered a significant degree of protection. The cavity in which the insulation exists is generally 20mm wide, but this can vary across the different manufacturers. Based on making drill holes at the building it was found that the cavity was within the 20-25mm range. There is a route for fire spread via the joint between panels, the silicone sealant used is of a substantial volume and will offer some fire resistance into the panel system, however, a period of time cannot be determined. Typically, a dry pack is present which aids in preventing fire re-entry into the building.

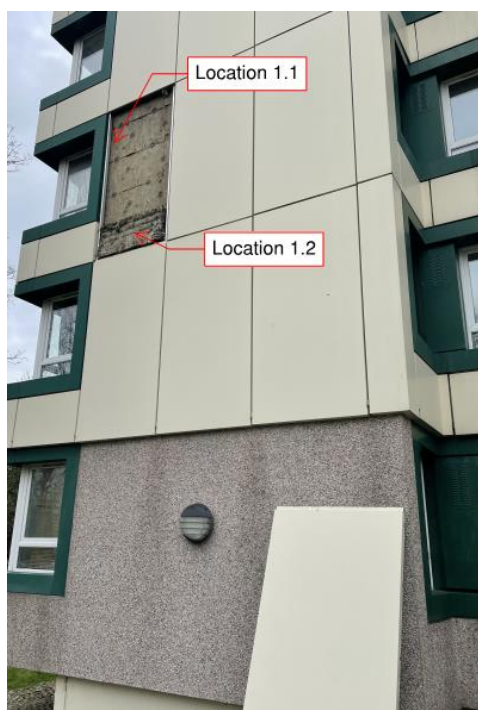
Figure 9. Location 1 areas inspected

- 5mm solid aluminium cassette panel attached to aluminium rail system which prevents cavity barriers spanning the full width of the cavity at floor level.
- 100mm horizontal (floor level) mineral wool cavity barrier reinforced with wire. The cavity barrier sat on top of the insulation (i.e., did not break the insulation) and was not under compression.
- 60-70mm clear cavity.
- 100mm mineral wool insulation with plastic fixings.
- >100mm solid concrete. A hole was drilled through the concrete to determine the thickness, however, it could not be further determined what was behind the concrete without potentially compromising the integrity of the structure and causing damage internally. Please refer to Section 3 for further details.

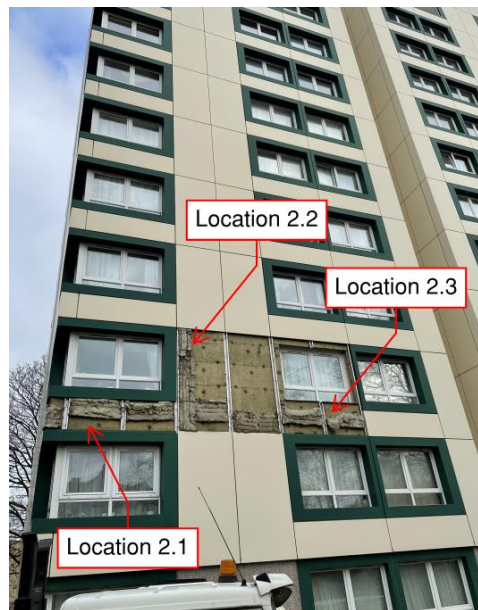
Figure 14. Location 2 areas inspected

- 5mm solid aluminium cassette panel attached to aluminium rail system.
- 100mm horizontal (floor level) mineral wool cavity barrier reinforced with wire. The cavity barrier sat on top of the insulation (i.e., did not break the insulation) and was not under compression.
- 60-70mm clear cavity.
- 100mm mineral wool insulation with plastic fixings.
- 100mm solid concrete. A hole was drilled through the concrete to determine the thickness, however, it could not be further determined what was behind the concrete without potentially compromising the integrity of the structure and causing damage internally. Please refer to Section 3 for further details.

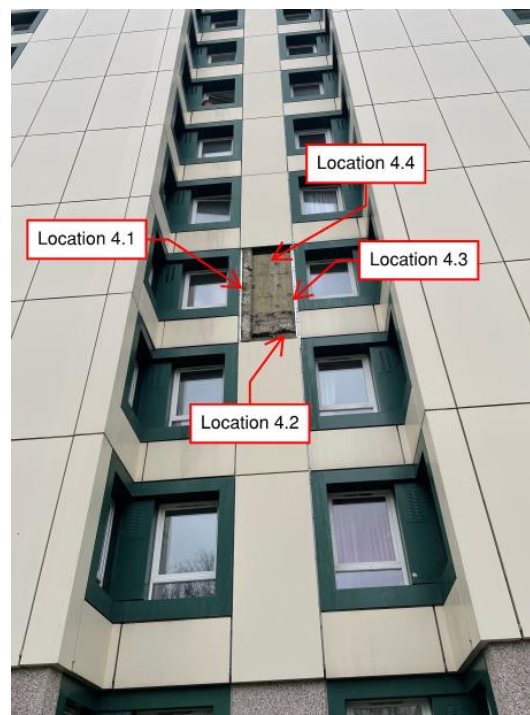
Figure 29. Location 4 areas inspected

Although a compartment line exists here between two flats, one vertical cavity barrier was observed around the window opening only. There was no vertical cavity barrier at the compartment line or around the adjacent window opening. However, it is considered reasonable to assume that the single vertical cavity barrier was not intended to perform as a cavity barrier around the window opening but as a cavity barrier along the compartment line instead. This approach is not considered to pose a significant fire risk to occupants as the barrier does divide the cavity between the compartments and is fitted under compression.

A horizontal cavity barrier was also observed at slab level.

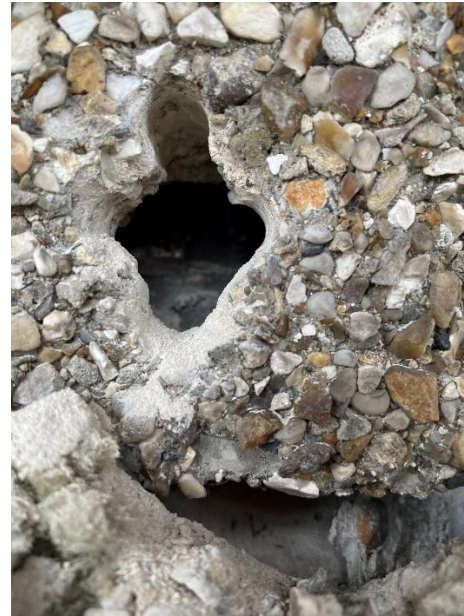
Figure 37. Location 4.4 drill hole through the stone cladding system

The mineral wool insulation does not fully cover the original external wall system as has been seen in other locations. This exposes the join line between the panels (see Section 3). The join line indicates these are LPS construction. However, Figure 37 shows the panels are not two 100mm leaves of RC either side of 20-25mm EPS or XPS as discussed in Section 3.

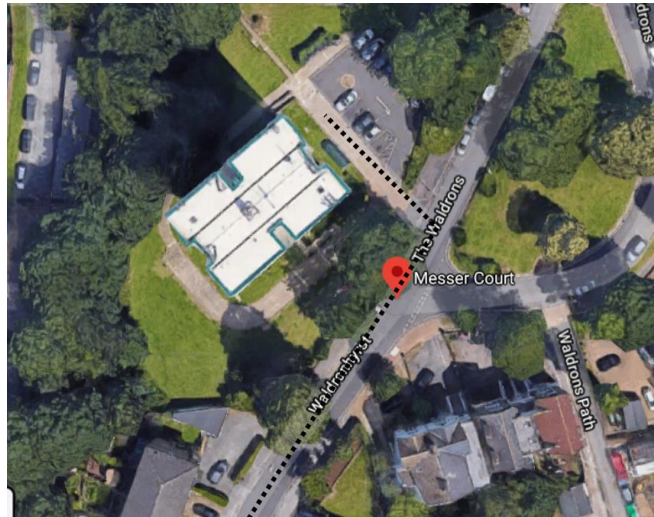
Figure 46. Site Plan

The building is bounded by one road only, The Waldrons, and the car park. This is considered to be limited vehicle access to the building's perimeter.
