# **EWS1 Report**

**1 – 44 Violet Lane**

**30<sup>th</sup> April 2021**

**Croydon Borough Council**

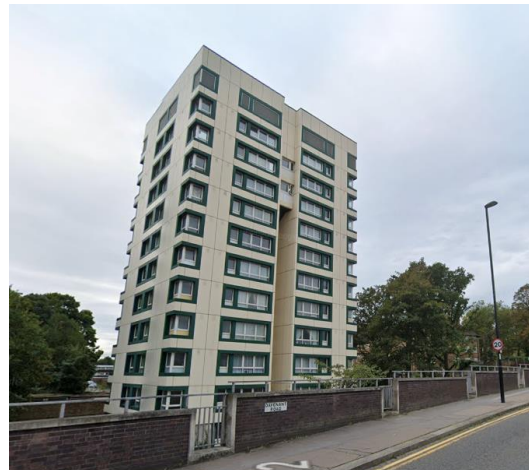
**Figure 2.** Blocks re-clad. Presumed circa late 1990s.

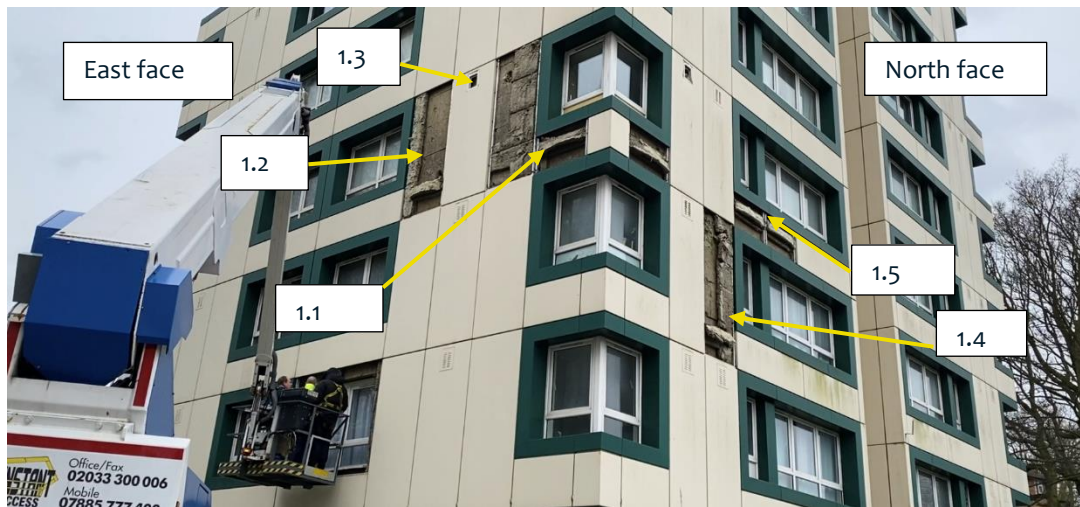
**Figure 9.** Locations 1 and 2 area inspected

Location 1.1 was at the 2<sup>nd</sup> floor under a flat window. Horizontal cavity barriers were identified at floor level. However, no cavity barriers were found around the window opening. Based on information from the contractor the re-cladding took place in the late 1990's, the guidance at this time did not require cavity barriers around openings. The barrier under the opening at compartment floor level was partially folded rather than fully folded along its axis. It is considered that this will still provide an effective break in the cavity.

It should be noted that sections of the horizontal barriers between locations 1.1 and 1.4 were not found to be folded, and therefore it is not fitted under compression. The cavity barrier is unlikely to provide effective resistance against fire and smoke spread.

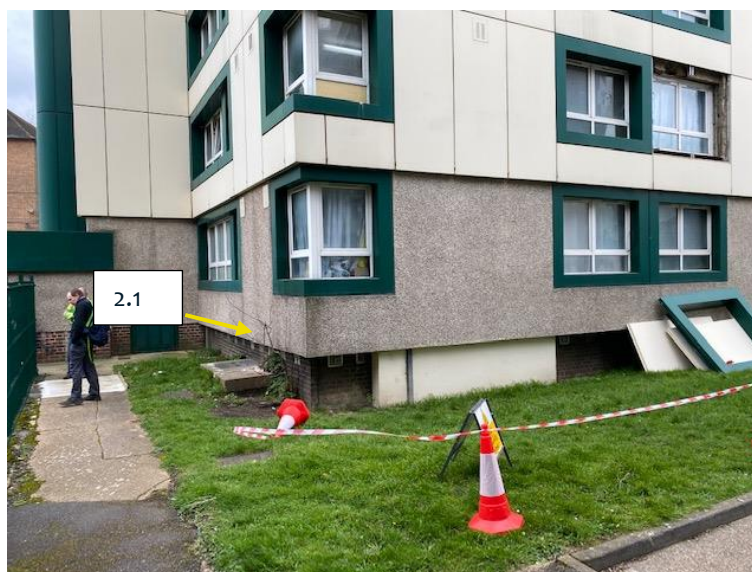
**Figure 18.** Location 2 areas reviewed

- 3-5mm render
- 150mm of insulation consisting of 20mm PIR style rigid insulation and 125mm of expanded polystyrene.
- No cavity barriers were identified.
- Original RC structure.

Material	Combustibility	Volume	Comments	Recommendations
100mm concrete / masonry	Euroclass A1 to BS EN 13501-1	All locations	Due to the non-combustibility BB7 consider that this item is low risk in terms of uncontrolled fire spread. Please note that there is likely a thin EPS insulant and expanded polystyrene between two >100mm layers of RC in the structure which is Euroclass E. Due to the encapsulation of this layer and the protection offered by the mineral wool this layer has been discounted as it is very unlikely to contribute to fire.	Combustible render systems should be replaced with a non-combustible system.
PIR & EPS insulants insulation with 3-5mm render	Typically, Euroclass E - F to BS EN 13501-1	All locations	Combustible insulation behind render with no break or cavity barrier identified at compartment walls.

**It is recommended that the render systems should be replaced with a non-combustible system.**
