EWS1 Report

1-87 Belgrave Road

30th April 2021

Croydon Borough Council

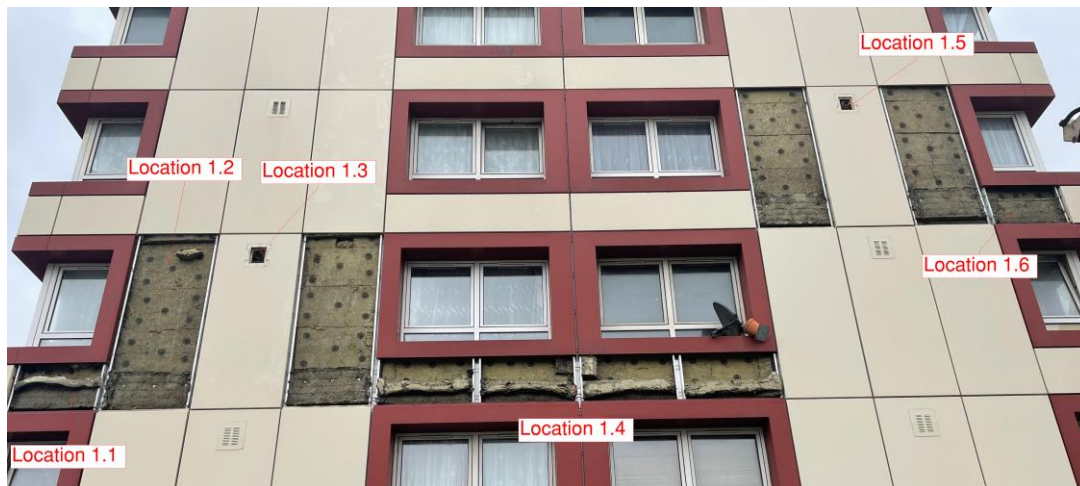
Figure 9. Location 1 area inspected

Location 1.1 was at the 2nd floor under a flat window. Horizontal cavity barriers were identified at floor level. However, no cavity barriers were found around the window opening. Based on information from the contractor the re-cladding took place in the late 1990's, the guidance at this time did not require cavity barriers around openings. The barrier under the opening at compartment floor level was partially folded rather than fully folded along its axis. It is considered that this will still provide an effective break in the cavity.

Location 1.2 was behind a large panel between flat windows on the 2nd floor. A horizontal cavity barrier was found at 3rd floor level. There was no vertical cavity barrier around the window as per location 1.1. This was on the elevation of a single flat, therefore, a vertical cavity barrier was not expected. The horizontal barrier above this point which was partially obscured by the cladding above was not found to be folded, and therefore it is not fitted under compression. The cavity barrier is unlikely to provide effective resistance against fire and smoke spread.

Location 1.4 was at the party wall between flats on the 2nd floor and both horizontal and vertical cavity barriers were identified. The cavity barriers at floor level sat between the aluminium rails (i.e. they were not continuous) and the vertical cavity barrier sat on the party wall between flats. It was found at this location that there are intermediate rails which are not open to fresh air and form a cavity between two windows. This will be addressed in Section 8 of this report.

It should be noted that the horizontal barriers between locations 1.1 and 1.4 were not found to be folded, and therefore it is not fitted under compression. The cavity barrier is unlikely to provide effective resistance against fire and smoke spread.

Location 1.6 was under the flat window at 3rd floor level. Horizontal cavity barriers were identified, however, they were not folded over and unlikely to be under compression behind the panel. They also sat between the aluminium rails so were not continuous, but the barriers were found to be sat flush with the insulation.

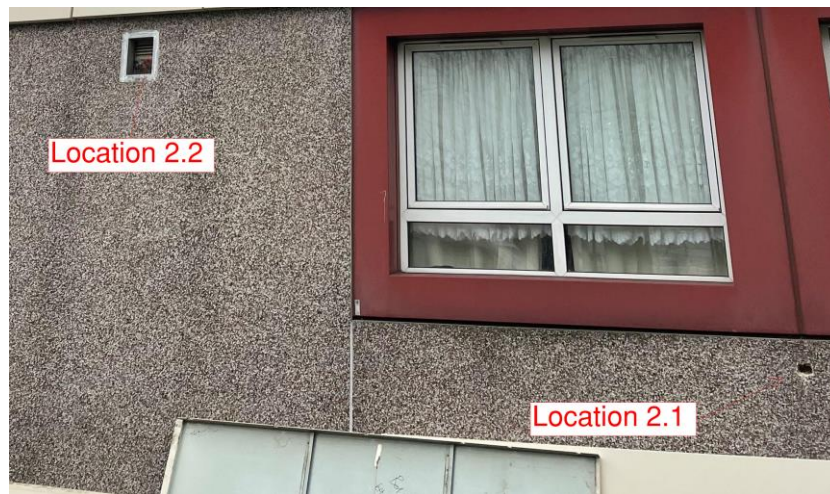
Figure 23. Location 2 areas reviewed

- 3-5mm render
- 150mm yellow PIR style rigid insulation
- No cavity barriers were identified
- Original RC structure.

It is recommended that the render systems should be replaced with a non-combustible system.

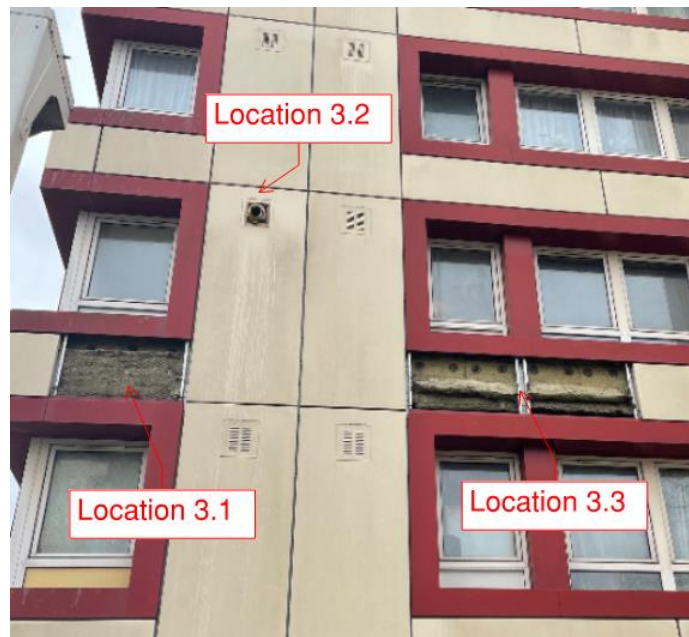
Figure 28. Location 3 areas reviewed

- 5mm solid aluminium cassette panel attached to aluminium rail system.
- 70mm horizontal (floor level) and vertical (party wall) reinforced mineral wool cavity barrier. The cavity barrier sat on top of the insulation (i.e. did not break the insulation) and was under compression.
- 60-70mm clear cavity.
- 110mm mineral wool insulation with metal fixings.
- >100mm RC structure.

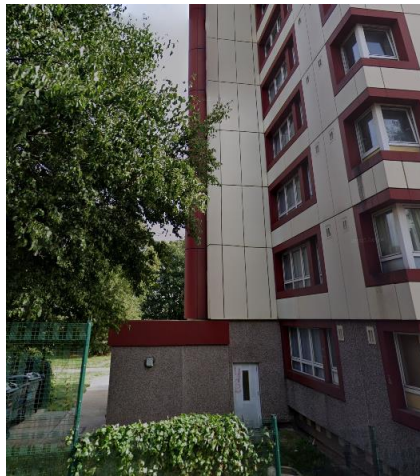
Figure 34. Bin chute & lobby side wall

Location 4 was on the bin chute extension on the side wall. The system was found to be:

- 5mm solid aluminium cassette panel attached to aluminium rail system.
- 70mm horizontal (floor level) reinforced mineral wool cavity barrier. The cavity barrier sat on top of the insulation (i.e. did not break the insulation).
- 60-70mm clear cavity.
- 110mm mineral wool insulation with metal fixings.
- Presumed 10mm cement particle board (CPB). A hole was drilled through to determine the thickness, however, it could not be further determined what was behind without potentially compromising the integrity of the structure and causing damage internally.

The system present on the refuse chute/lobby section of the building is very similar to the system present on the building with the exception of the substrate. Whilst cementitious particle boards are Euroclass B combustible materials they contribute very little to fire spread generally. BS8414 testing with combustible insulants show that the temperatures at the sheathing board layer are normally low and in the region of room temperature. BB7's recommendations for this system are the same as that for the main system in that cavity barriers should be compression fitted to prevent the unseen spread of fire and smoke.
