EWS1 Report

463- 549D Lodge

Lane Croydon

30th April 2021

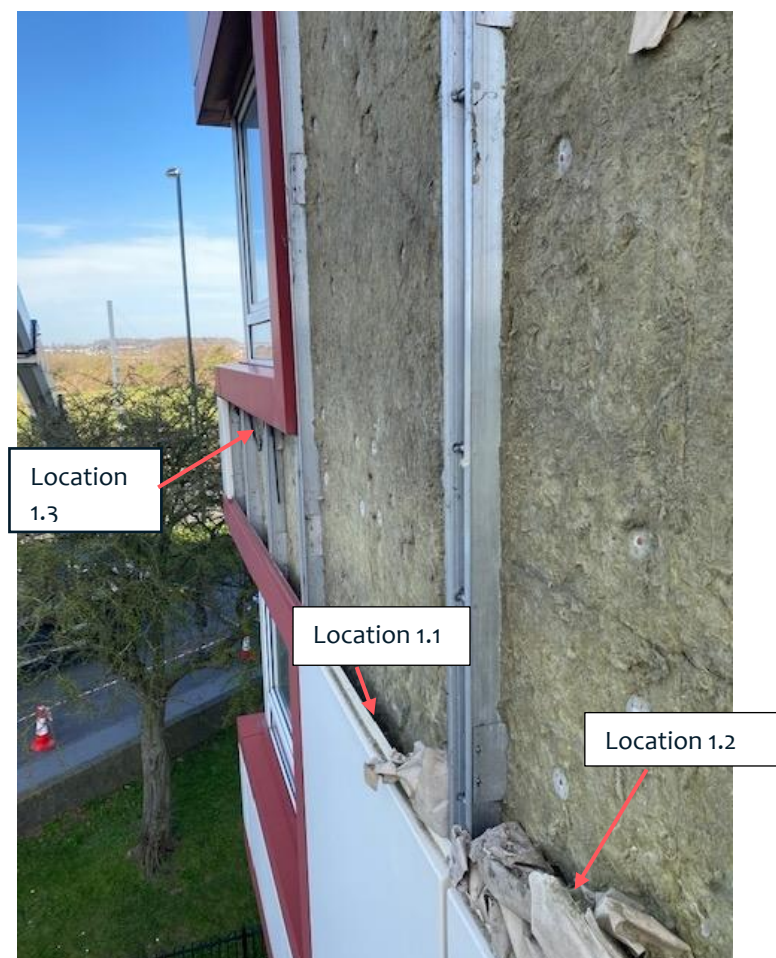
- 5mm solid aluminium cassette panel attached to aluminium rail system.
- 100mm horizontal (floor level) and vertical (party wall) high density mineral wool cavity barrier. The expectation is that cavity barriers should be in place which are aligned with compartment floors within the building, these were not in place in some locations.
- 60-70mm clear cavity.
- 110mm mineral wool insulation with metal fixings.
- >100mm solid concrete. A hole was drilled through the concrete to determine the thickness; however, it could not be further determined what was behind the concrete without potentially compromising the integrity of the structure and causing damage internally. Please refer to Section 3 for further details.

Figure 10. Location 1 areas inspected

The building paper has come away from the face of the mineral wool sheets to which it was originally attached and has subsequently gathered on the horizontal rails of the framing system. It should be noted that the paper is resting on the edge of the panel and not a cavity barrier which was also missing from this location.

recommendation for cavity barrier replacement works to be undertaken. BB7 recommend that cavity barriers are provided at all compartment wall and floor lines where they are found to be missing, and defective barriers should be replaced where found.

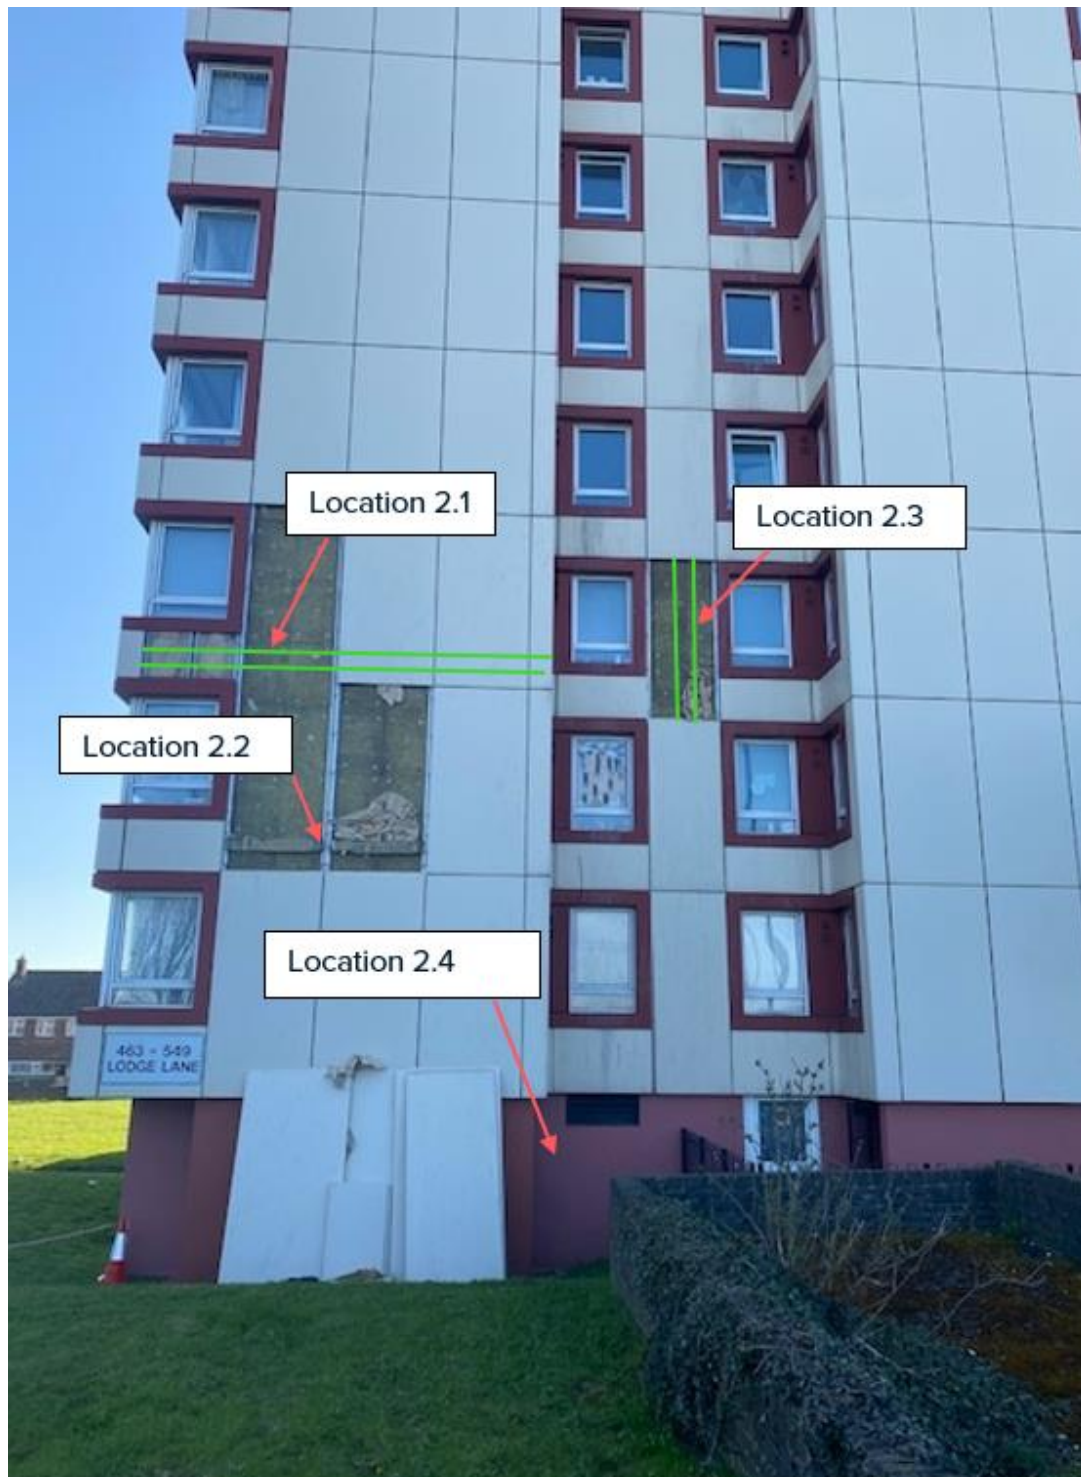
- 5mm solid aluminium cassette panel attached to aluminium rail system.
- 100mm horizontal (floor level) and vertical (party wall) high density mineral wool cavity barrier. The expectation is that cavity barriers should be in place which are aligned with compartment floors within the building, these were not in place in some locations.

- 60-70mm clear cavity.
- 110mm mineral wool insulation with metal fixings.
- 100mm masonry. A hole was drilled through the masonry to determine the thickness; however, it could not be further determined what was behind without potentially compromising the integrity of the structure and causing damage internally.

Figure 15. Location 2 areas inspected The green lines indicate internal compartment lines.

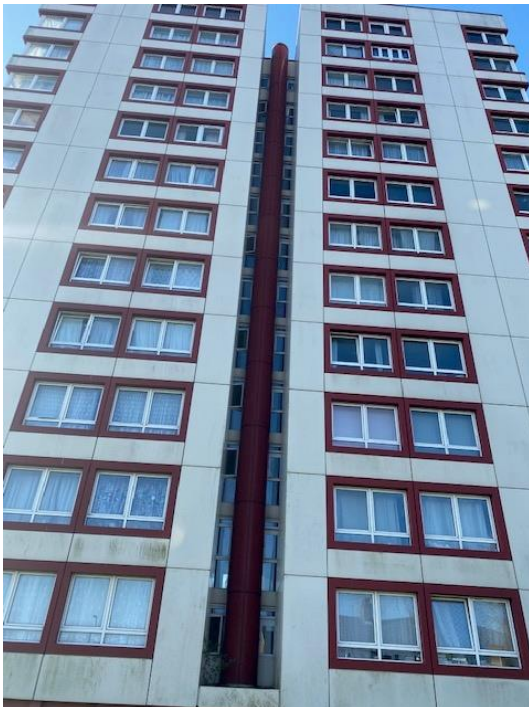
Figure 31. Showing the rubbish chute on the north face of the building

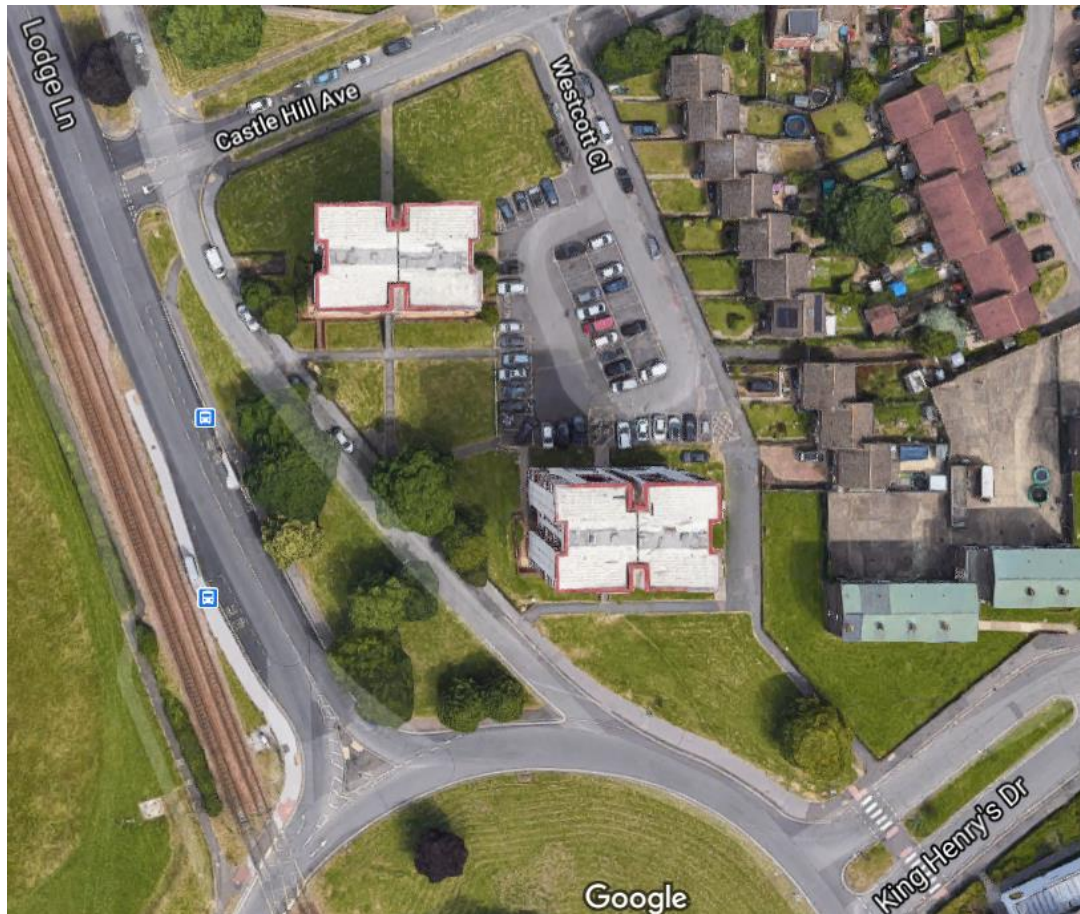
This section has been added to demonstrate the access for a fire appliance to each elevation to fight a fire, statutory access does not include provisions in respect of fighting a fire on the external faces. Although the height of fire service aerial appliance is around 28m to 30m access roads are not designed to allow for rescue operations to all parts of the elevations, there is likely to be sufficient access to provide a reasonable application of water to the elevations.

Figure 36. Site Plan

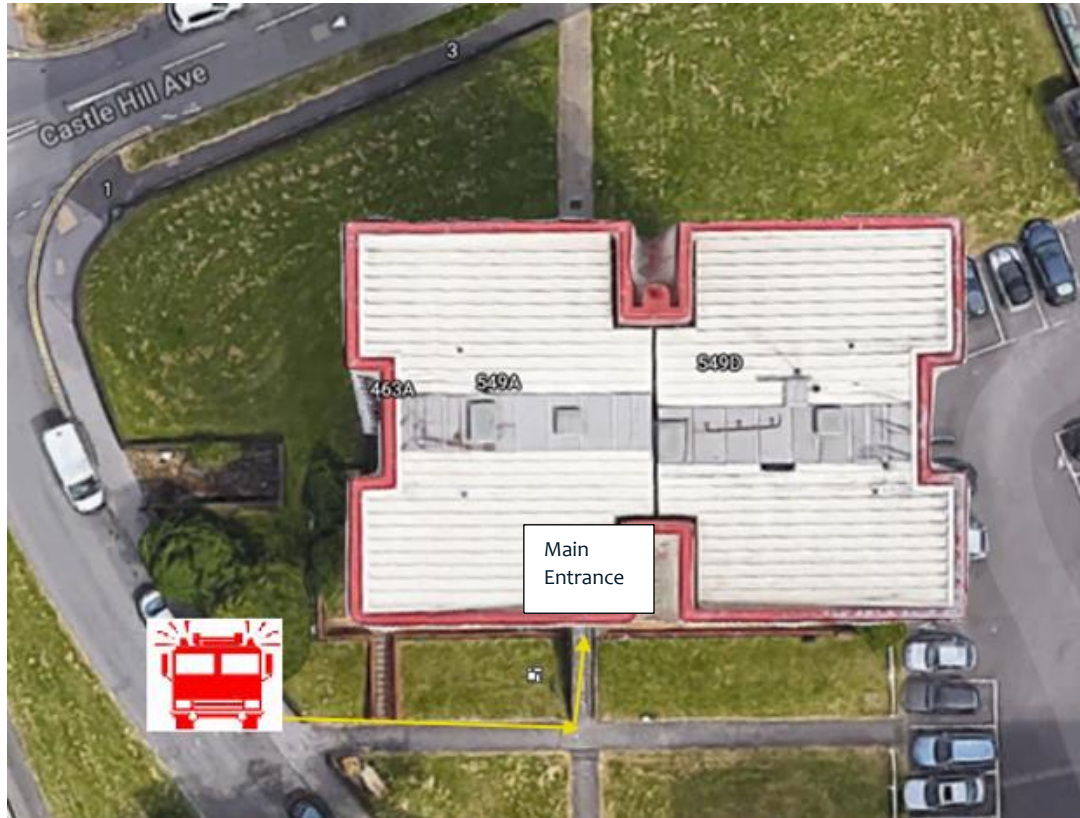
There are dry riser outlets provided on alternate floors levels within the lobby serving the stair. The riser inlet is provided in the lobby on the ground floor.

Figure 37. Site Plan showing access route to the dry riser inlet.
