EWS1 Report

1-44 Keeling Court

30th April 2021

12125BB

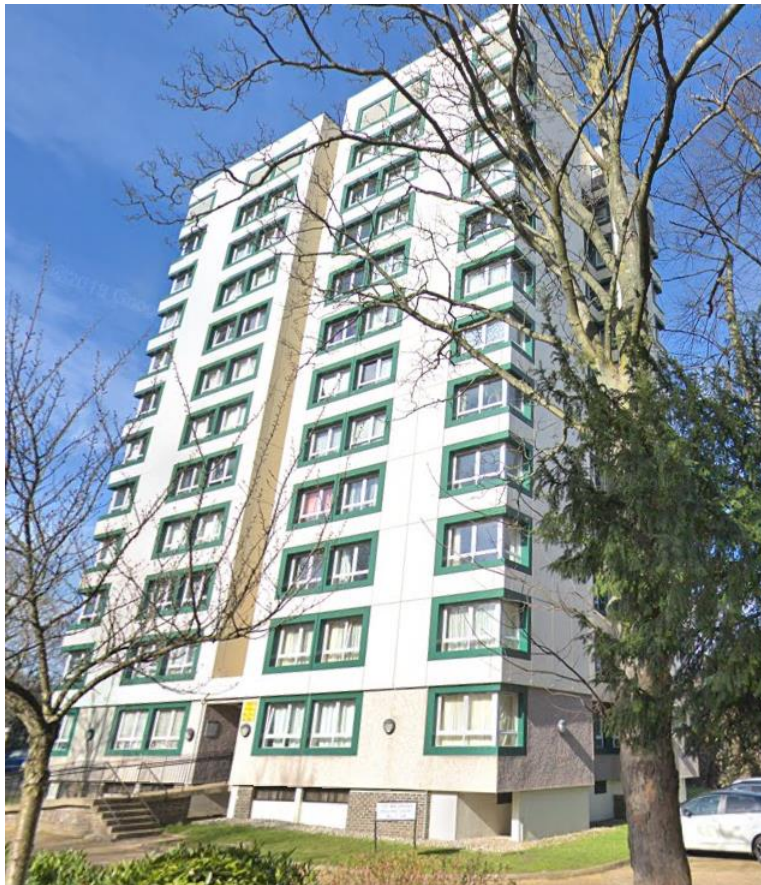
Figure 1. Block overclad. Presumed circa late 1990's

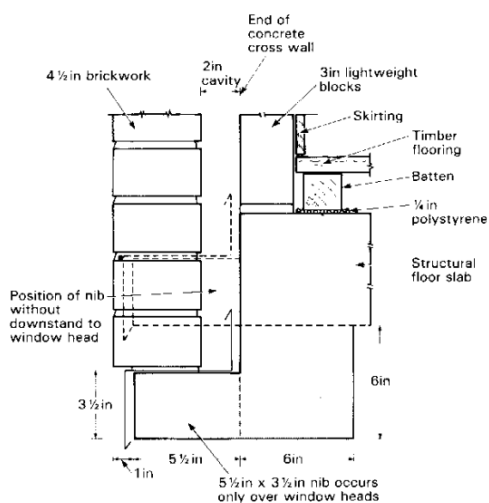
Figure 5. Typical brick on RC downstand

Similar to the method shown in Figure 5 there are a number of instances where the facing brick work is supported with an RC upstand/downstand. The residual cavity formed is similar to that shown in Figure 6.

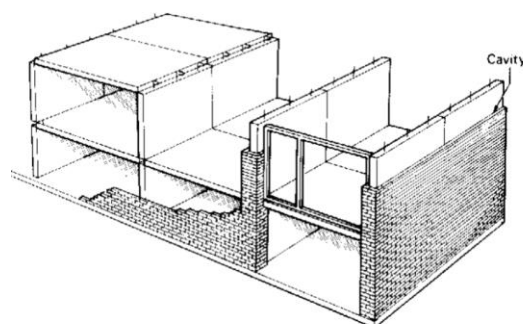
Figure 6. Typical brick façade to LPS

A cavity is typically formed between the facing brick work and the RC structure/block work substrate. Based on drill hole surveys this cavity was found to exist., but it could not be determined whether insulation exists in this cavity.

Typically, cavity barriers can be omitted from cavities formed between two layers of masonry which are >75mm thick, and the guidance has historically allowed for combustible insulation to be present in such cavities. This is due to the fact that masonry is dense, inert, robust and non-combustible and is very unlikely to contribute to uncontrolled fire spread. As per the rest of the wall system the brick work is situated by c. 100mm mineral wool insulation which will offer a high degree of protection. On that basis it is considered reasonable to omit the areas behind the facing brick work from the risk assessment, however, the presence will still be acknowledged.

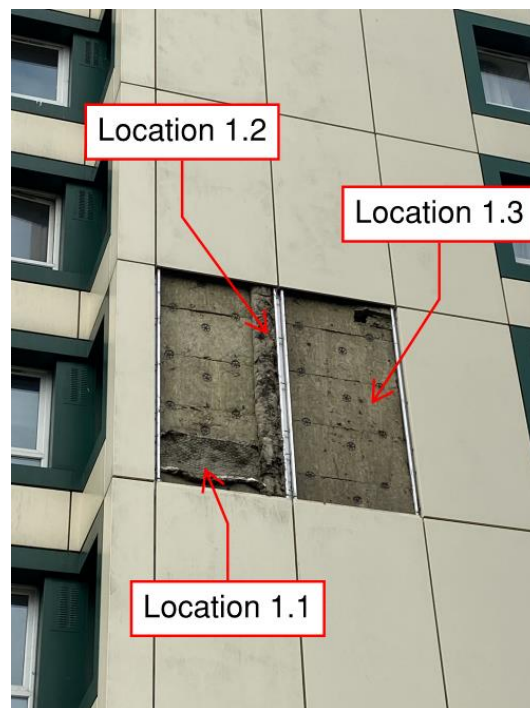
Figure 9. Location 1 areas inspected

- 120mm vertical cavity barrier that was folded and under compression. However, this location does not appear to be a compartment line between two flats or similar separation.

- 60-70mm clear cavity.
- 100mm mineral wool insulation with plastic fixings.
- 100mm solid concrete. A hole was drilled through the concrete to determine the thickness, however, it could not be further determined what was behind the concrete without potentially compromising the integrity of the structure and causing damage internally. Please refer to Section 3 for further details.

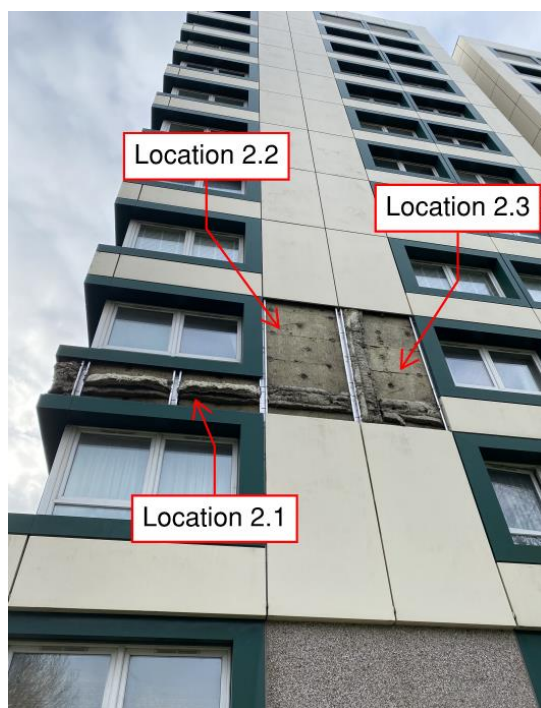
Figure 16. Location 2 areas inspected

- 5mm solid aluminium cassette panel attached to aluminium rail system.
- 100mm horizontal (floor level) mineral wool cavity barrier reinforced with wire. The cavity barrier sat on top of the insulation (i.e., did not break the insulation) and was not under compression in a number of cases.
- 60-70mm clear cavity.
- 100mm mineral wool insulation with plastic fixings.
- 100mm solid concrete. A hole was drilled through the concrete to determine the thickness, however, it could not be further determined what was behind the concrete without potentially compromising the integrity of the structure and causing damage internally. Please refer to Section 3 for further details.

Location 2.1 was on the second floor below a window on the corner of the building. The windows have been installed into the original structural openings and, therefore, have not been moved to suit the cavity. Cavity barriers are not continuous either below windows or at slab level as they are interrupted by the cladding rails. The brackets centrally located along wider cladding panels, such as those under the window, are hidden completely, particularly on the left hand side of Figure 17, so are not open to the atmosphere. The cavity barrier is broken where the fixing bracket passes through it.

Again, the barriers were mineral wool type product reinforced with wire, which were common at the time of installation. This cavity barrier has to be folded over in order to ensure that the barrier fills the full depth of the cavity to reach the rear of the cassette panel, however, the barriers were found in some cases to be poorly fitted with gaps appearing next to the façade carrier system, it was not under compression so it may allow fire to bypass the compartment line here, which is not permissible.

For the cavities to be divided at compartment lines, as was the design intent of guidance at the time of the over cladding, it is recommended to ensure horizontal and vertical cavity barriers are installed along compartment lines and are fitted under compression. Reference should be made to the relevant sections of ADB for materials, orientation, and fixings.
