# **EWS1 Report**

## **Sevenoaks House**

30<sup>th</sup> April 2021

Croydon Borough Council

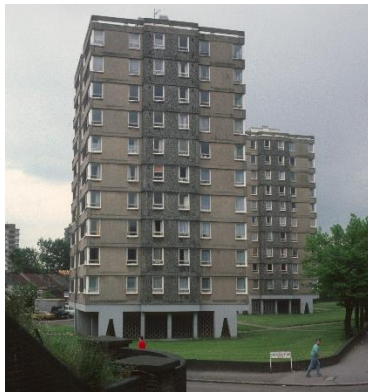
**Figure 1.** Block with existing cladding circa 1960s

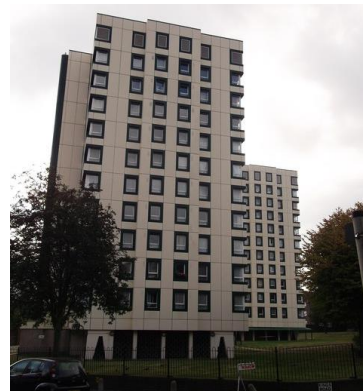
**Figure 2.** Block overcladd. Presumed circa 1990s

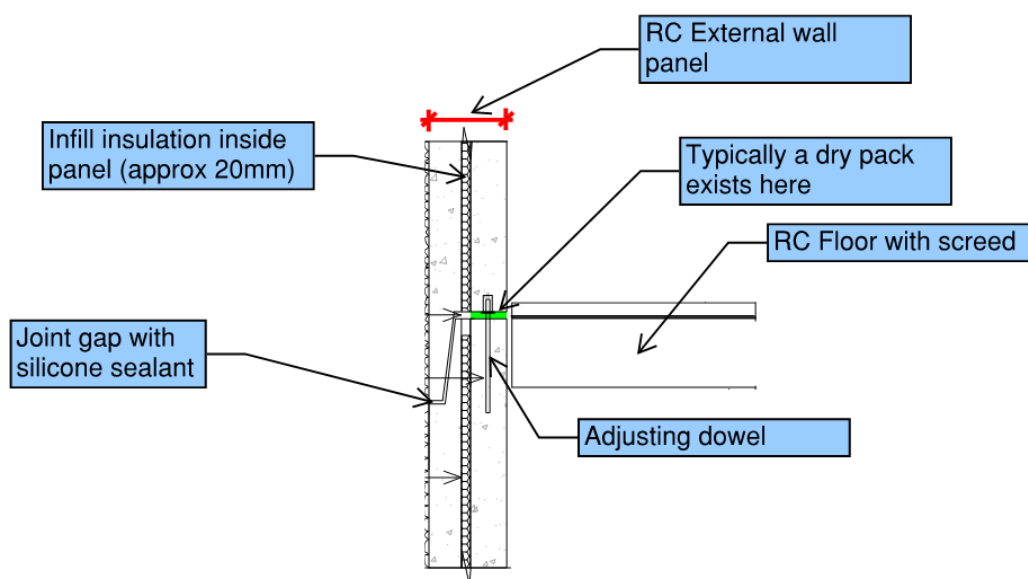
**Figure 5.** Typical composition of external walls

It can be seen that there is a thin insulation layer within the panel itself and there is a path to this cavity from outside at the joint gap. This insulation is typically a form of EPS or XPS which is a highly combustible substance, however, it is encapsulated between two >100mm leaves of reinforce concrete (RC) which means it is offered a significant degree of protection. The cavity in which the insulation exists is generally 20mm wide, but this can vary across the different manufacturers. Based on making drill holes at the building it was found that the cavity was within the 20-25mm range. There is a route for fire spread via the joint between panels, the silicone sealant used is of a substantial volume and will offer some fire resistance into the panel system, however, a period of time cannot be determined. Typically, a dry pack is present which aids in preventing fire re-entry into the building.

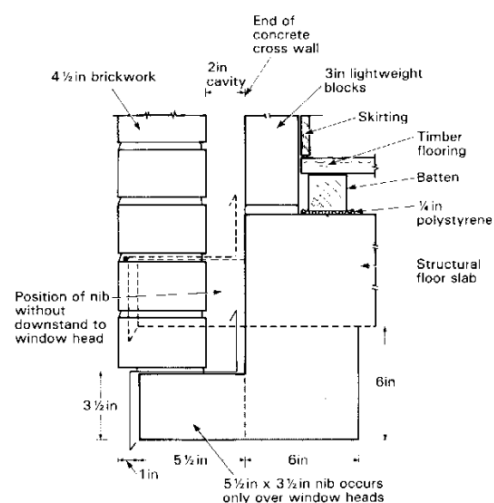
Similar to the method shown in Figure 6 there are a number of instances where the facing brick work is supported with an RC upstand/downstand. The residual cavity formed is similar to that shown in Figure 7.

**Figure 6.** Typical brick on RC downstand

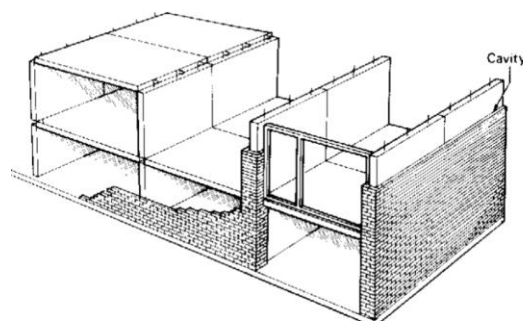
**Figure 7.** Typical brick façade to LPS

A cavity is typically formed between the facing brick work and the RC structure/block work substrate. Based on drill hole surveys this cavity was found to exist, but it could not be determined whether insulation exists in this cavity.

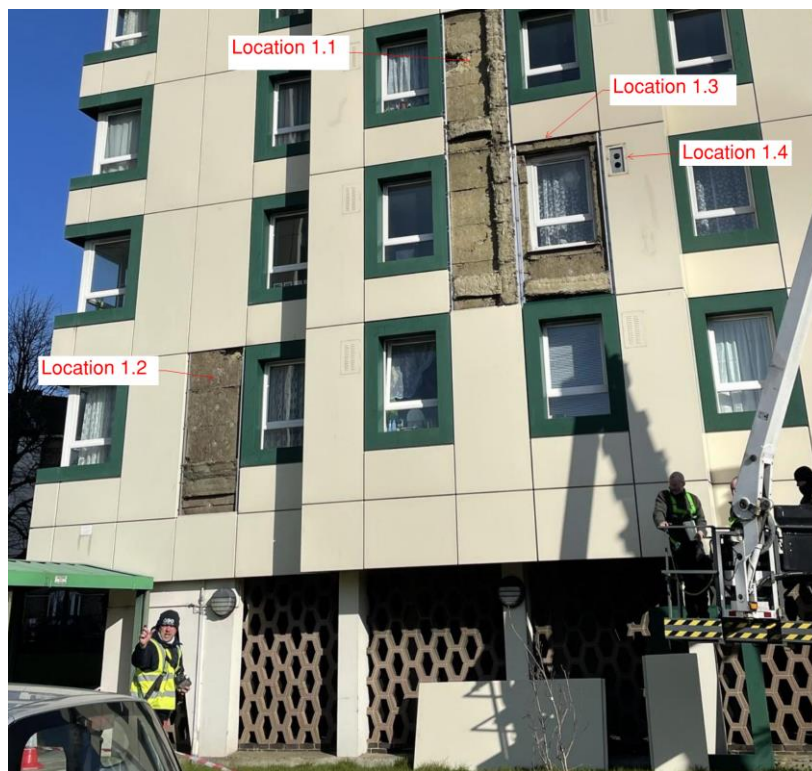
**Figure 9.** Location 1 areas inspected

- 5mm solid aluminium cassette panel attached to aluminium rail system. The panel was approximately 50mm deep due to it being a cassette.
- 100mm horizontal (floor level) and vertical (party wall) mineral wool cavity barrier reinforced with wire. The cavity barrier sat on top of the insulation (i.e. did not break the insulation) and was under compression in all instances surveyed.
- 60-70mm clear cavity.
- 110mm mineral wool insulation with metal fixings.
- >100mm RC Structure. A hole was drilled through the concrete to determine the thickness, however, it could not be further determined what was behind the concrete without potentially compromising the integrity of the structure and causing damage internally. Please refer to Section 3 for further details.

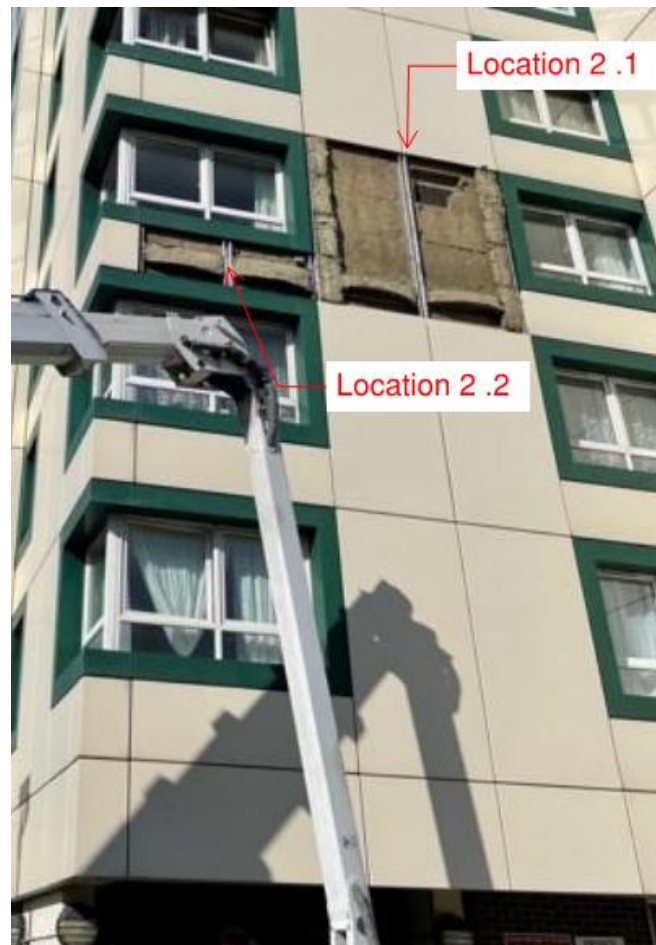
**Figure 22.** Location 2 areas inspected

- 5mm solid aluminium cassette panel attached to aluminium rail system.
- 100mm horizontal (floor level) and vertical (party wall) mineral wool cavity barrier reinforced with wire. The cavity barrier sat on top of the insulation (i.e. did not break the insulation) and was under compression.
- 60-70mm clear cavity.
- 110mm mineral wool insulation with metal fixings.
- 100mm masonry. A hole was drilled through the masonry to determine the thickness, however, it could not be further determined what was behind without potentially compromising the integrity of the structure and causing damage internally. Please refer to Section 3 for further details.
- The presence of brick work is as expected based on Figure 1.
